# Abrasive Effects Observed in Concrete Hydraulic Surfaces of Dams and Application of Repair Materials

José Carlos Alves Galvão,  
Kleber Franke Portella and Aline Christiane Morales Kormann  
*Federal Technological University of Paraná, Institute of Technology for Development,  
Federal University of Paraná  
Brazil*

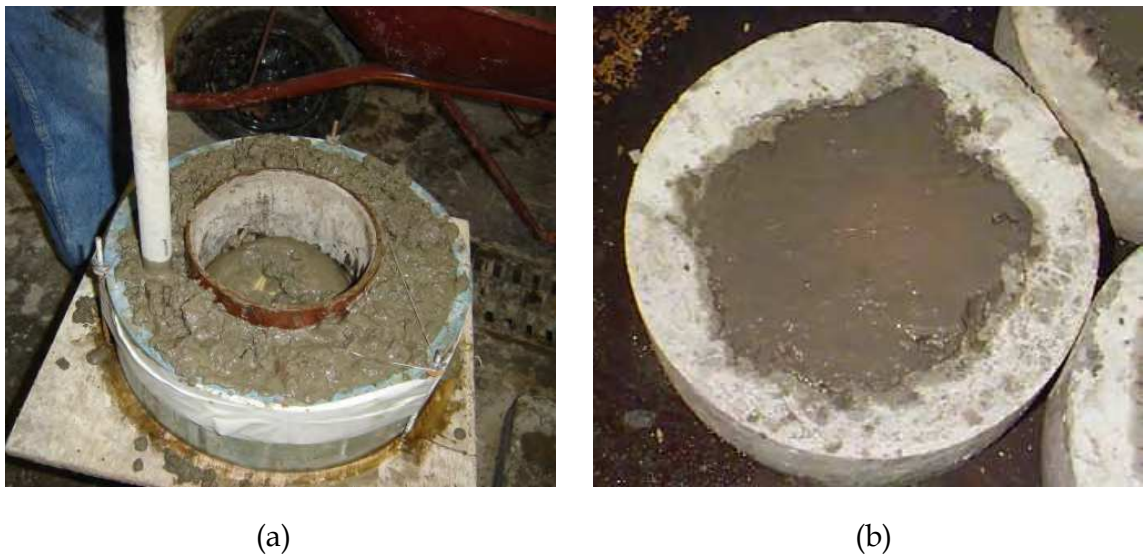
Fig. 3. Preparation of specimens for testing abrasion. (a) Release and compacting concrete reference. (b) System: substrate | repair material.

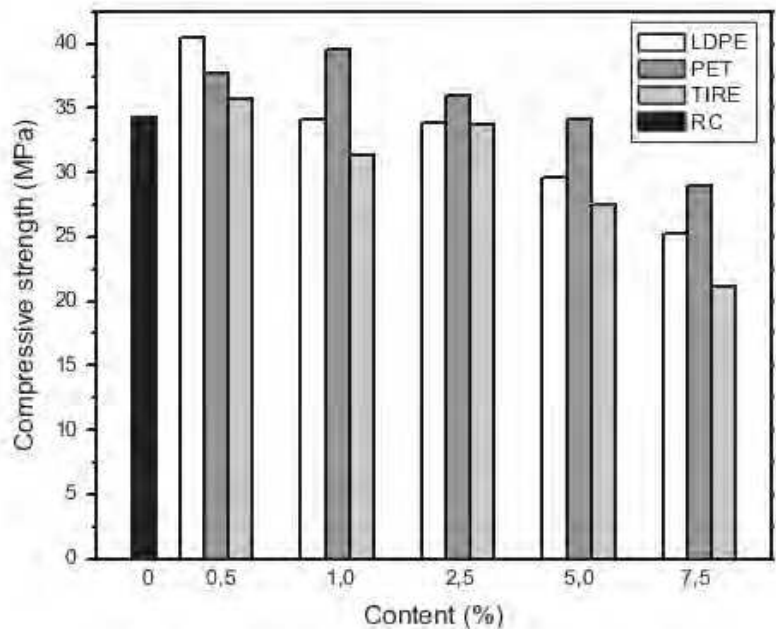
In Figure 9, shows the average results of compressive strength at 28 days to cure the concrete with the addition of recycled polymer materials (Galvão et al, 2011).

Fig. 9. Comparative graph of compressive strength, at 28 days, of concretes with additions of waste and its respective contents.

For the different materials studied and their respective contents verified that the results obtained from tests for compressive strength as a function of curing time were inversely proportional to the content of addition of recycled fibers. This trend was also observed by Choi et al (2005) when they studied the effects of adding waste PET bottles in the properties of concrete and by Al-Ismail & Hashmi (2008) in the bond strength between the surface of the waste polymer and cement paste.

In the analysis of all the values of compressive strength (Fig. 9), were chosen levels of 2.5% and 5.0% addition of recycled material for the manufacture of polymeric materials to repair
