Seismic Performance of Historical and Monumental Structures

Halil Sezen and Adem Dogangun

1. Introduction

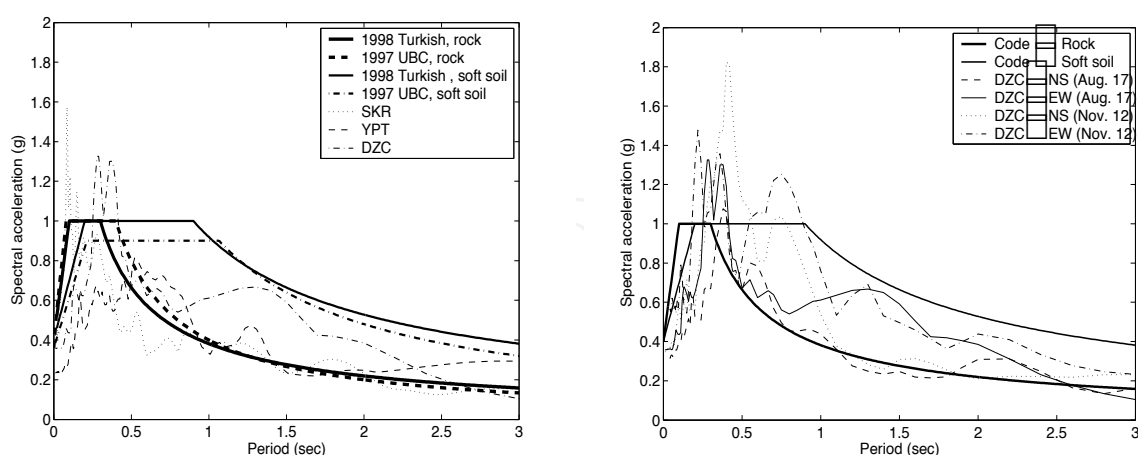
Figure 1. Absolute Acceleration Response Spectra

The descriptions of ground motion characteristics, structural damage, and performance of structures during these earthquakes are provided in Sezen et al. (2003). Response spectra for selected acceleration histories for 5% damping are presented in Figure 1. The ground motions included in Figure 1 were recorded at: SKR station in Adapazari (Peak Ground

Acceleration, PGA 0.41g, stiff soil); YPT station in Yarimca (PGA 0.23g, soft soil); and DZC station in Düzce (PGAs: EW-Aug.17 0.36g, NS-Aug.17 0.31g, EW-Nov.12 0.54g, and NS-Nov.12 0.35g, soft soil). Figure 1 also provides a comparison between the linear elastic acceleration response spectra calculated for rock and that calculated for soft soil sites using the provisions of the Uniform Building Code (UBC, 1997) and those of the Turkish seismic code (1998) with 5 percent damping for the highest seismicity in the United States and in Turkey, respectively. From Figure 1, it can be concluded that, for a structure with given periods of vibration, the difference between the base shear calculated using the 1998 Turkish seismic code and the base shear demand obtained from the recorded acceleration response spectra do not differ significantly. If the static lateral load distribution over the height is suggested by the code is assumed to be credible, structures designed and detailed according to the Turkish code should not have collapsed or suffered severe damage during the 1999 earthquakes.

Specifically, according to Figure 1, a structure with a fundamental period of 0.5 seconds would be subjected to seismic forces larger than those specified in the code. The period of older masonry structures with thick and shorter walls tends to be relatively small, probably 0.5 seconds or less. On the other hand, the minarets or very slender towers tend to be very flexible with relatively large fundamental periods. Figure 1 shows that the recorded spectral accelerations are significantly large at large periods. The authors' field observations after the 1999 earthquakes, especially the November 12 Duzce earthquake (DZC), showed more damage in slender structures like minarets. In addition, among other factors leading to inadequate performance, the extent of damage observed in most reinforced concrete structures including minarets after the 1999 earthquakes is probably related to poor engineering and lack of conformance to the relatively new Turkish seismic code.

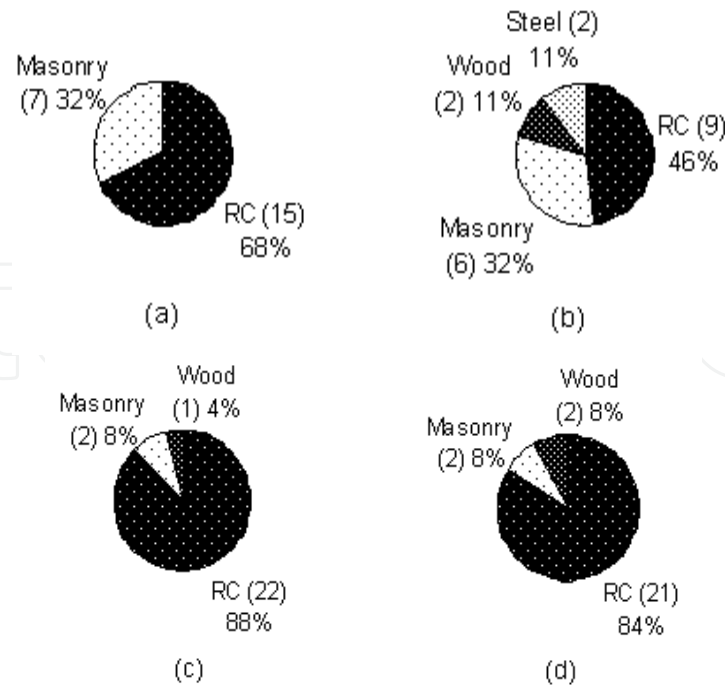
Figure 5. Type of construction for (a) mosques, (b) minarets in Bolu; and (c) mosques, and (d) minarets in Duzce and Kaynasli (number of mosques/minarets is given in parenthesis)

Before mid-1960s, major construction materials were wood and stone or brick masonry. Most of the recently constructed mosques and minarets were reinforced concrete. All of the reinforced concrete mosques were built after 1965. In older mosques, solid bricks were used in infill walls. Hollow clay tiles were used as infill material in the mosques built after late 1970s. As shown in Figure 5, 84 percent of the minarets surveyed in Duzce and Kaynasli were reinforced concrete, whereas only 46 percent of the minarets were reinforced concrete in Bolu. Unreinforced stone masonry was commonly used in old minarets as well as in the minarets constructed in recent years.

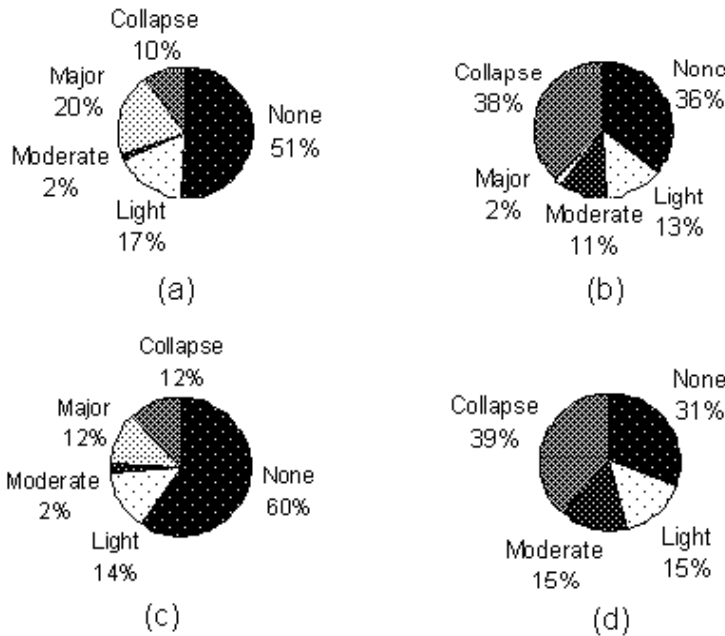
Figure 6. Damage distribution for (a) all mosques and (b) all minarets, and damage distribution for (c) RC mosques and (d) RC minarets

The Figure 6 shows the damage distribution for the mosques and minarets surveyed. Damage distribution for RC mosques and minarets are presented in Figures 6c and 6d separately.

Comparison of Figures 6a and 6c indicates that the damage in RC mosques was less as compared to other structural systems. More than ten percent of the mosques surveyed collapsed. Three of the 26 mosques surveyed in Duzce and Kaynasli region collapsed. There was no collapsed mosque in Bolu, but five of the 21 mosques surveyed had to be closed after the October 12, 1999 earthquake. Closed Mosques in Bolu were Semsi Ahmet Pasa (Imaret),

As illustrated in Figures 6b and 6d, percentage of all damaged minarets and only RC minarets are similar. Almost forty percent of the minarets collapsed, and approximately one third of the minarets were undamaged. Failure plane for almost all collapsed RC minarets was within 1.5 meter long region above the minaret base or pyramid-shaped transition segment (Figure 7a), where the longitudinal reinforcing bars were usually spliced. Horizontal circumferential cracks and spalling of concrete were commonly observed at the bottom of the cylindrical body of RC minarets (Figure 7a). Frequently, flexural cracks, concrete crushing or spalling was observed in this region of the damaged RC minarets. As shown in Figure 7, less frequently collapse or damage occurred within the transition segment and middle of the cylindrical body or near the top of the minaret.

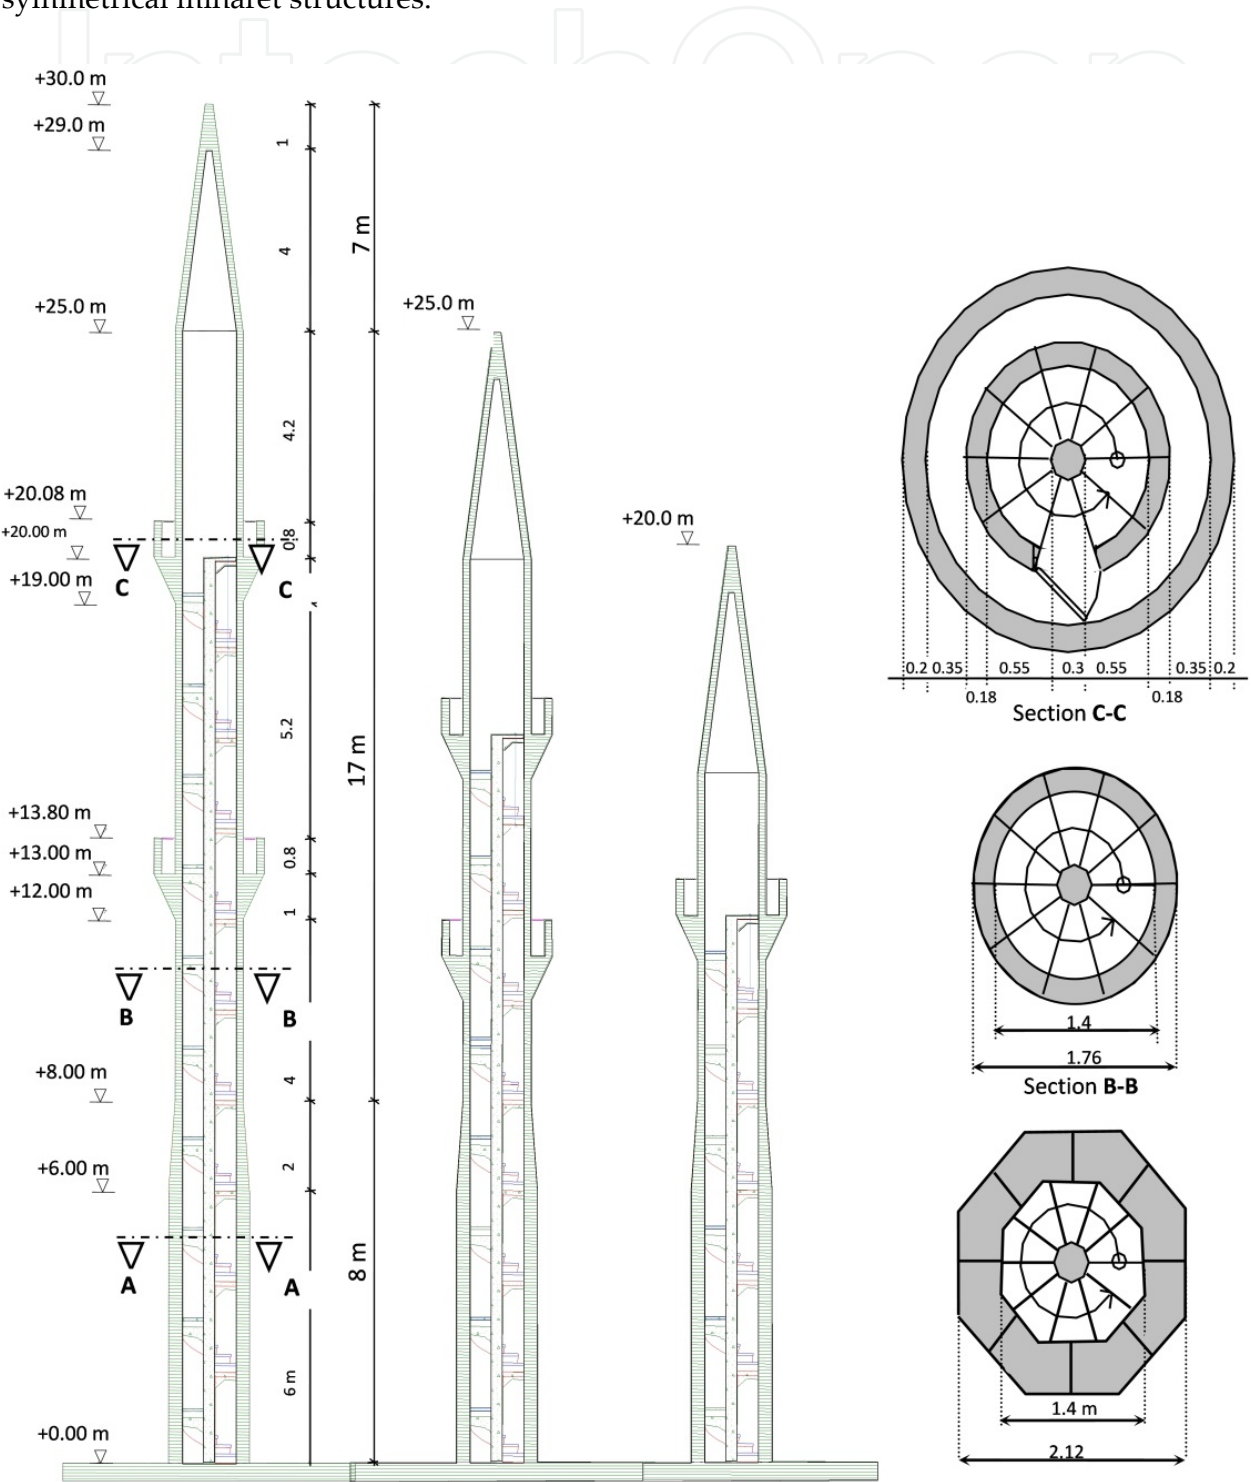
Figure 11. Three minaret models and their geometrical and cross-sectional properties

Although the height of a minaret varies greatly depending on many factors such as the location or construction materials used, the height of a typical minaret with a single balcony over its height is about 20 to 25 m. In this research, two generic minarets with a height of 25 and 30 m and double balconies (Minaret I and Minaret II) and another 20 m tall minaret with a single balcony (Minaret III) were modeled and analyzed. As shown in Figures 11 and 12, only the height of the cylindrical minaret body was varied while the geometrical properties of the base or boot, transition segment, balconies and conical cap were kept the same in all three models. It should be noted that not all conical caps at the top of the masonry minarets are constructed using masonry materials. For uniformity, all minarets including the conical caps are modeled with the same masonry material in this study.

and flexural stiffness. The calculated first or fundamental periods were 1.41, 0.90, and 0.51 seconds for the minaret models I, II, and III, respectively. The calculated modal response quantities indicate that the contribution of higher mode effects to total dynamic response is significant. The first mode contribution to the total response is about 47 or 49 percent. The torsional or the fifth mode has virtually no effect on the total response of the almost symmetrical minaret structures.

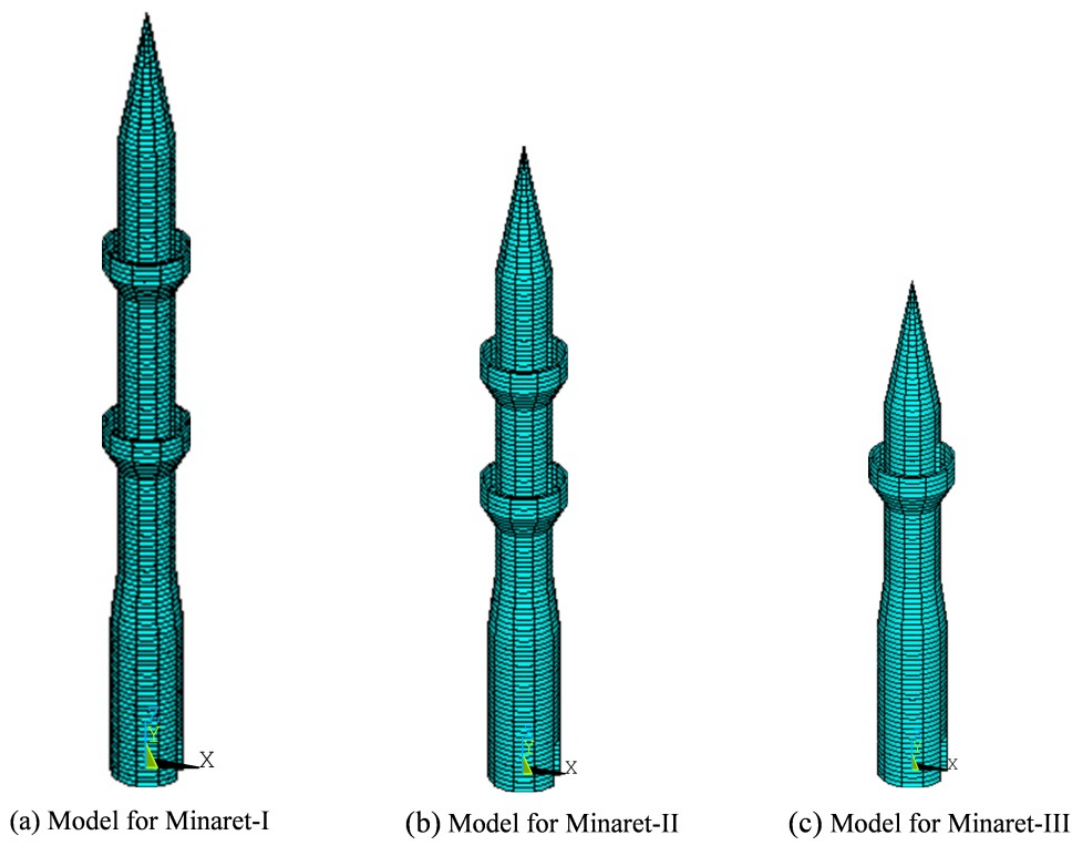
Figure 12. Finite element models of the three minarets

The finite element models of the three minarets are shown in Figure 12, and significant mode shapes of a typical minaret are shown in Figure 13 (Sezen et al. 2008). The computer program, ANSYS was used to model and analyze the minarets (see Dogangun et al. 2008 for details). In the models, the modulus of elasticity of uncracked section, Poisson's ratio and unit weight of masonry material (ordinary limestone) are taken as 3000 MPa, 0.2, and 20 kN/m³, respectively. In the models, linear elastic material models and five percent damping ratio is used in all dynamic time history analyses. It is assumed that the minaret is located in a high seismic region Zone 1 in Turkish Earthquake Code (TEC, 2007). Considering the TEC, a structural behavior factor, R of 3 and an importance factor, I of 1.2 can be used for such structures.

The most critical axial stress contours calculated during the dynamic analysis of minaret models are shown in Figure 15. The maximum tensile and compressive stresses occur at a height of 8 m, immediately above the transition zone (Figure 12). This is consistent with the most common minaret failure mode observed in the field after the earthquakes (Figures 7a, 8a and 8b). The minaret models used here were stand-alone fixed-ended cantilevers, which did have any lateral support over their height. Nevertheless, in some cases one side of the minaret boot or base (bottom 6 m of the minaret models) are supported by or attached to the mosque structure (Type II in Table 4, e.g., Figures 8a and 8b). Such a partial lateral support, even on one side, provides added stiffness near the bottom of the minaret. This will further increase failure potential at the top of the transition zone as shown in Figures 7a, 8a, 8b and 14.
