# Power System Protection Design for NPP

Chang-Hsing Lee and Shi-Lin Chen

## 2. Taipower "318 Event"

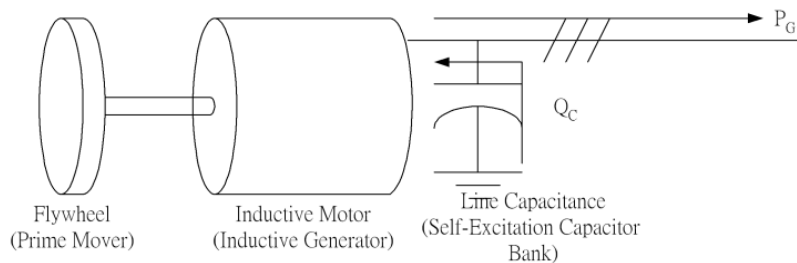
**Figure 4.** Equivalent Circuit of Motor-Generating Effect.

Figure 4 shows the 2 essential condition for induction motor generating effect: large capacitance and continuous rotating motor. When an induction motor lost its external voltage source, the flywheel with large inertia will keep the motor rotating and the capacitance of transmission line will provide the necessary voltage support for the induction motor to act as a generator. The magnetization curve of the motor and the amount of capacitance will jointly determine the overall motor generating effect as shown in Fig. 5. If the capacitance is too small to provide enough magnetizing current (curve C0 in Fig. 5), the terminal voltage of motor will decay exponentially and the generating effect will not sustain. However, if the capacitance is large enough, the motor generating effect will sustain and the terminal voltage is determined by the intersection of the capacitance and magnetizing curve such as (V1, C1) and (V2, C2) in Fig. 5.

At "t1" in Fig. 3(a), the last 345kV transmission line connecting to the NPP was tripped on remote end due to a flashover on the line turning the NPP into an electrical island. As the local end of the 345kV line did not trip, a motor generating condition equivalent to Fig. 4 was formed with the 127km transmission line providing sufficient capacitance to support the voltage of the various motors in the NPP. As can be seen in Fig. 3(b), the terminal voltage is increased to 1.4 p.u. and the overall resultant frequency is 56 Hz.

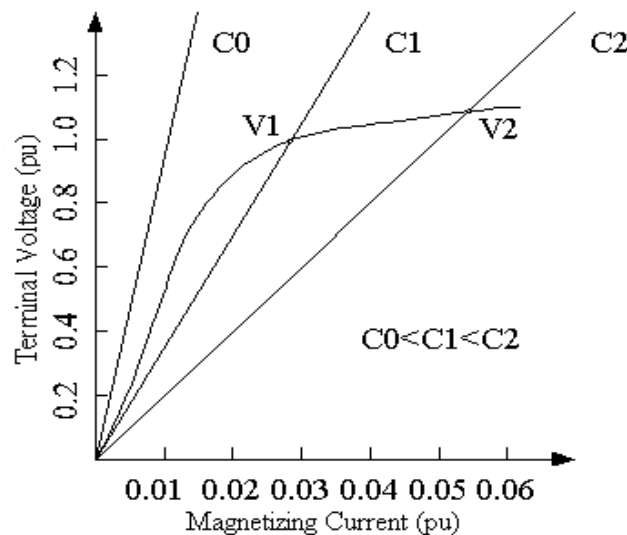
**Figure 5.** Relationships between Motor Terminal Voltage, Magnetization Curve, and External Capacitance

During this first overvoltage period, the terminal voltage of motor was about 1.4 p.u. (Fig. 3(b)) but the line voltage was about 1.29 times the rated line-to-ground peak voltage (Fig.

3(a)). This implied that the power transformers have saturated. As a result, a lot of harmonics were produced and the zero sequence components of them would be integrated into the neutral voltage resulting in unexpected high neutral voltage. This period ended at "t2" in Fig. 3(a) when the flashover grounded both phase A and B.

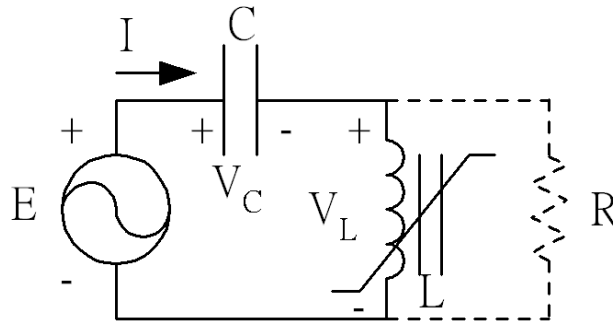
**Figure 6.** Equivalent RLC Circuit

Figure 6 shows the four essential conditions for a ferroresonance to occur: voltage source, capacitance, nonlinear inductance (ferromagnetic and saturable), and low losses. The R in the RLC resonant circuit in Fig. 6 is very large due to the "low losses" condition and can often be ignored. The nonlinear inductance L is the magnetizing curve of the motors and transformers in the system and the capacitance is provided by the transmission line.

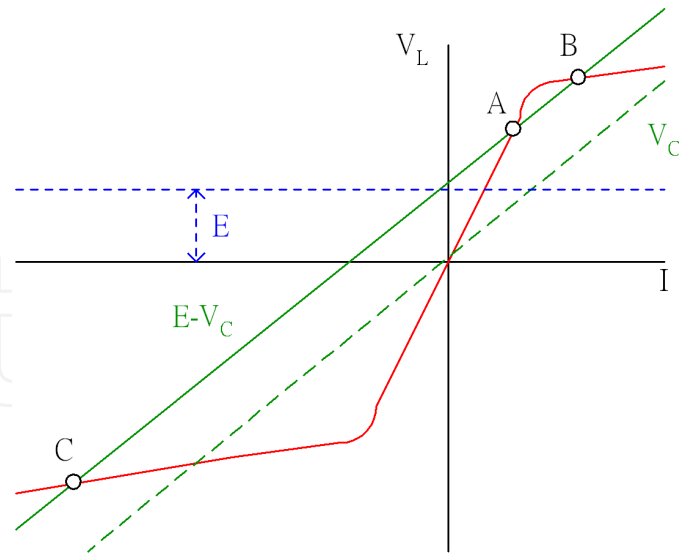
**Figure 8.** Ferroresonance Phenomenon Explanation

As the inductances in the systems are now deeply saturated, there is a possibility that ferroresonance can occur. (Note: Ferroresonance is nonlinear resonances in power system where the voltage and current may change from normal steady state to another steady state with large harmonic distortion.) The phenomenon can be best understood from a circuit perspective using Figure 6 as example. In Fig. 6, the total equivalent impedance of the circuit is  $(jX_L - jX_C)$ . When the inductance is saturated and current further increases, it will drive the inductor into deeper saturation where the inductor impedance  $jX_L$  will reduce when current further increases. A critical point will be reached at Point B in Figure 8 when  $(jX_L - jX_C)$  becomes zero. Any current increase beyond Point B will cause the total impedance change from a positive value to a negative value causing resonance effects near this operating point[7].

Based on analysis of all available data, it is believed that the 2<sup>nd</sup> overvoltage from t4 onward is on the boundary to be ferroresonance therefore the 2<sup>nd</sup> overvoltage is caused by a combination of motor-generating effect and nonlinear resonance.

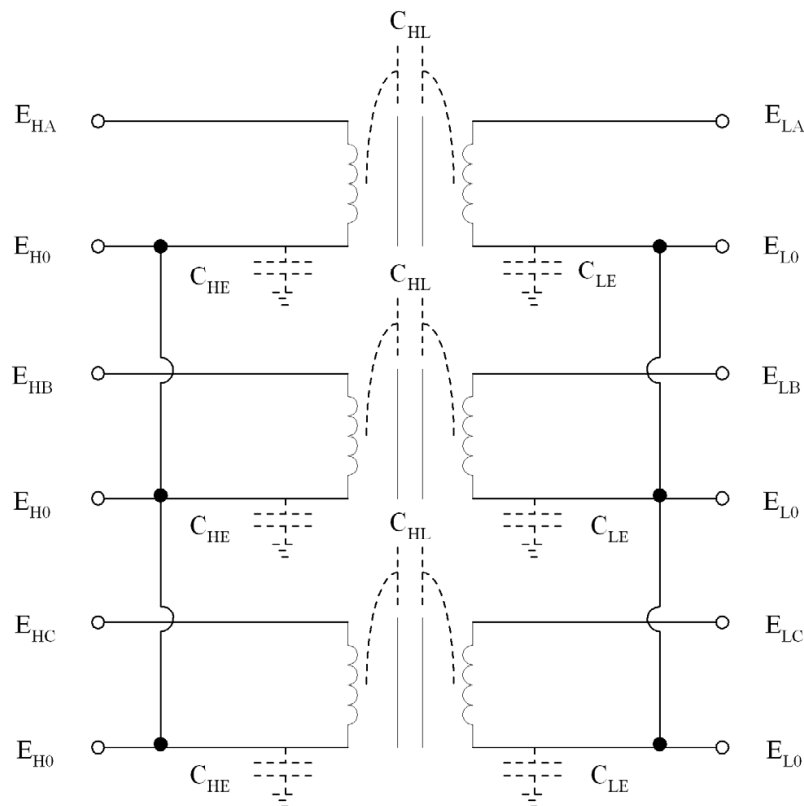
**Figure 9.** Voltage Transfer Diagram of 345 kV/4.16 kV Transformer

It can be seen from Figure 3 that overvoltage can be observed not only on the line conductor but also on the neutral conductor as well. In order to understand this phenomenon we need to look at Fig. 9 where the equivalent circuit of a transformer is shown including its stray capacitances.

In Fig. 9,  $C_{HE}$  and  $C_{LE}$  depict the stray capacitance between high voltage (HV) winding to ground, and low voltage (LV) winding to ground, respectively, while  $C_{HL}$  depicts the stray capacitance between HV and LV windings. Typical stray capacitances for the 345/13.8/4.16kV power transformer are shown in Table 3.

As indicated by Fig. 3(a), the neutral on 345kV side does not appear to have been effectively grounded possibly due to grounding failure. The result is that very high neutral voltage was established on the 345kV neutral and if the 4.16kV neutral was not grounded it will see a neutral voltage (through capacitive neutral transfer) of
