# Failure Analysis of High Pressure High Temperature Super-Heater Outlet Header Tube in Heat Recovery Steam Generator

Ainul Akmar Mokhtar and  
Muhammad Kamil Kamarul Bahrin

## Abstract

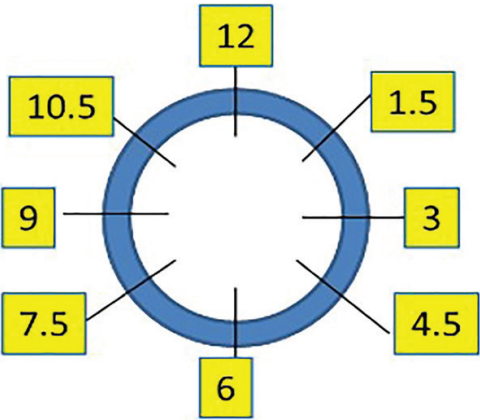
Figure 7. Dimensional reference of OD and ID tube.

The OD and ID for both tubes did not show any significant signs of tube bulging, deformation and wall thinning over the length, as compared to the design values, where OD was 31.8 mm and ID was 26.2 mm.

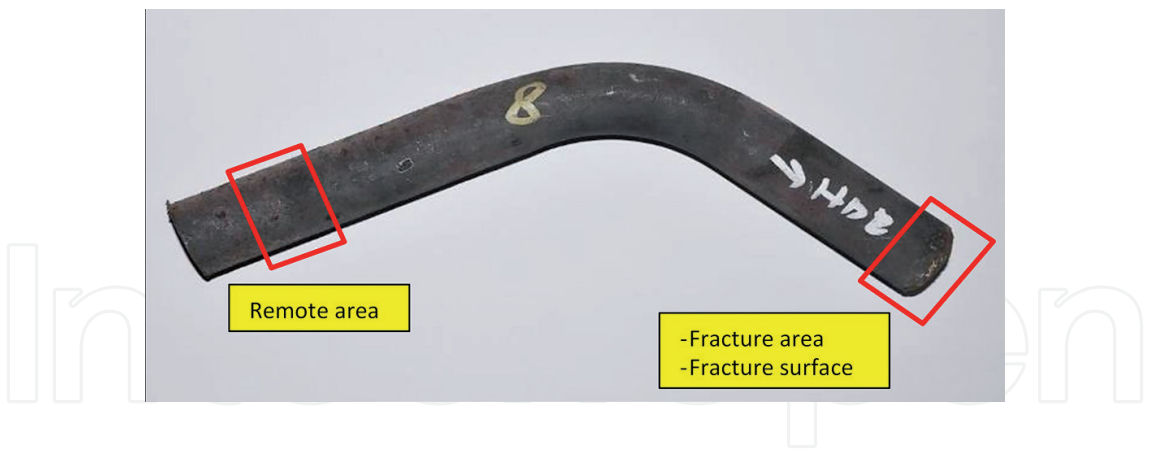
Figure 9. Dimensional reference of oxide thickness measurement.

The location of interest for internal oxide assessment for Tube 8 and Tube 18 is shown in Figure 9.
