Degradation Monitoring of Photovoltaic Plants: Advanced GIS Applications

Miguel de Simón-Martín, Ana-María Diez-Suárez,
Laura-Álvarez de Prado, Alberto González-Martínez,
Álvaro de la Puente-Gil and Jorge Blanes-Peiró

<http://dx.doi.org/10.5772/intechopen.75650>

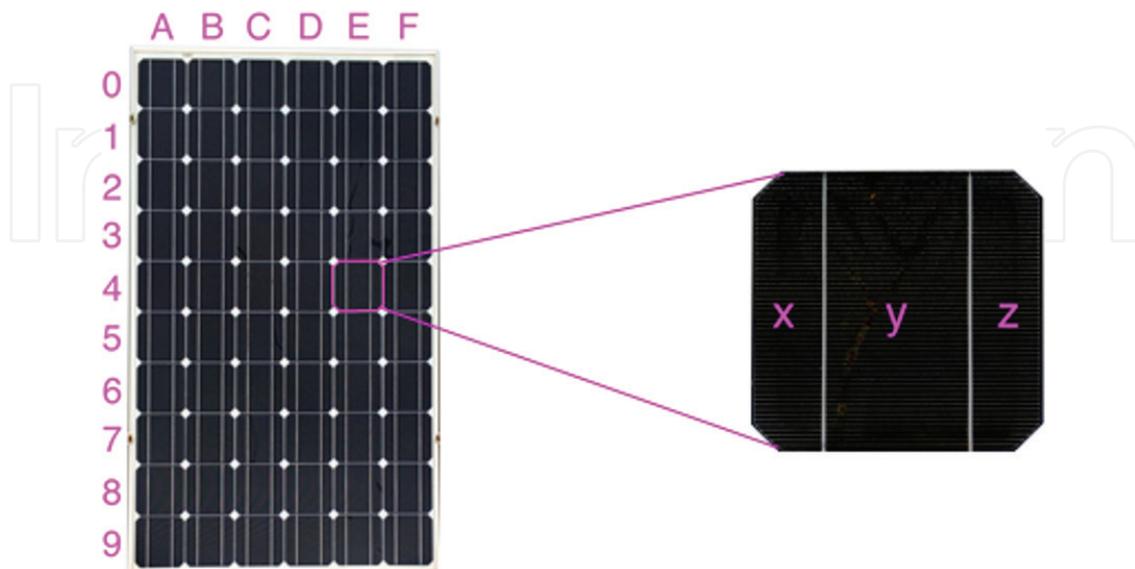
Figure 5. Adopted nomenclature for PV defect identification.

A systematic procedure needs to be set up to identify the geographical position of a defect within a panel. A photovoltaic module is made up of 180 thirds of cells so the following nomenclature is suggested. Each cell in the panel can be split into 6 columns (A–F) and 10 rows (0–9). Each cell is, in turn, split into three thirds (X, Y, or Z). In this way, the position of a defect can be indicated in the third of the cell where it is located by an alphanumeric code (e.g., 4EY). **Figure 5** shows such an identifying code applied to a panel.

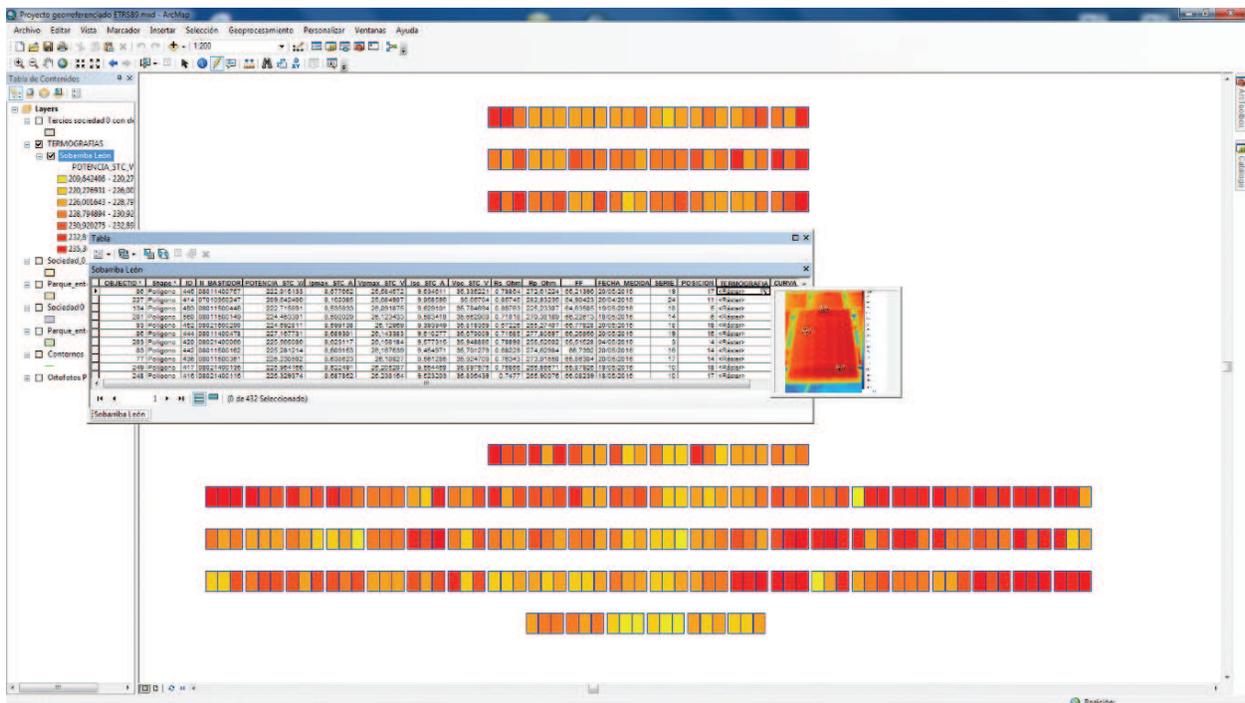
Figure 7. Instantaneous access to a PV module frontal thermography.

As shown in **Figure 7**, pictures, thermographs, and I-V curves are spatially referenced and associated with each module. This is extremely useful as it means graphic information can be spatially related to the measured attributes in each panel. Furthermore, all graphic information is available both from the geo-database and through the GIS map.

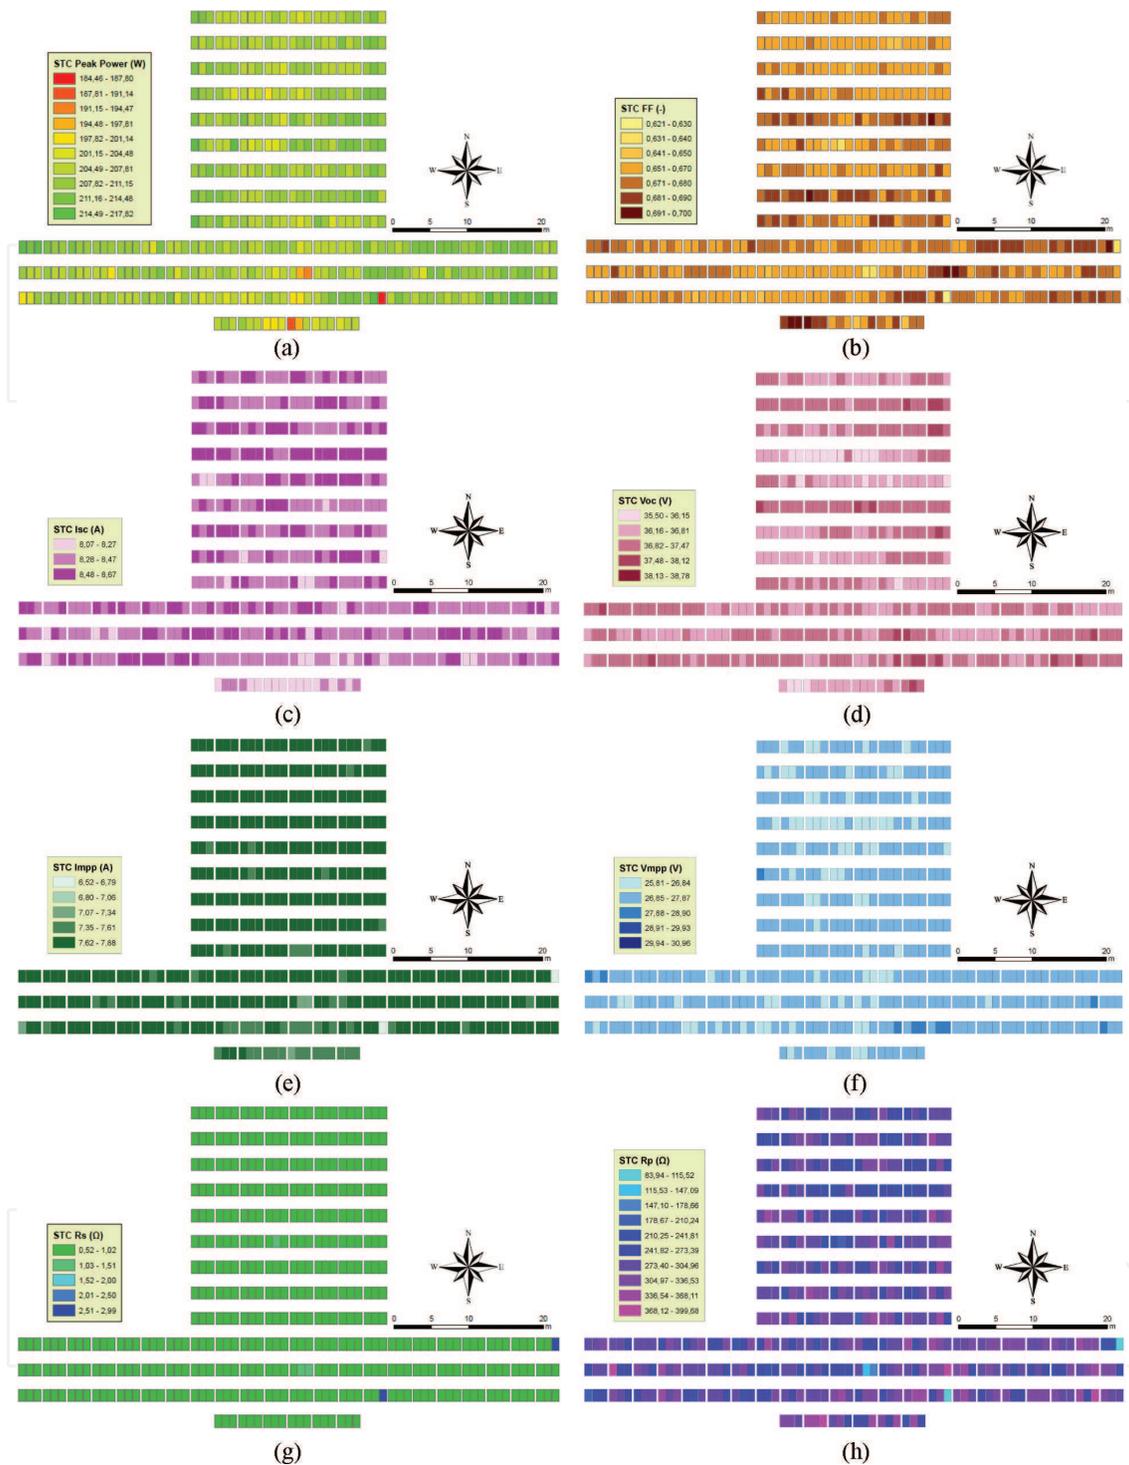
Figure 8. Electrical parameter distributions: (a) STC peak power, (b) STC fill factor (c) max. power voltage, (d) max. power current, (e) open circuit voltage, (f) short circuit current, (g) serial resistance, (h) parallel resistance (108 kWp PV plant).

The effective application of the GIS tool allows the observation of all electrical parameters in a holistic way. As shown in **Figure 8(a)**, critical peak power performances can be easily detected among more than 400 PV modules. Other electrical parameters, such as fill factor, open circuit voltage, or short circuit current dispersion, can also be observed in the context of the facilities.

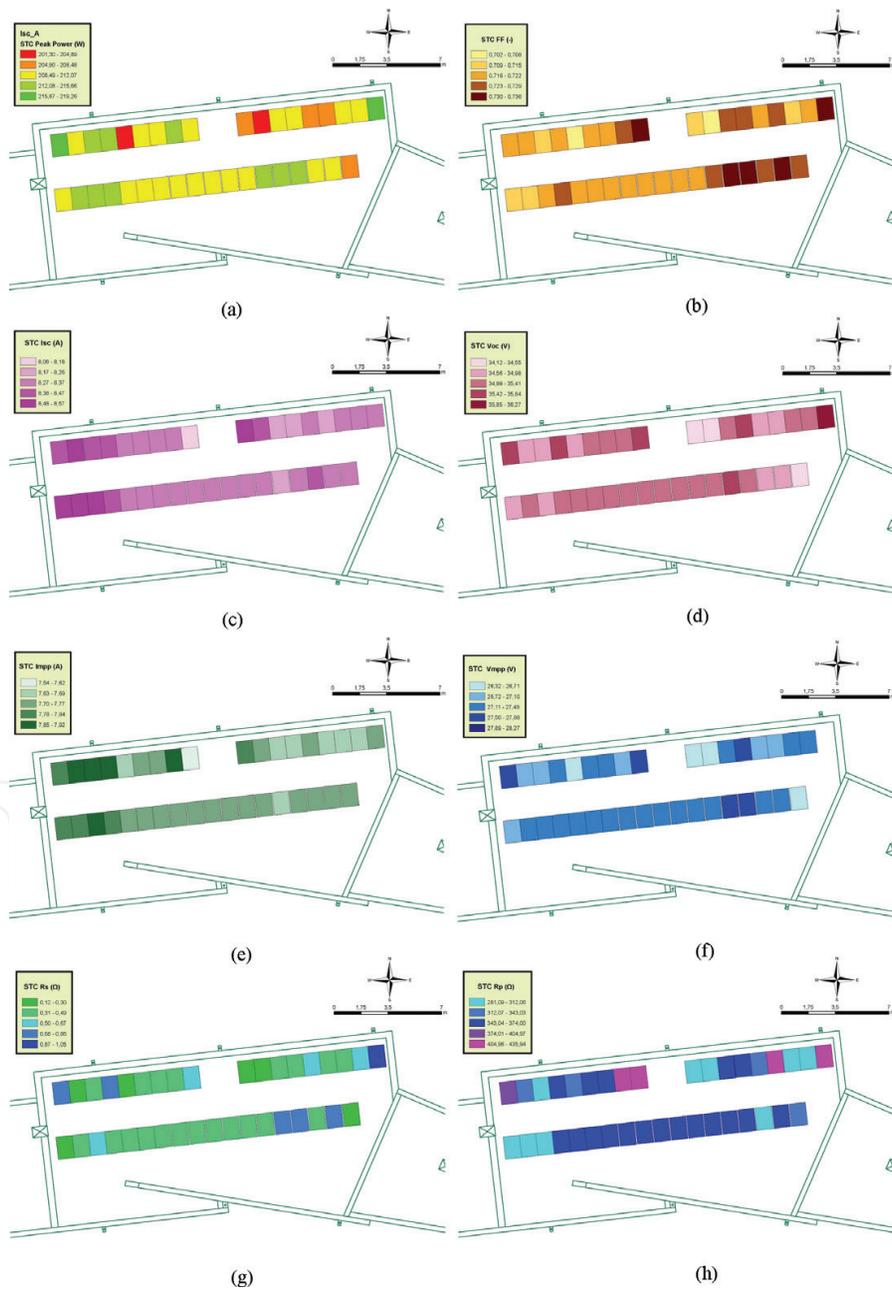
Figure 10. Electrical parameter distributions: (a) STC peak power, (b) STC fill factor (c) max. power voltage, (d) max. power current, (e) open circuit voltage, (f) short circuit current, (g) serial resistance, (h) parallel resistance (9 kWp PV plant).

Once again, it is considerably easier for staff to supervise and monitor the PV plant state. However, distribution of electrical parameters may be less significant as only 36 PV panels are included in this installation.
