New Non-Destructive Methods of Diagnosing Health of Gas Turbine Blades

Józef Błachnio^{1,2}, Mariusz Bogdan² and Artur Kułaszka¹

¹*Air Force Institute of Technology, Warszawa,*

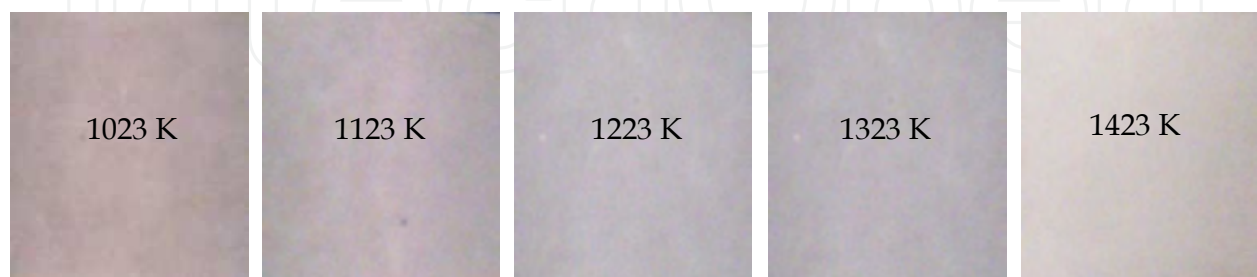
Images of surfaces of blade specimens were acquired both before and after specimens soaking in the furnace. The photos were taken on a purpose-built workbench (Bogdan & Błachnio, 2007; Błachnio & Bogdan, 2008;) with a digital photo camera, while the surfaces were illuminated with scattered white light. Repeatability of the obtained results was proved by taking multiple photos of the same specimens, under the same conditions with appropriate settings of parameter of the digital photo camera. The soaking of blade specimens in the furnace led to alterations in colour of the surfaces. An exemplary set of images is shown in Fig. 7.

Fig. 7. Images of surfaces of specimens soaked at various temperatures

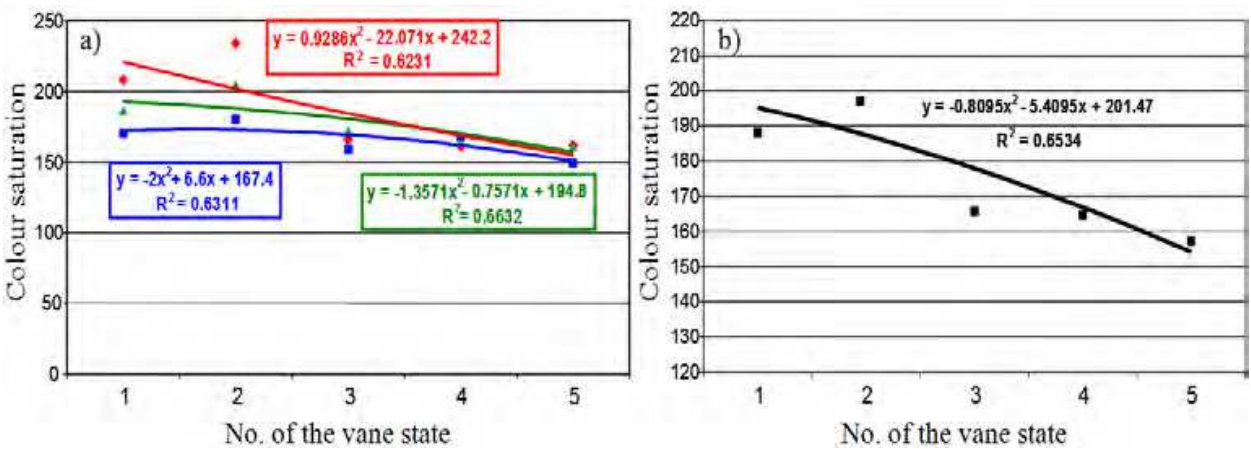
Fig. 18. Dislocation of the maximum saturation amplitudes of the image for various states of vanes: a) RGB components; b) grey shades

- for images recorded with the digital photo camera (Fig. 18):
- for images recorded with use of the videoscope No 1(Fig. 19):

The curves (trend lines) demonstrate correlation coefficients much worse than those obtained from laboratory tests. It has been caused by the forms of histograms (the colour range of images is wider). However, for images recorded with a digital photo camera the surface colour represents changes due to the exposure of the material to high temperature (Fig. 18). To recognise microstructures of vanes that had already been in operation further metallographic examination was carried out under laboratory conditions. As in the experiment with new blades subjected to soaking, the examination was carried out using metallographic microsections. Two microscopes were used: optical and scanning (SEM) ones. After long-time operation the vanes manufactured of the ŽS6K alloy demonstrated different health conditions. On the basis of metallographic examination (Bogdan, 2009) it was found that initially, after some time of operation, the vane coating suffers no degradation and its thickness is nearly the same as that of a new vane. Later on, it starts to suffer swelling, which after a pretty short time may result in crack nucleation due to thermal fatigue. Since the working agent (exhaust gas) of high kinetic energy keeps affecting the vane material (the surface layer), successive changes in thickness of this layer follow. The coating is getting thinner and thinner and, therefore, loses its protective properties. Consequently, temperature of vane material grows by approx. 100 K and it is no longer protected against chemical effect of the exhaust gas. The vane becomes much more vulnerable to the exhaust gas, which results in complete deterioration of the protective coating or even the parent material. Furthermore, morphology of the γ' phase has been found to prove that after critical temperature is exceeded the alloy becomes overheated. The turbine vane cannot be then considered serviceable (fit for use). Therefore, on the basis of findings of vane microstructure analysis it is possible to state that vane no. 1 (i.e. State I) exhibits correct microstructure, whilst the structure of vane no. 5 (i.e. State V) is overheated. When these results are compared to those of the analysis of blade surface images, it is possible to infer that vanes no. 1 and 2 are in sound condition, since parameters of image properties are comparable. On the other hand, vanes no. 4 and 5 are overheated, as values calculated from the histogram (as well as from the co-occurrence matrix) are much different from those for earlier discussed items. Thus, it is feasible to demonstrate correlation between
