A Structural Health Monitoring of a Pitch Catch Active Sensing of PZT Sensors on CFRP Panels: A Preliminary Approach

K.D. Mohd Aris, F. Mustapha, S.M. Sapuan and D.L. Majid

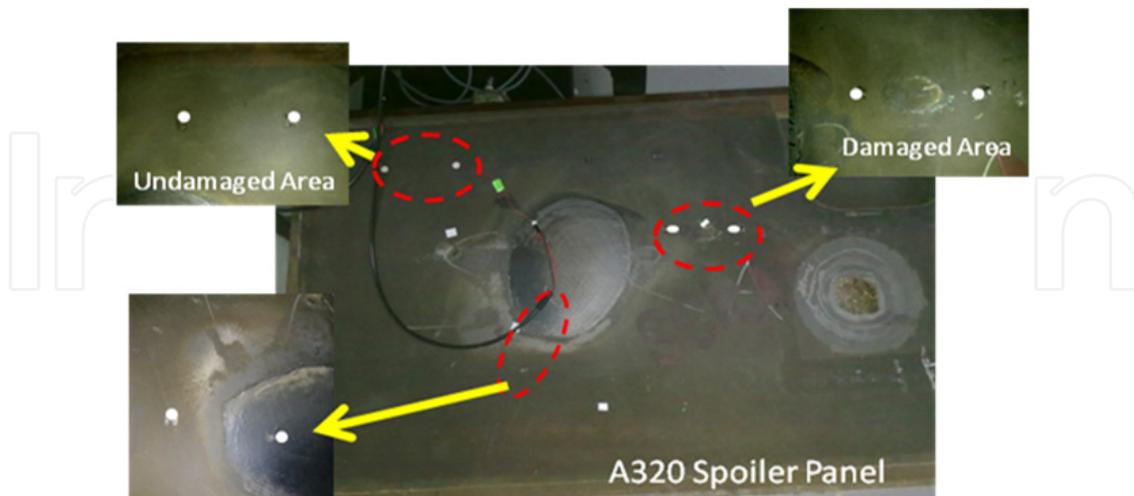
Figure 1. Locations of the structural conditions and PZT sensor placements

An aircraft spoiler was used for this research. The use of the structure is only arbitrary at this stage. It is use to seek the workability of the sensor upon trial on several flat panels. Three conditions were introduced to the panel which is the undamaged/ parent, damaged and repaired area. The undamaged/ parent was the area free from any defects. The undamaged area is the original conditions or controlled area. The damaged area was damage caused by impact that removes the top laminate. It was made by impacting the faced planes with a blunt object and creating damage less than 40mm diameter fracture. The level of impact is not an interest in this particular testing due to the studied conditions is only applicable to small surface damage due to impact. The repaired area was where the

damage plies were removed and replaced in accordance with the SRM [23]. The damaged area was repaired by scarfing method.

The PZT sensors were placed at 100mm apart for the three studied conditions. For damaged condition, the sensors were placed in between the damage area and for the repaired area, the sensors were replace across the actual and the repair doubler surface. This is to ensure

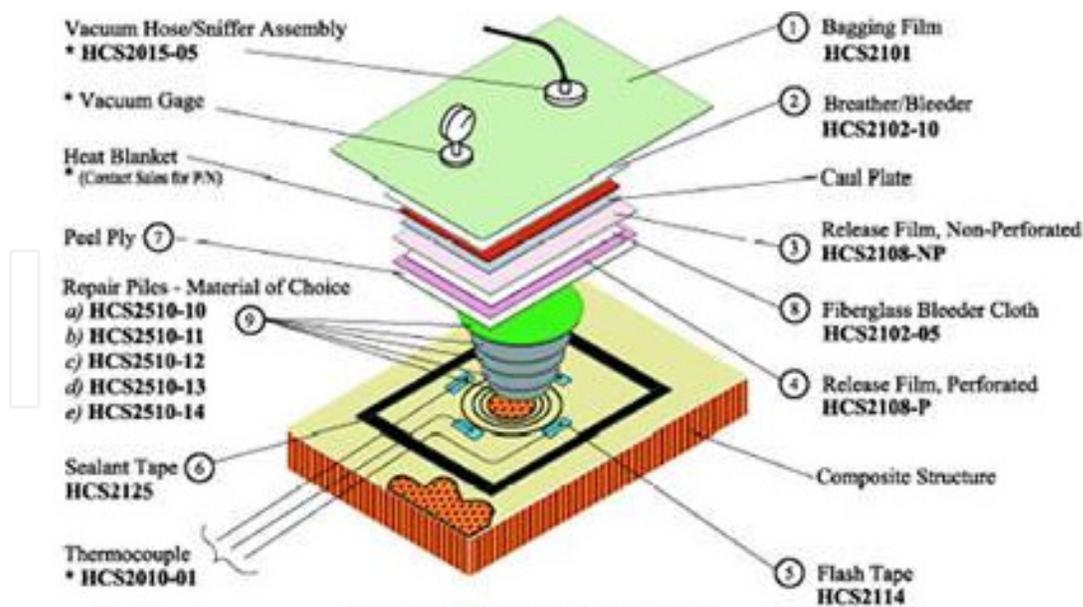
Figure 2. Hot bonder materials sequence for repairing aircraft composite parts. [24]

The repair was conducted by using hot bonder from Heatcon Inc. The Hexply® M10/38%/UD300/CHS/460mm CFRP pre-preg system from Hexcel Corp was used for the repair process. Care and take were observed to ensure similar procedures as per SRM recommendation. All plies were cut according to the sizes required and laid up accordingly. The affected area were vacuum bag as per Figure 2 and cured at 120°C at atmospheric pressure for 120 minutes. All vacuum bag materials were removed once the cycle ended.

bonding was cured in accordance with Aircraft Structural Repair Manual (SRM). A scarf cutting technique was used to remove the damage and replaced the affected its areas. Curing was achieved by using the Heatcon HCS4000 hot bonder with assisted consolidation from vacuum bag as per Figure 2. The parameters were ramp rate at $3^{\circ}\text{C}/\text{min}$, dwell time at 120 minutes, dwell temperature at 121°C , cooling rate at $3^{\circ}\text{C}/\text{min}$ and vacuum pressure attained at 22 in mg/ 1 bar.

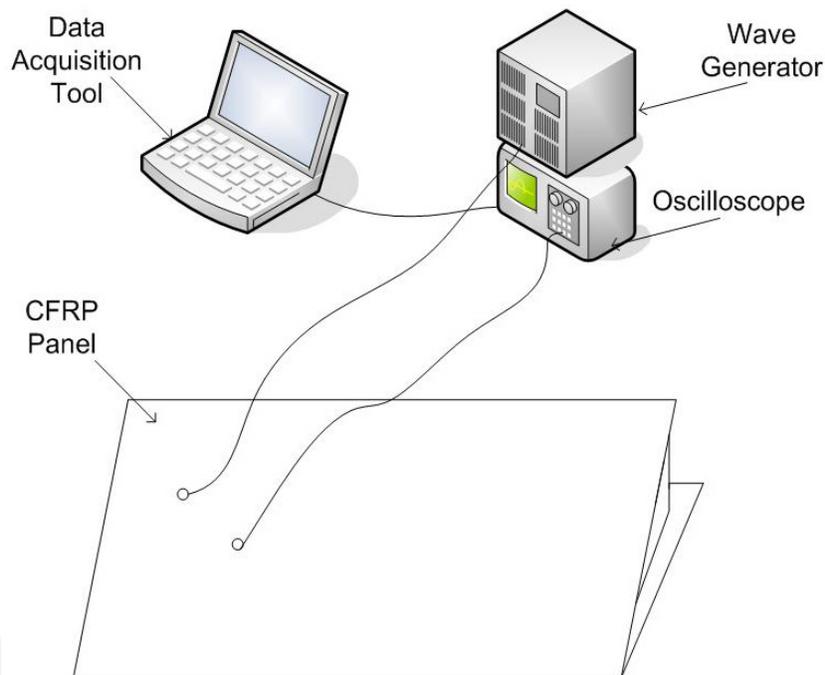
Figure 3. Aircraft spoiler with PZT sensor on specimens set-up.

distance consistency of 100mm between the sensors. One of the sensors acted as an actuator. The actuator controls the surface guided in the form of elastic perturbation through the surface guided wave across the panel. The wave was controlled by a function generator with the setup as per Table 2.

The receiving sensor modulated as the guided wave reached and transmit the energy to electrical signal. The received signals were saved for post processing by using oscilloscope. The arrangement of the equipment is shown in Figure 4.

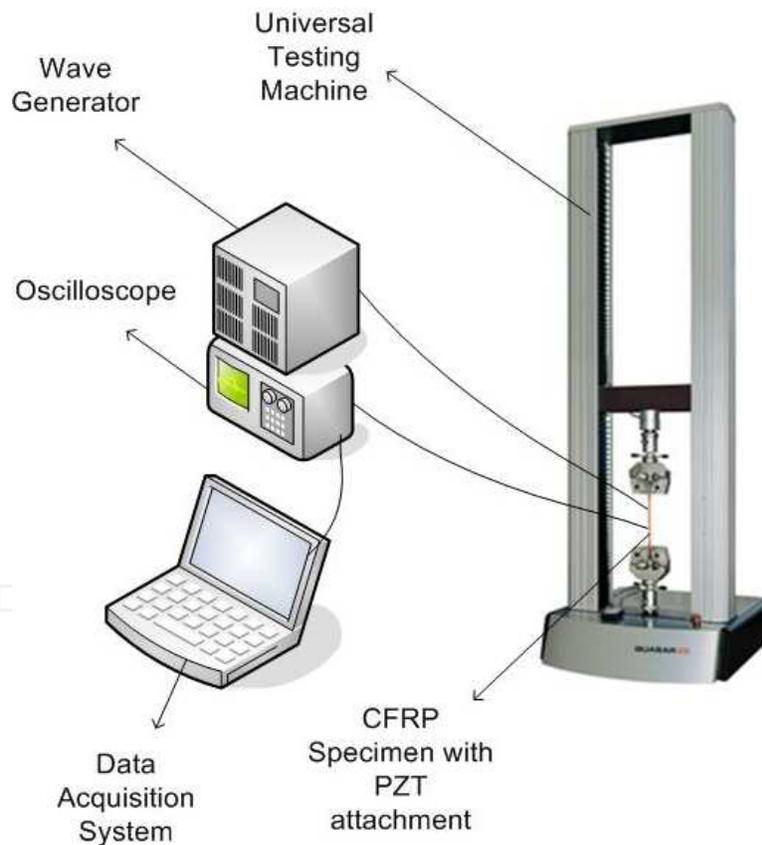
Figure 4. Tensile test with PZT sensor on specimens set-up.

Once cured, the panels were cut into specimen size according to ASTM D638 standard with five specimens prepared for each conditions by using Shimadzu AGx-50kN Universal Testing Machine as per Figure 5. The specimens were clamped on both ends. The data for mechanical properties were collected by using the Trapezium-X software came with the UTM machine. For the wavelet pitch-catch analysis, two APC 850 PZT smart sensors were affixed at 100mm apart and symmetrical to each other. Similar connection with the spoiler's test was applied to the relevant apparatus for data mining and post processing. The data from the sensor was interrogated and collected at three stages which were at the beginning of the test, within the elastic range, after the detection of the first ply failure and prior to separation.

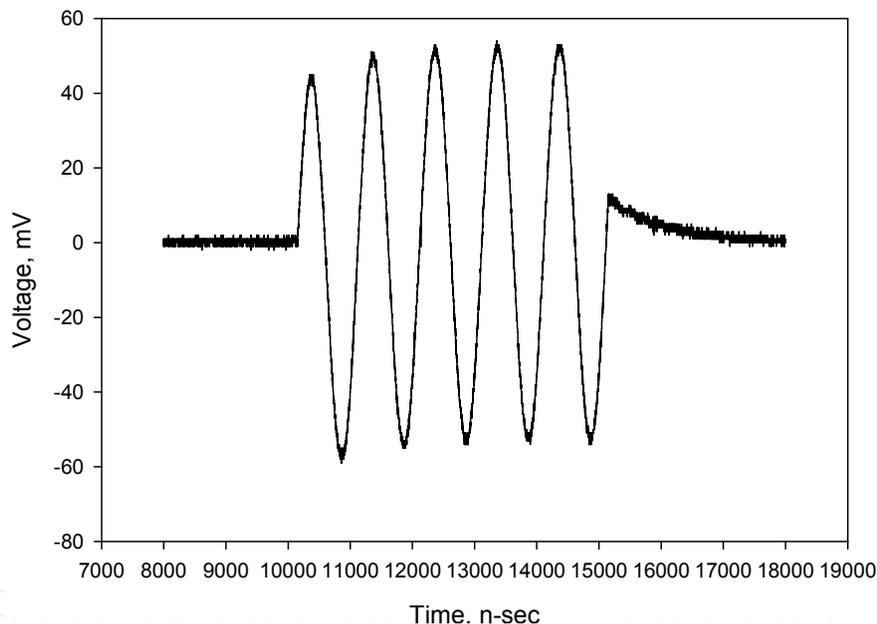
Figure 5. Actuating signals

Parameter	Unit	Parameter	Unit
Frequency	250kHz	Symmetrical	50%
Voltage	+10V	Time Generation	3ms at 333.3 Hz
V_{pp}	50Ω	Burst Count	5
Phase	0°

Statistical pattern recognition was used to analyze the lamb wave generated by the PZT actuator. [15] A total of 100 wave packets were taken for each conditions stated. Each wave packets consisted of 25000 points by default from the oscilloscope. From the 25000 points, it was then grouped to 1000 intervals data set for analysis. There were two significant spike occurred each at point 12000 ~ 13000 and 18000 ~19000 as shown in Figure 4. The reduction of data intervals were applied in order to assist the further analyze the distributions. By judgment, the first group of the spike was concerned and the data packet was zoomed again in 500 data intervals. Figure 6 shows the actuating signals for each of the testing. Consistence settings are required to ensure the wavelet generates similar wave perturbation throughout the experiment.

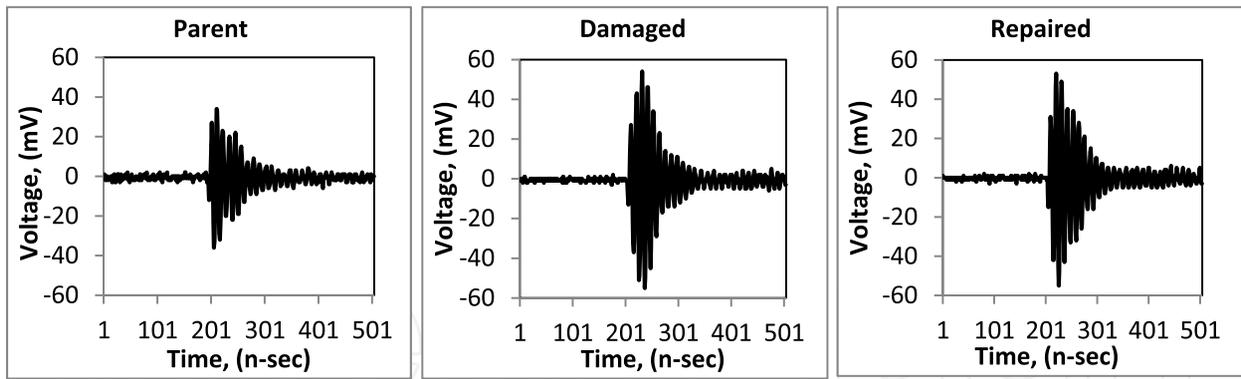
Figure 6. Wave packet samples from a) undamaged, b) damaged and c) repaired structural conditions after synthesized.

Figure 7 shows the results of the receiving wave packet upon synthesized by the points for each condition. Different behavior from the voltage (V_{pp}) and complete time of flight cycle are shown which characterized the evaluated conditions.

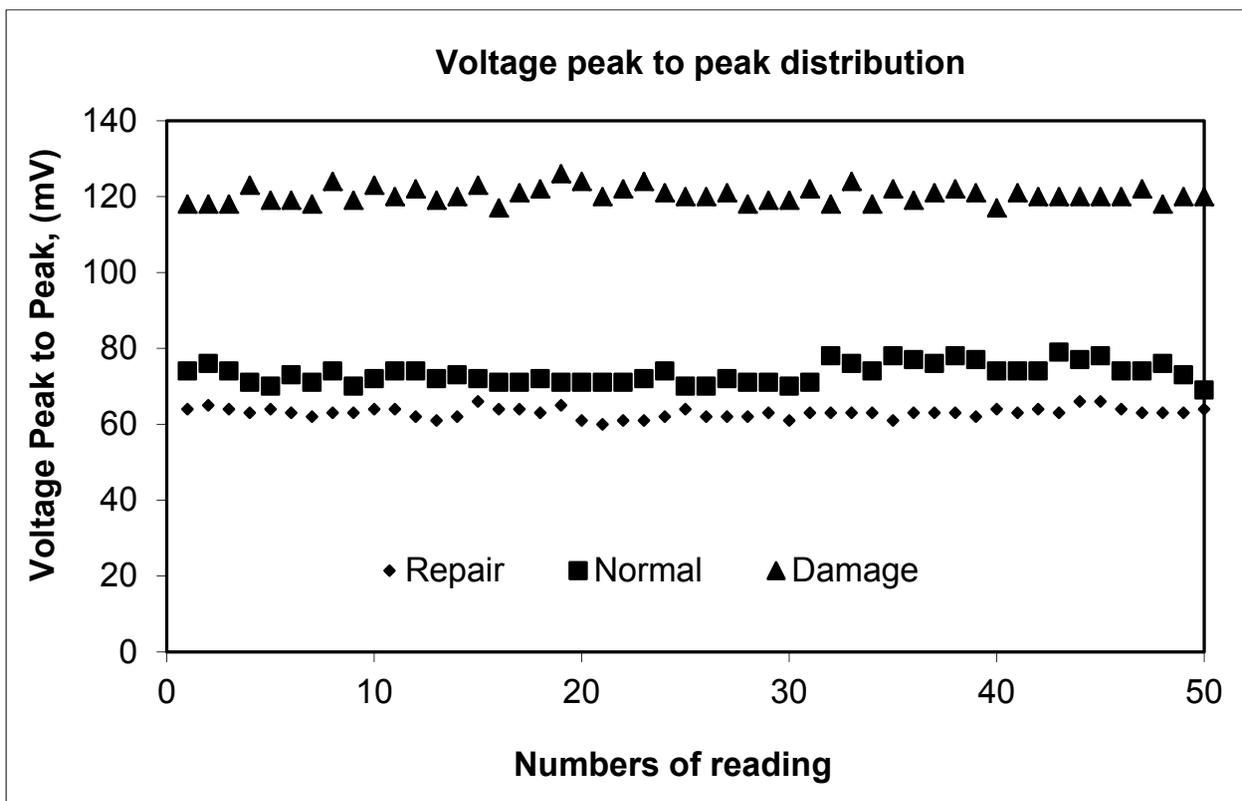
Figure 7. V_{pp} distribution among the structural conditions

Then, each of the receiving structural conditions wavelet data were compared between to ensure the signals was homogeneous to each other on the timeline basis. Since this is the unsupervised learning process the clusters were assigned to separate three conditions as stated in the methodology. The V_{pp} or voltage peak to peak is the attribute to distinguish the conditions. More than 50 V_{pp} values were collected and tabulated. The scattering of the V_{pp} for the three conditions were examined and is shown in Figure 8.

The V_{pp} showed similar values for the undamaged and damaged structure condition. It was assumed that the wave travel without discontinuity due to partial damage at that particular area. However several other types of damage need to be examined before any conclusive evidence can be finalized.

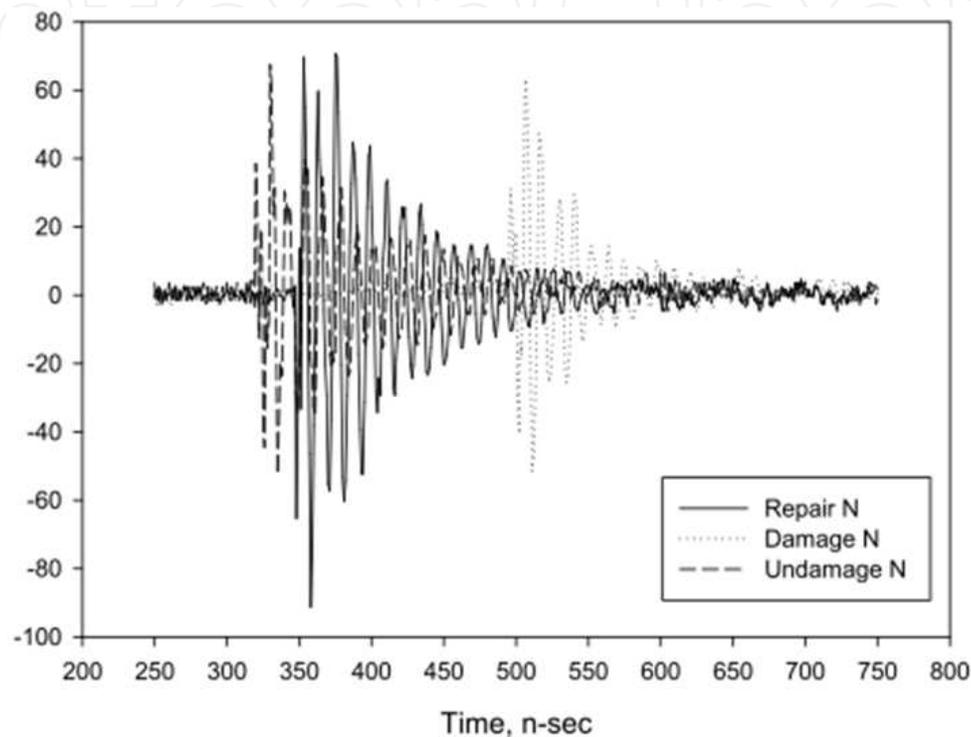
Figure 8. Overlay Outlier Pattern for different structural condition

A further post processing was carried out by overlapping the three conditions in one graph with similar time-domain comparison. The most common interest point lies within points 12250 ~ 12750. This was the first spike seen in the wave packet. In the earlier V_{pp} comparison, the distribution data between the damage and undamaged were identical. Therefore it was difficult to interpret the data for the latter machine learning process.

However, when all three data was overlapped, a significant different can be seen as shown in Figure 9. The undamaged signals appear at the initial time frame indicated that there was a clean surface wave traveling from the actuator to the receiver. However, once the partial damage was introduced, the spike appear later about 200nsec due to the discontinuity of the spoiler surface. The unaffected wave bifurcated to the receiver with delay. For the repair condition, since the surface integrity has been restored by the flush repair, the continuity of the surface wave was preserved again with delay about 50 nsec .

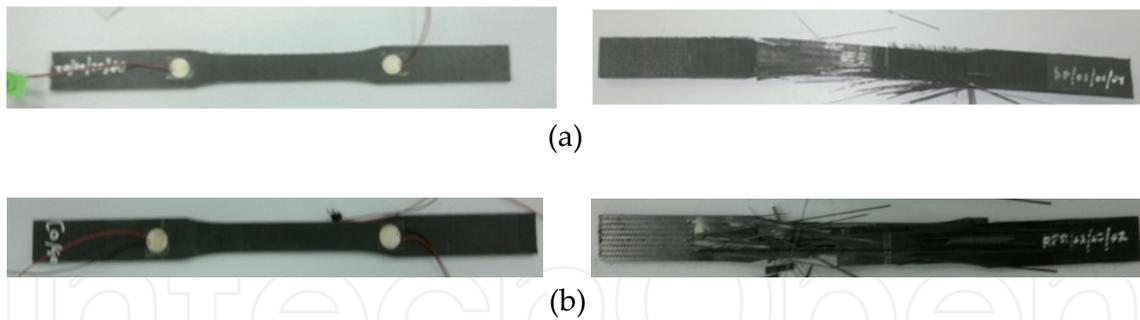
Figure 9. CFRP result before and after tensile test for parent specimens for a) normal and b) repaired specimens

The tensile test results showed a similar behavior towards a brittle stress-strain curve. Below are the results of the tensile test on normal and repaired specimens. All specimens were found to have breakage at center. The fiber breakage for parent specimens occurred at arbitrary layer. However, for the repaired specimens, the breakage occurred at the intermediate bonding layer between the original layers and repair plies. This is due to the fiber discontinuity and the matrix is the only medium to transfer the stress from the parent surface to the repair surface.

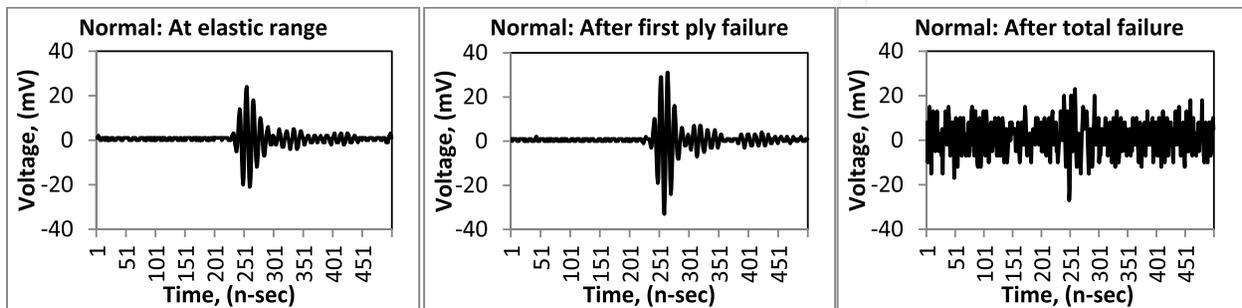
Figure 10. Receiving signals for parent panel with a) at elastic range, b) after first ply failure and c) at failure.

Based of the wavelet analysis from the Sigmaplot software, both conditions showed a significant changes at the investigated stages. At the elastic range, the wavelet shows a significant solid wave at the respective time of flight. However a slight change appeared after the first ply failure occurred. The V_{pp} values were found to be higher and there are also a distinct echo developed after the main wave packets. At the end of the testing, the signal lost its signature due to damage upon breakage of the panels. An online monitoring during the course of the test shown a good unique characteristics for anomalies to be identified.

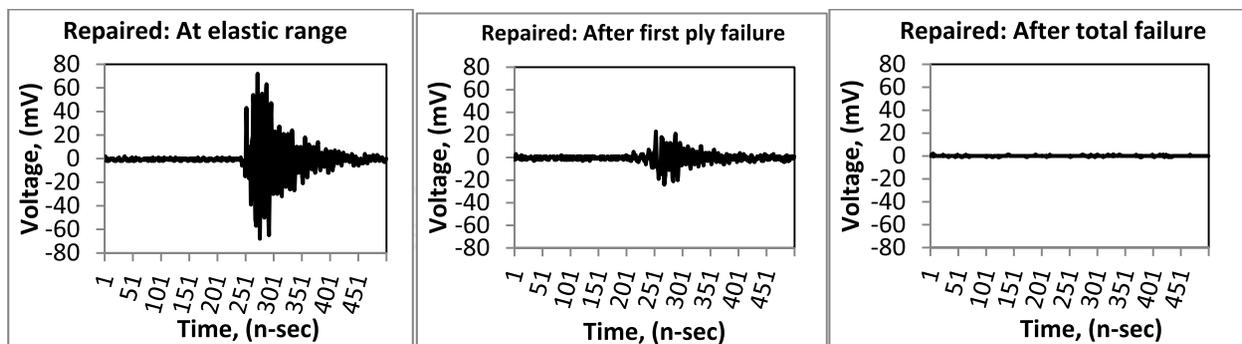
Figure 11. Receiving signals for parent panel with a) at elastic range, b) after first ply failure and c) at failure.

Figure 11 shows the behavior of the full repair panel throughout the testing. The degradation of the signal indicates the lamb wave attenuation has lost due to separation of the repair plies. This can be seen by 50% reduction of the V_{pp} at the initial of the testing. The significant reduction of the signal strength correlates with the structural integrity lost as the test reached the total fractured. Towards the end of the testing, all the specimen failed at the center and disintegration of the sensor due to the failure of the panels.
