# Influence of Chemical Properties of Soil on the Corrosion Morphology of Carbon Steel Pipes

*Muhammad Wasim and Shahrukh Shoaib*

## Abstract

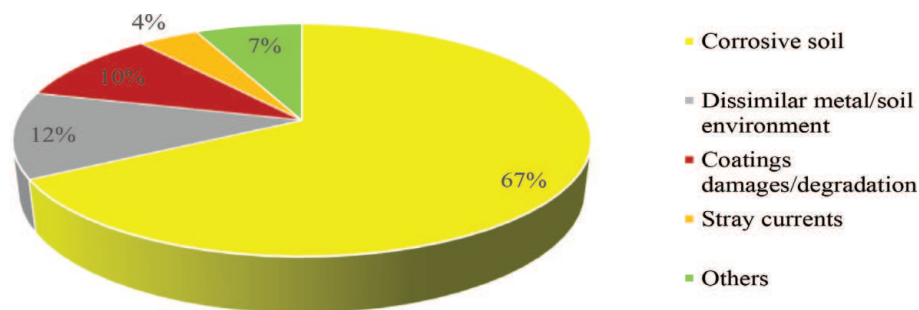
**Figure 1.** Worldwide causes of corrosion of metallic buried pipes (redrawn, originally by [3]).

As per above referred studies, soil's constituents cause corrosion of buried pipes; these include moisture contents, pH, temperature, soil resistivity, soil type, soil particle size, permeability, differential aeration, and sulphate-reducing bacteria (see references above). Researchers have adopted various approaches based on field testing (all above references) and experiments [8–10] to investigate these factors. Soil has been reported as the main stimulants causing failure of buried metallic pipes as shown in **Figure 1** [3].

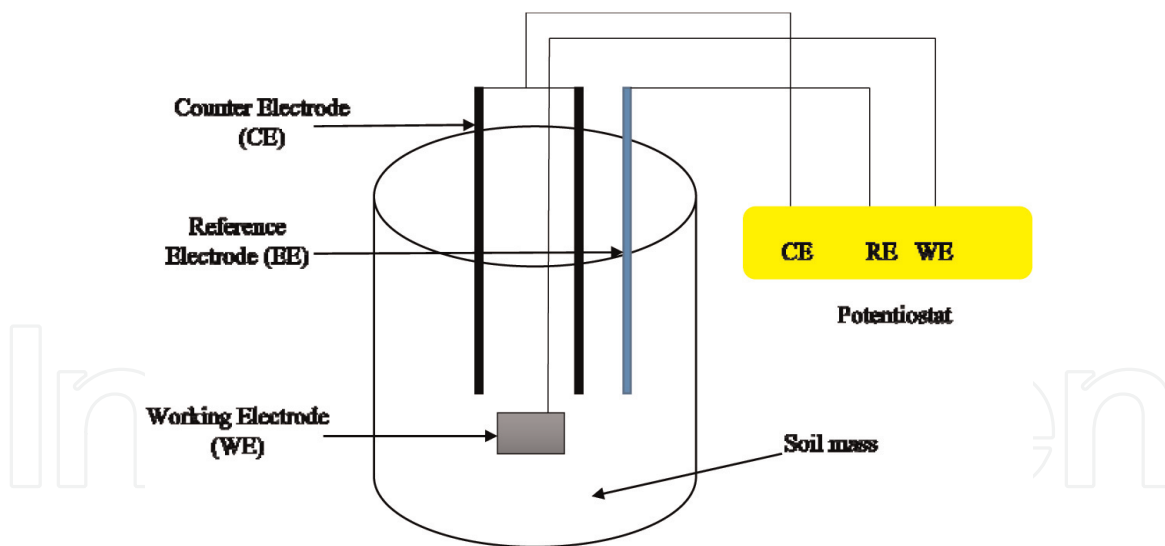
Experiments were performed under laboratory-controlled temperature of  $27 \pm 1^\circ\text{C}$ . The set-up for the electrochemical measurements consisted of three electrode cells. The schematic diagram of the experimental test set-up is shown in **Figure 2**. In this figure, the specimen is represented by rectangular shape; was a carbon steel without coating, and with zinc- and copper-electroplated coatings, respectively; and was used as working electrode. In addition, two counter electrodes made of graphite and joined through electrical connector and copper/copper sulphate ( $\text{Cu}/\text{CuSO}_4$ ) solution as reference electrode (RE) were used, respectively, for corrosion measurement of each specimen used in the current research. The surface area ratio between working electrode/counter electrode was kept at 0.909.

**Figure 2.**  
 Set-up for electrochemical measurement (modified after Shoaib et al. [15]).

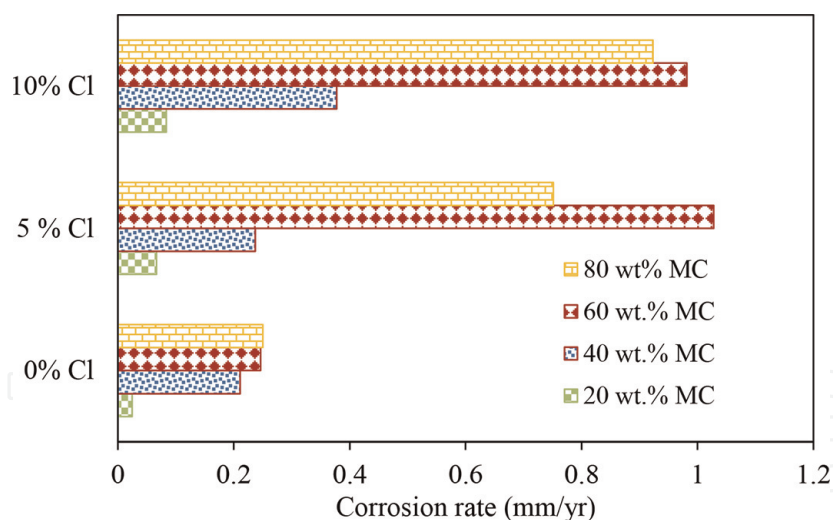
The corrosion rates of carbon steel samples under different exposure conditions are shown in **Figure 3**. The detailed discussion on the corrosion behaviour of various specimens can be found elsewhere [15]. After electrochemical

**Figure 3.** Corrosion rates of SS400 steel samples under different moisture and chloride conditions (modified after Shoaib et al. [15]).

Electrochemical results showed that the corrosion rate of SS400 carbon steel sample increased with increase in moisture content up to 60 wt.% and decreased after this value. Moreover, with the addition of chloride, corrosion rate increased appreciably. The maximum corrosion rate was noticed for carbon steel exposed to soil containing 60 wt.% moisture and 5 wt.% moisture. Theoretically, carbon steel specimen buried in 60 wt.% moisture and 10 wt.% chloride should have more corrosion rate because of exposure of higher chloride content. Probably, the possible reason could be a non-homogeneous nature of the soil, or there is a possibility that organic contents might have caused the increase in soil's resistivity and hence the decrease in corrosion rate even in the presence of higher chlorides.

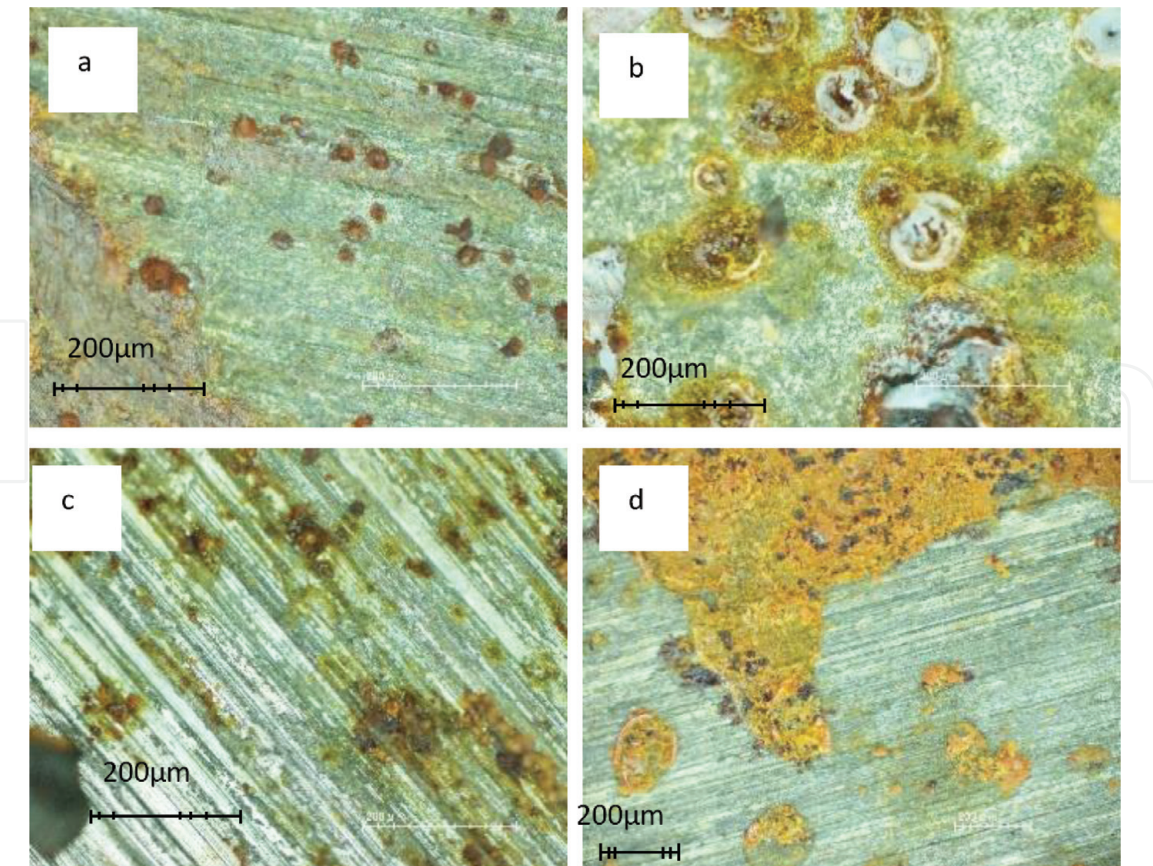
**Figure 4.**  
*Corrosion morphology of carbon steels tested in different soil moisture contents (a = 20 wt.% MC; b = 40 wt.% MC; c = 60 wt.% MC; d = 80 wt.% MC).*

First, the coupled effects of varying moisture and chloride on corrosion were measured [15]; then their subsequent impact on the microstructure of specimens was investigated using Olympus laser microscope. Corrosion patterns on specimens after exposure to various corrosive soils are shown in **Figures 4–6**; from these figures red rust can be seen on all samples. Interestingly, there was a further addition of red rust with the increase of chloride contents indicating the presence of iron oxides on the surface. Moreover, optical images also confirmed that the addition of chloride promoted corrosion progress. With further addition of chloride, more red rust was observed.

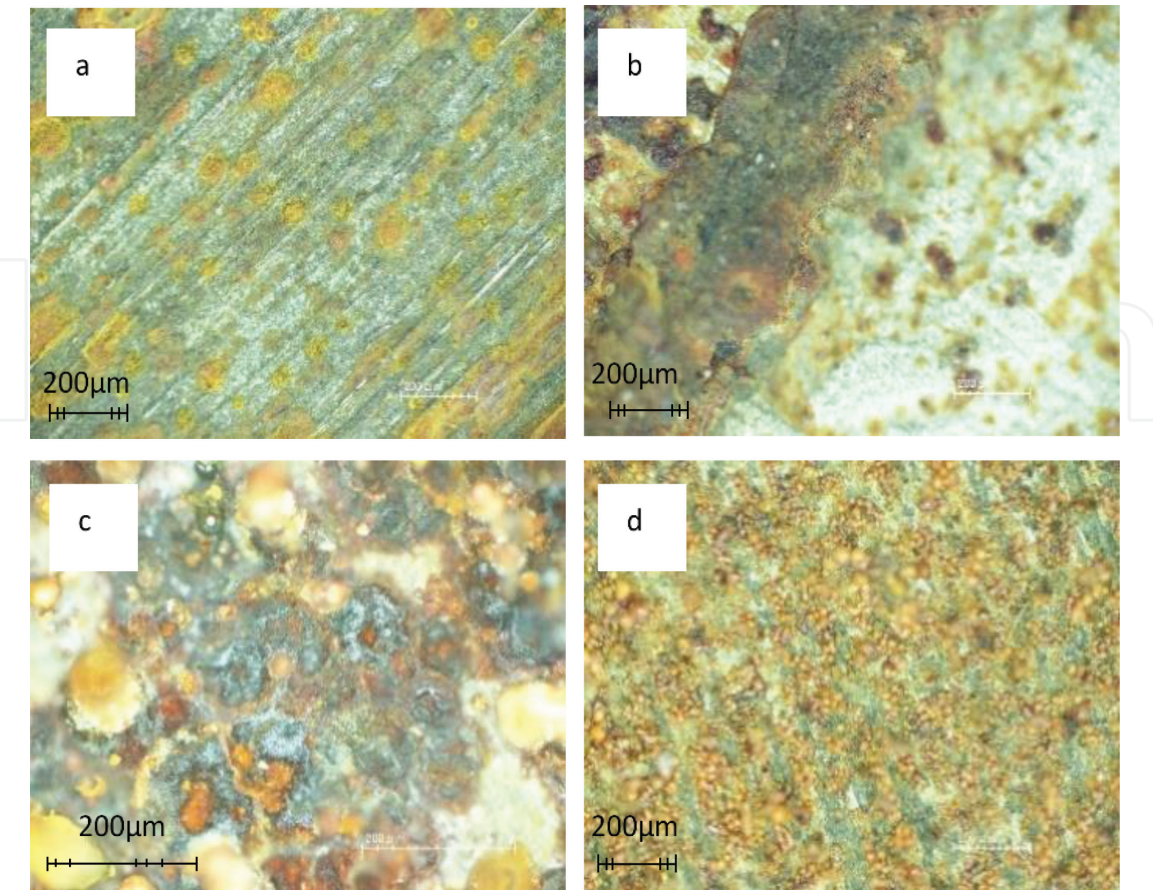
**Figure 5.**  
*Corrosion morphology of carbon steels tested in soil with 5 wt.% chloride (a = 20 wt.% MC; b = 40 wt.% MC; c = 60 wt.% MC; d = 80 wt.% MC).*

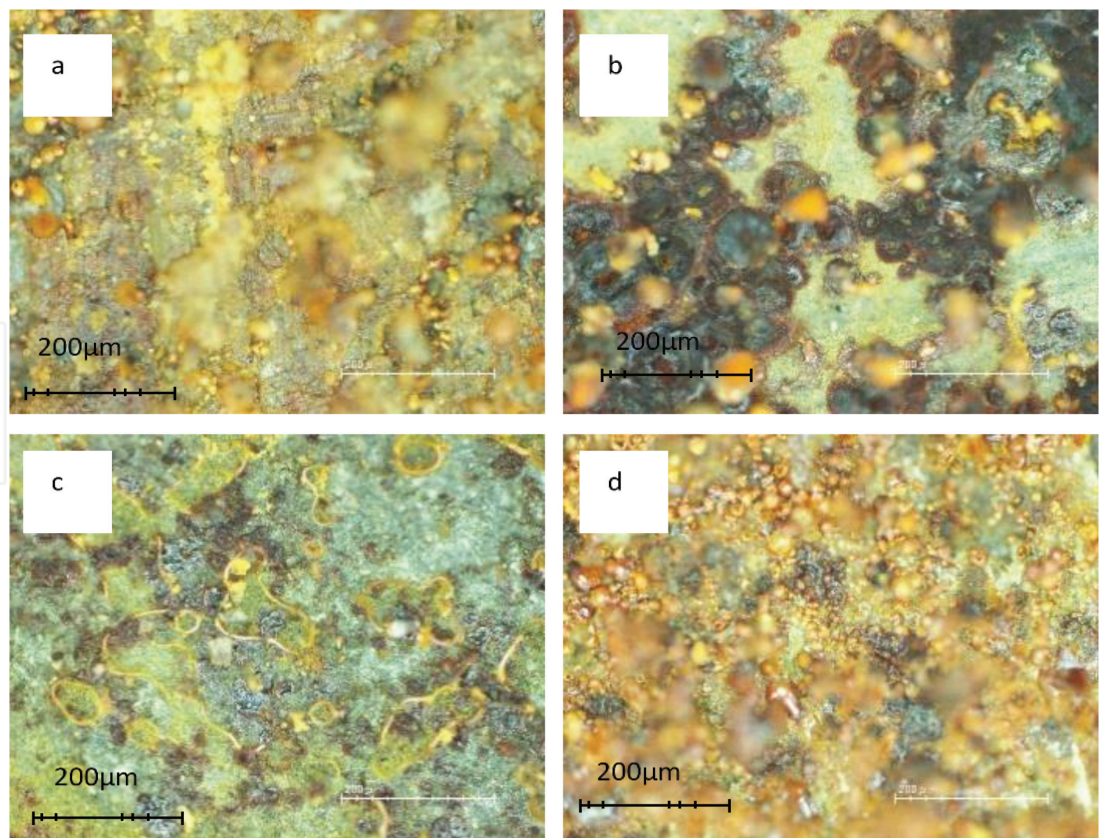
**Figure 6.**  
*Corrosion morphology of carbon steels tested in soil with 10 wt.% chloride (a = 20 wt.% MC; b = 40 wt.% MC; c = 60 wt.% MC; d = 80 wt.% MC).*

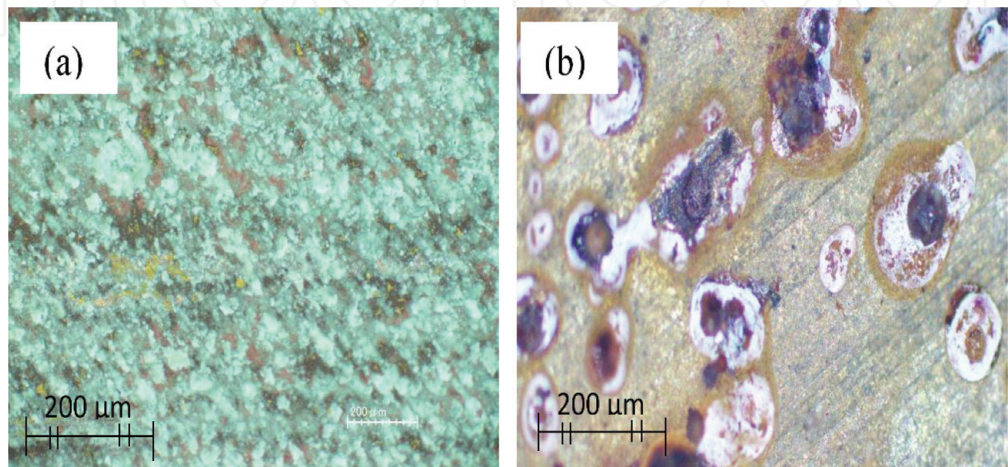
**Figure 7.**  
*Corrosion morphology of (a) copper-electroplated and (b) zinc-electroplated steels tested in soil with 60 wt.% moisture and 5 wt.% chloride.*

Two kinds of corrosion behaviour were observed in specimens, i.e., general and localised corrosion. Carbon steel sample exposed to soil containing 60 wt.% moisture and 5 wt.% chloride showed localised corrosion, while the samples buried in soil of 80 wt.% moisture and 10 wt.% chloride suffered general corrosion. **Figure 7** shows the corrosion morphology of copper-electroplated and zinc-electroplated steel samples. However, for copper-electroplated steel samples, there was no clear pattern of corrosion. On the other hand, zinc-electroplated steel indicated localised corrosion.

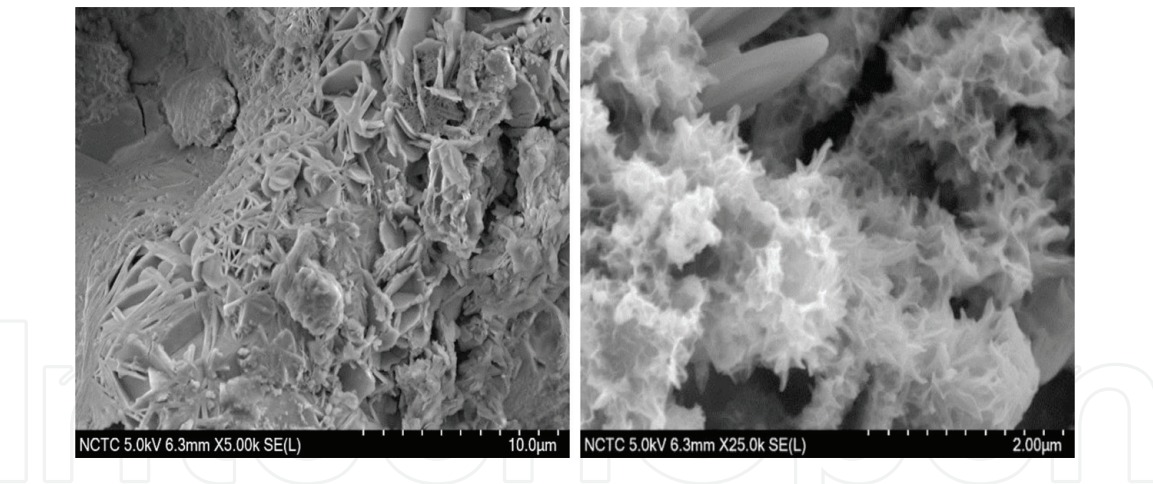
**Figure 8.**  
*SEM images of carbon steel buried in soil of 60 wt.% moisture and 5 wt.% chloride.*

SEM analyses were performed after the samples were corroded to various soil conditions. **Figure 8** shows the SEM micrographs of low and high magnifications of carbon steel. From this figure, a porous and honeycomb-like structure appeared, which is also reported by earlier researchers [16]. **Figure 9** shows EDS spectra of elements present in corrosion product of carbon steel, while the elements in the corrosion layer of carbon steel are shown in **Table 1**. The presence of sodium (Na) on a metallic surface, indicating that cation in soil penetrated through corrosion product layer and reached the sample's surface. As a result of this penetration, the corrosion process is accelerated. However, it has been reported in literature that the

**Table 1.**  
EDS analyses (wt.%) of carbon steel of selected spots in **Figure 8**.

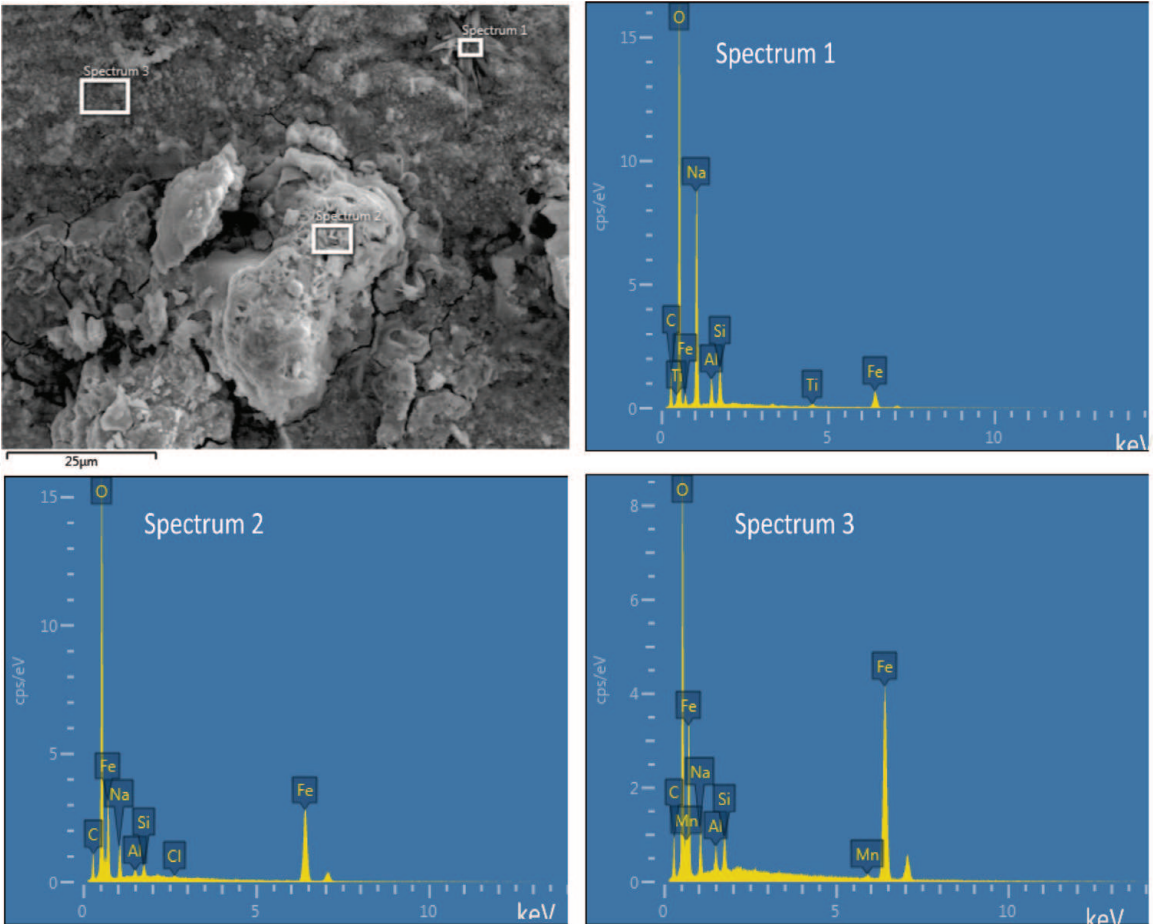
**Figure 9.**  
*EDS spectra of carbon steel tested in soil with 60 wt.% moisture and 5 wt.% chloride.*

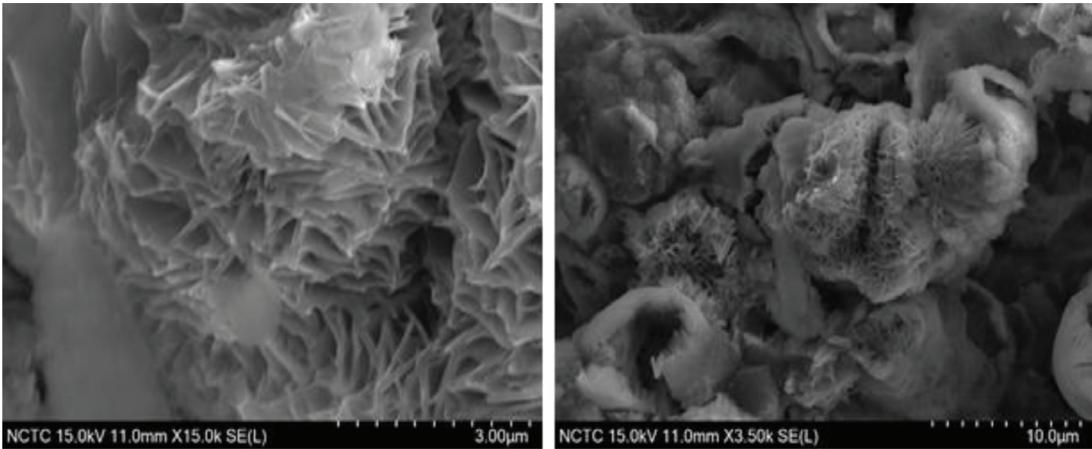
**Figure 10.**  
SEM images of zinc-coated steel tested in soil with 60 wt.% moisture and 5 wt.% chloride.

**Figure 10** SEM images of zinc-electroplated steel with a low and high magnification. A crystalline structure was observed which spread over the surface area of the sample. This indicates the occurrence of generalised corrosion mechanism [19]. The EDS spectra of elements present in corrosion product of zinc-electroplated steel are shown in **Figure 11**. Three locations were selected for the determination of elements in corrosion product. Elements obtained from the corroded layer of zinc-coated steel are shown in **Table 2**. Elements determined were Zn, Fe, O, and Cl

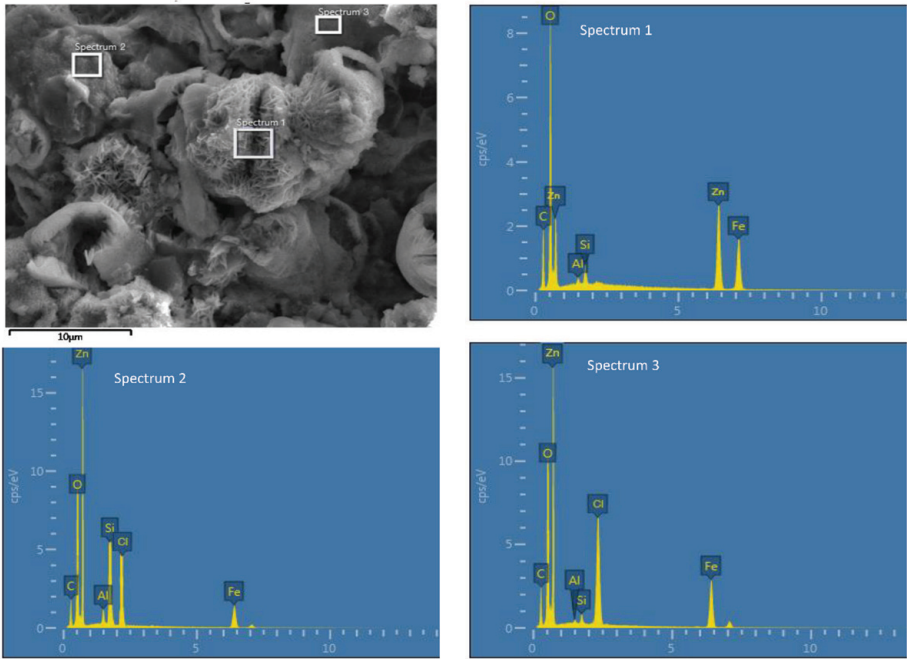
**Figure 11.**  
EDS spectra of zinc-coated steel tested in soil with 60 wt.% moisture and 5 wt.% chloride.

which indicated the likelihood of zinc oxide (ZnO) is formed. Zinc oxide provides a protective layer and protects the substrate metal from further corrosion [20]. However, the presence of Fe indicates that protective layer of zinc was removed partially due to soil aggressiveness.

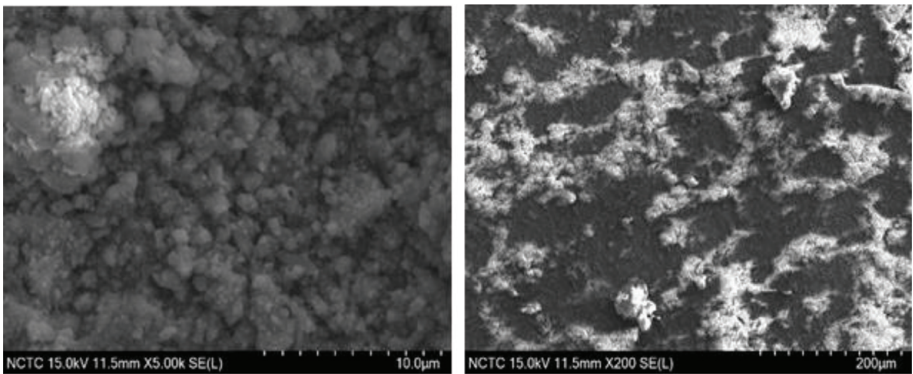
**Figure 12.**  
SEM images of copper-coated steel tested in soil with 60 wt.% moisture and 5 wt.% chloride.

**Figure 12** shows SEM micrographs of copper-coated steel with a low and high magnification. From this figure corrosion pattern of granular and compact structure can be seen which is also reported in the literature [21]. However, **Figure 13** demonstrates EDS spectra of elements present in corrosion product of copper-coated steel, also listed in **Table 3**. From the table it can be seen that Br was present in trace

**Table 3.**  
EDS analyses (wt.%) of copper-coated steel for selected spots in **Figure 12**.

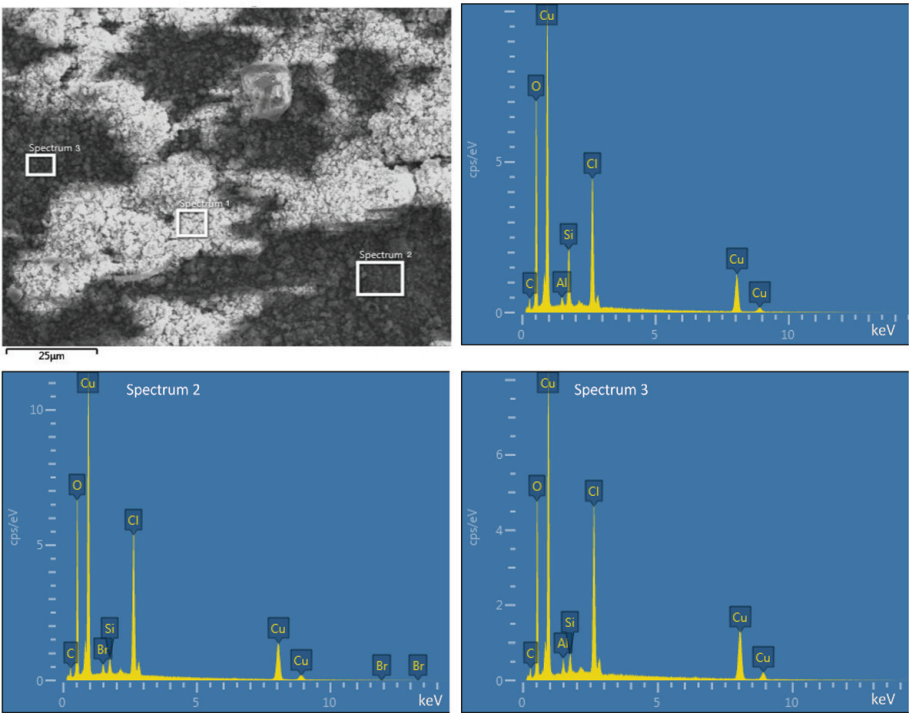
**Figure 13.**  
EDS spectra of copper-coated steel tested in soil with 60 wt.% moisture and 5 wt.% chloride.

amount in substrate metal. Br contributes to the acceleration of corrosion, but it is less aggressive than Cl. From the analysis results, it is evident that there is less quantity of Br (1.6%) in corrosion product of copper-coated steel which means Br did

not contribute to corrosion significantly. The elements present in the corrosion product show the possibility of the presence of copper chloride and copper oxide [21, 22].

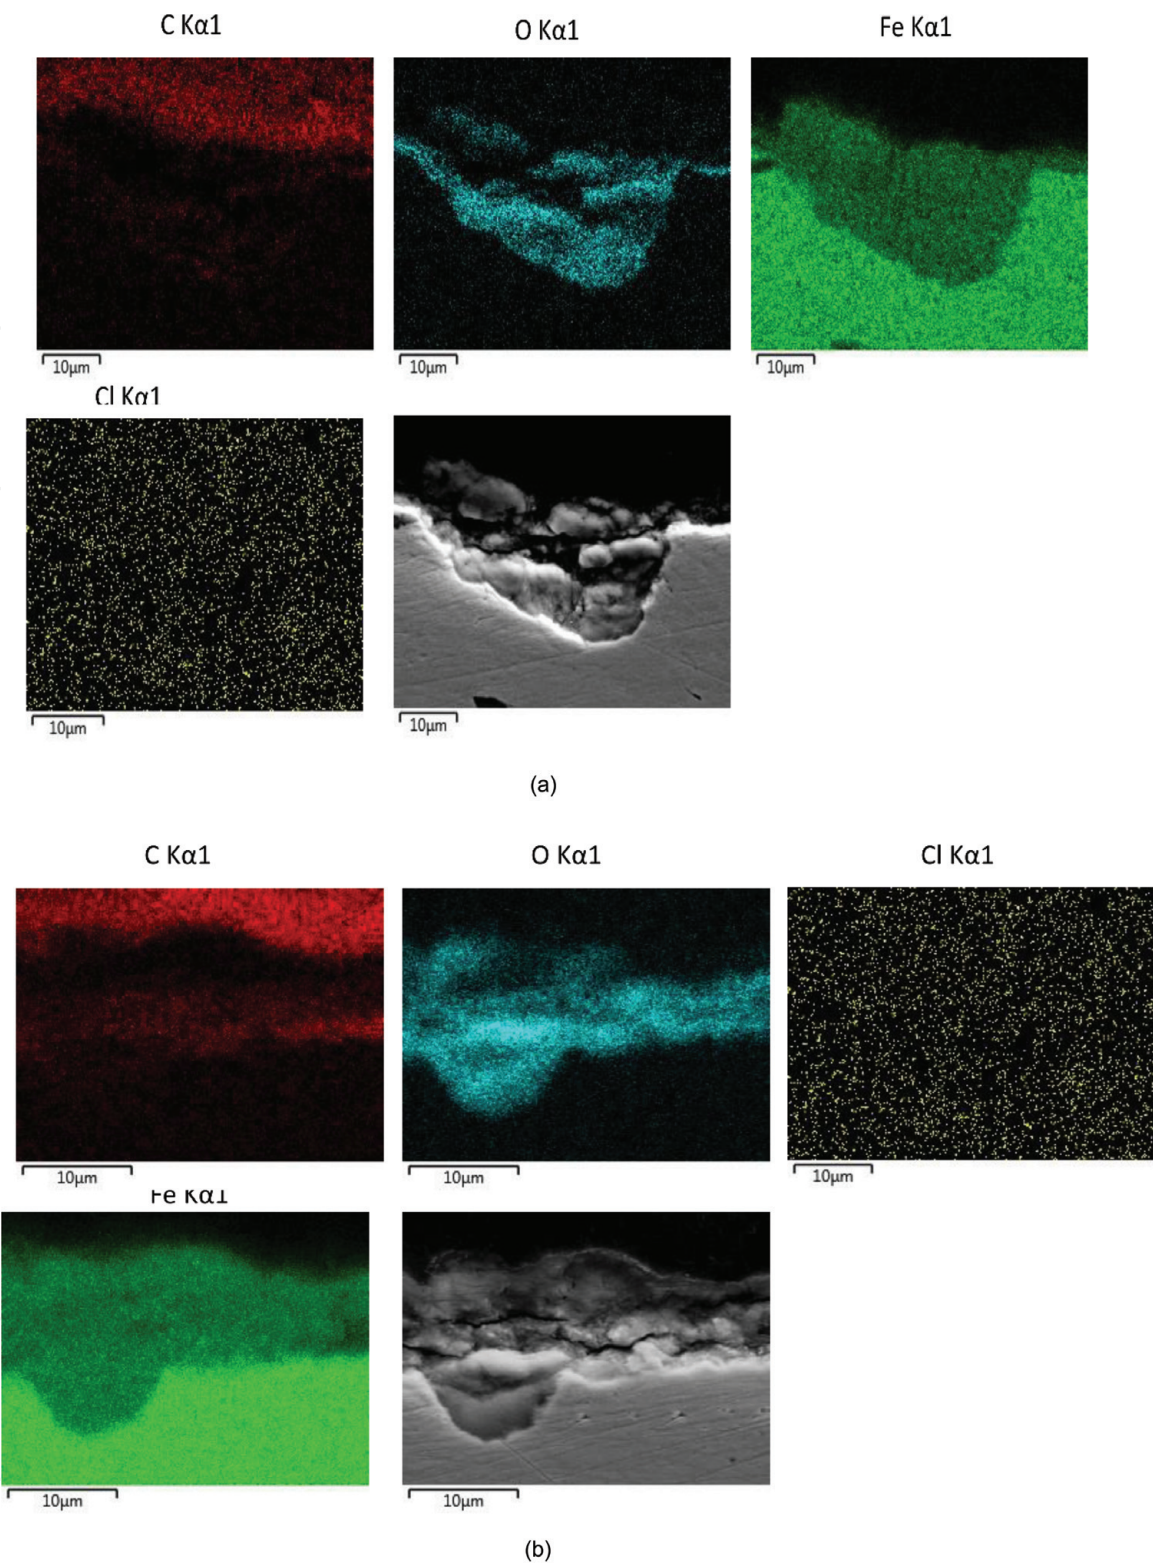
**Figure 15.**  
(a) EDS map of carbon steel exposed to soil containing 60 wt.% moisture and 5 wt.% chloride (site 1). (b) EDS map of carbon steel buried in soil containing 60 wt.% moisture and 5 wt.% chloride (site 2).

**Figure 15a** and **b** demonstrates cross-sectional EDS map of carbon steel sample exposed to soil containing 60 wt.% moisture and 5 wt.% chloride at site 1. A pit can be observed on carbon steel sample. It confirms that exposure of carbon steel to soil containing chloride accelerates the corrosion; as a result pitting is observed. The layer of oxygen has a variable thickness, and C layer from epoxy has a non-uniform thickness due to which no chloride contents were observed. The possible reason is that any element having a concentration less than 1% cannot be mapped by EDS mapping technique because peaks of elements having less concentration are difficult to separate from the background. **Figure 15b** shows EDS mapping at site 2, where the pit is less wide than site 1.

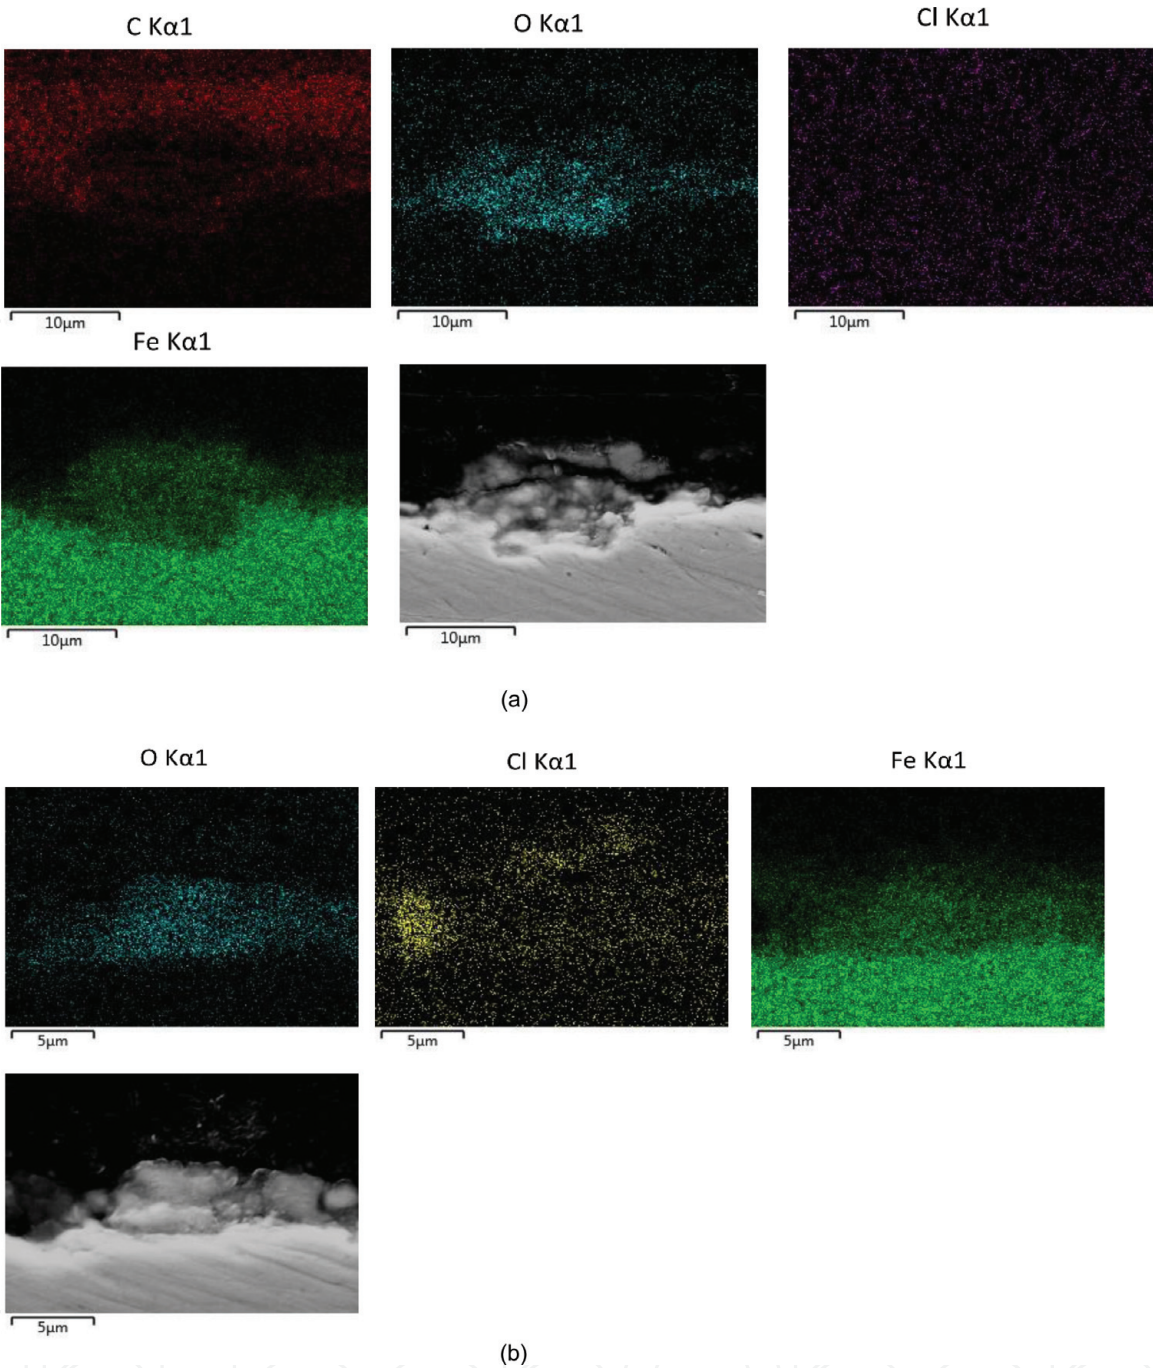
**Figure 16.**  
(a) EDS map of carbon steel exposed to soil containing 60 wt.% moisture and 10 wt.% chloride (site 1).  
(b) EDS map of carbon steel exposed to soil containing 60 wt.% moisture and 10 wt.% chloride (site 2).

**Figure 16a** and **b** illustrates the EDS mapping of steel specimens buried in soil containing 60 wt.% moisture and 10 wt.% chloride. This specimen showed entirely different behaviour as there was less O-K concentration, which also confirms the SEM results of no stable oxide layer, while the concentration of Fe-K came out to be high. It can be interpreted from mapping results that there are fewer oxides present in this condition.

Theoretically, carbon steel specimens exposed to 10 wt.% chloride should be more corroded than 5 wt.% chloride; however, experimentally this was not observed. The reason for this phenomenon is probably due to the fact that soil is a non-homogeneous, and its properties vary within the soil itself. There is a possibility that soil sample used for 60 and 5 wt.% chloride conditions might have considerable chloride already present in it. Furthermore, it is also possible that the soil sample used
