Degradations of Incoloy 800 Steam Generator Tubing

Dumitra Lucan

*Department of Corrosion and Circuits Chemistry,
Institute for Nuclear Research, POB 78, Pitesti
Romania*

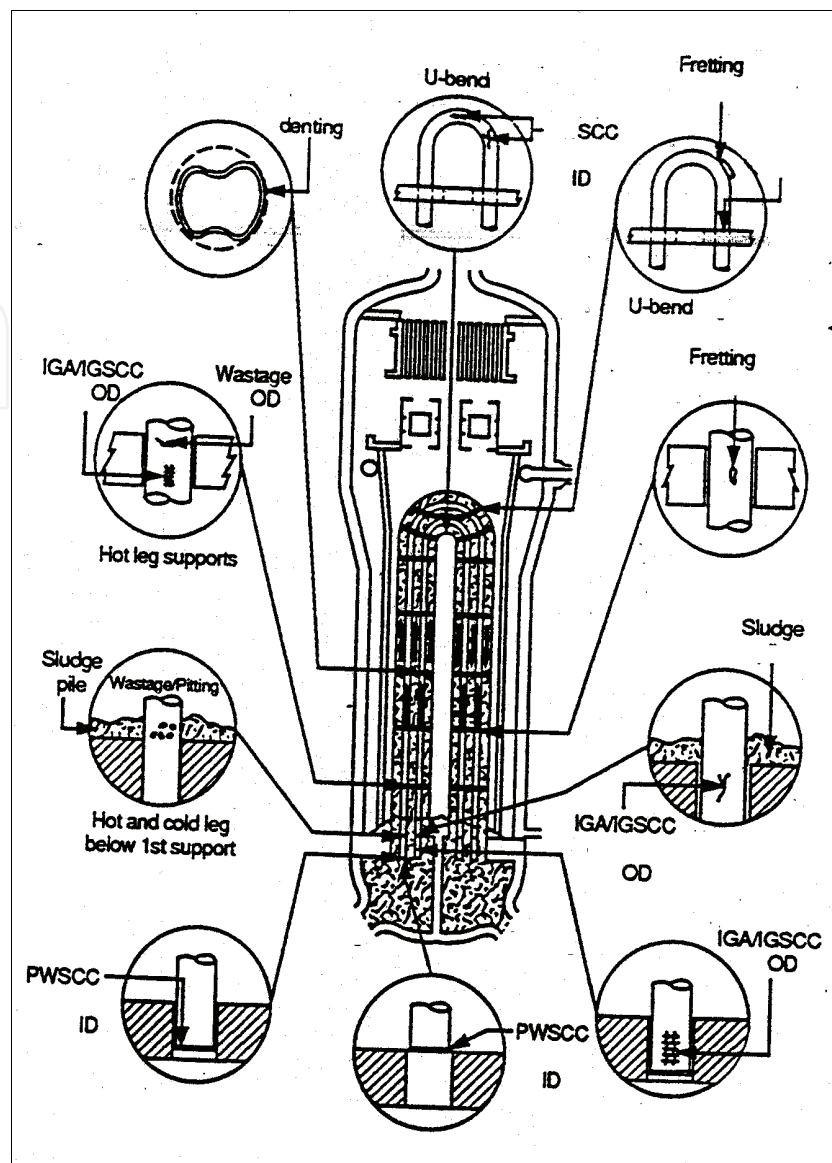
Fig. 1. is a schematic layout of corrosive attacks specific to Steam Generators.

Fig. 1. Types of corrosion specific to the steam generator, (IAEA, 1997)

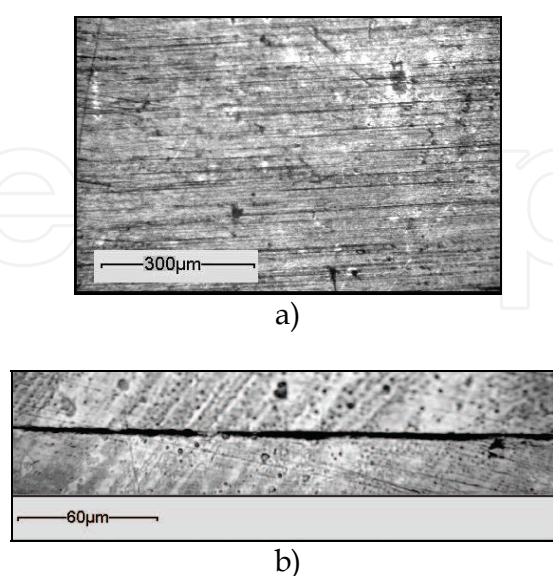
Fig. 2. Surface morphology (x200) (a) and aspect of the superficial layer (x1000) (b) for Incoloy-800 exposed for 1680h in demineralised water, pH=7.5, T=260°C and p=5.1MPa

The chemical composition of Incoloy-800 in percent weight is: C=0.02%, Mn=0.64%, Si=0.49%, S=0.01%, Ni=33.40%, Cr=21.90%, Cu=0.01%, Al=0.24%, Ti=0.41% and Fe=42.88%. Some examples of experimental results for the testing of the Incoloy-800 samples for different times in demineralised water environments with pH=7.5, pH=8.5 and pH=9.5 (AVT) at secondary circuit steam generator specifically parameters (260°C and 5.1MPa) are presented in the Fig.2 ÷ Fig.4.

The aspect of the surface and film formed on the samples tested 1680h in demineralised water at a pH=7.5 are presented in Fig.2. The exposure times for the metallographic analysis of the samples tested at a pH=8.5 were: 240h, 720h, 1200h, 1416h, 1656h, 1824h, 2064h, and 3600h. On the Incoloy-800 samples, tested for 240h in demineralised water with a pH=8.5 adjusted with morpholine and cyclohexylamine, at 260°C and a pressure of 5.1MPa a uniform, continuous and adherent oxide layer is noticed, whose thickness is smaller than or equal to 1.9 μm . The surface morphology for some samples exposed for 240h in demineralised water at a pH=8.5 (AVT) at parameters specific to the steam generator secondary circuit shows the presence of the oxide, its colour being brown-red. The samples surface is completely covered by oxide and there are no uncovered spots, while the visual aspect is almost identical for the entire surface. It is to be noticed that the oxide layer for the samples tested 720h in demineralised water with a pH=8.5 is in this case, uniform, continuous, adherent and its thickness ranges between 0.7 μm and 0.8 μm . The oxide is uniform, with brown-red shadows and formed in continuous film on the samples surface. For the Incoloy-800 samples tested for 1200h in demineralised water with a pH=8.5 the result of the exposure was the formation of an oxide layer with a uniform thickness of 1.2 μm . In this case the oxide uniformity is noticed. The aspect of the oxide layer existing on the samples tested 1416h is shown that the film thickness on these samples is about 0.8 μm . The surface morphology for the samples exposed for 1416h has a uniform aspect.

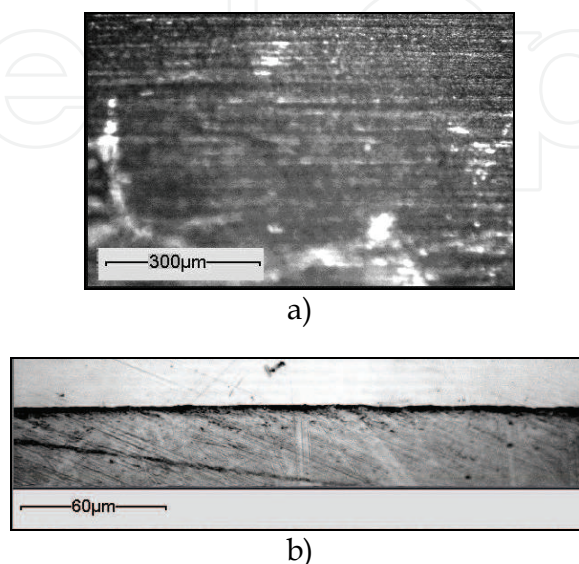
Fig. 3. Surface morphology (x200) (a) and aspect of the superficial layer (x1000) (b) for Incoloy-800 exposed for 3600h in demineralised water, pH=8.5, T=260°C, p=5.1MPa

The aspect of the oxide layer on the surface of samples tested for 2064h in demineralised water with a pH=8.5 is uniform, continuous and adherent. The uniformity and continuity of the oxide layer can be noticed by the surface morphology of samples exposed for 3600h in demineralised water with a pH=8.5, Fig.3. The oxide layer is uniform, continuous and adherent and has a thickness smaller than 3.5 μm . The aspect of the oxide layer and the surface morphology, respectively, for a sample exposed for 3192h in demineralised water at a pH=9.5 under operating conditions specific to the secondary circuit are presented in Fig.4.

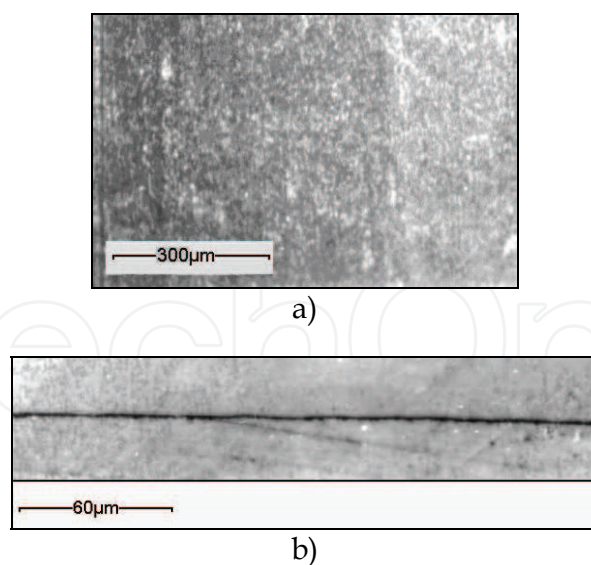
Fig. 4. Surface morphology (x200) (a) and aspect of the superficial layer (x1000) (b) for Incoloy-800 exposed for 3192h in demineralised water, pH=9.5, T=260°C, p=5.1MPa

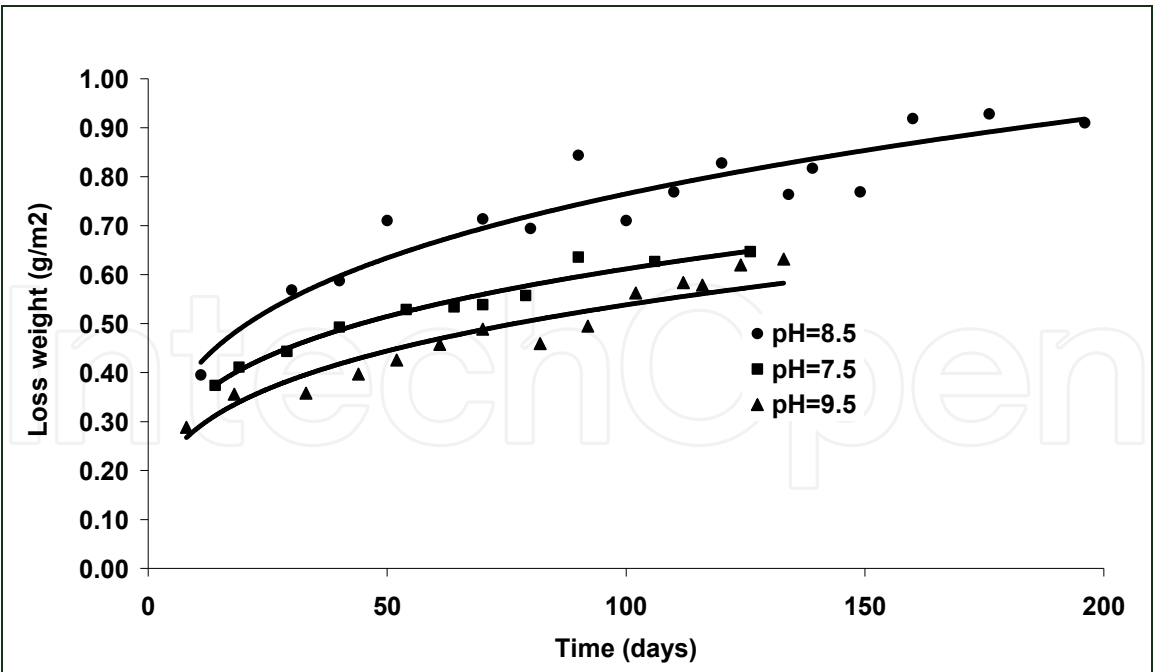
Fig. 5. Loss of metal by corrosion vs. time

After autoclaving operation the samples were descaled in two stage alkaline permanganate – citrox, (Taylor, 1977). Fig.5 ÷ Fig.11 comparatively present the corrosion kinetics for: metal loss by corrosion; corrosion rate; totally formed corrosion products; adherent corrosion products, released corrosion products; corrosion products release, and the release rate of

metal at a pH=7.5, pH=8.5 and pH=9.5, respectively. The Table 1 presents the equations for the corrosion kinetics. For the weight loss due to corrosion and corrosion rate it is noticed that, in the case of a pH=9.5 these have the smallest values (Fig.5 and Fig.6), (Lucan et al., 1998; Lucan et al., 2001; Lucan et al., 2003; Lucan et al., 2005; Cojan et al., 2008). The results are confirmed by the experiments presented in articles from specialty journals, (Taylor, 1977; Stellwag, 1998; Iglesias & Calderon, 2003).

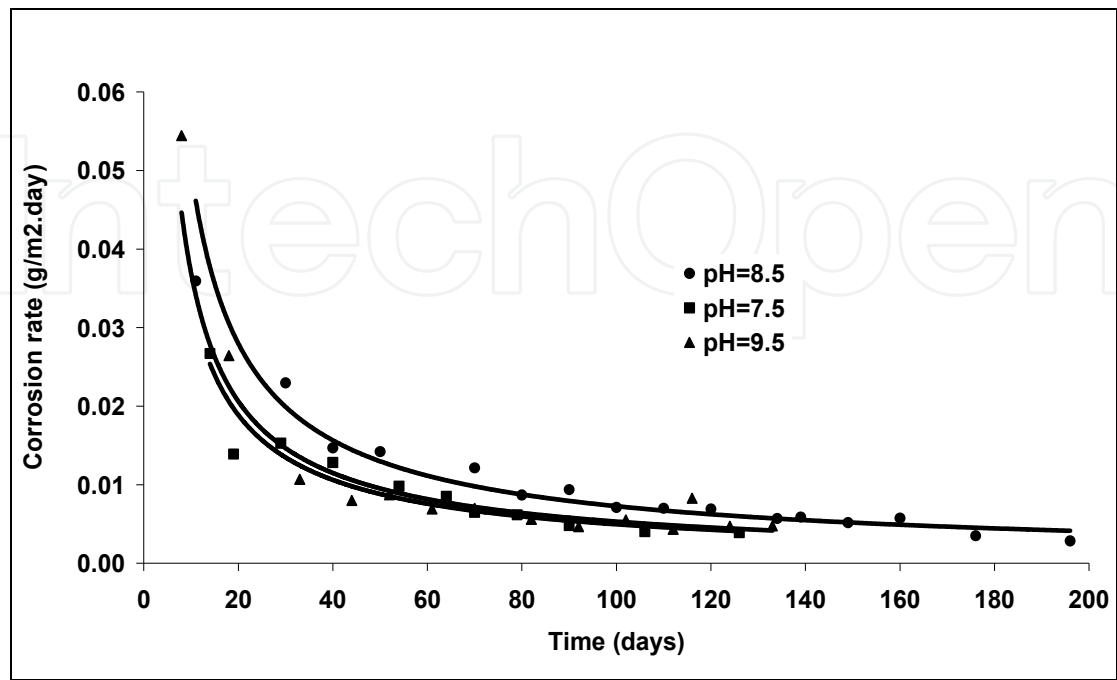
Fig. 6. Corrosion rate vs. time

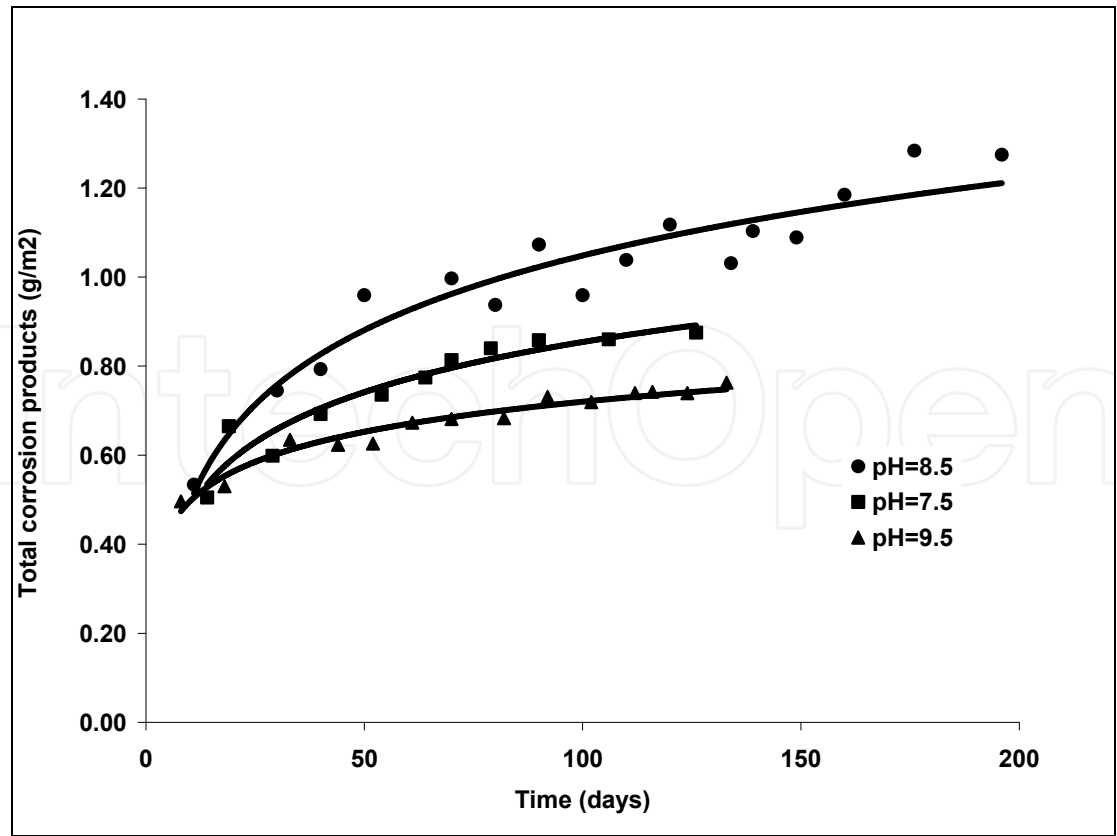
Fig. 7. Total corrosion products vs. time

Also, in the case of totally formed corrosion products the smallest values have been obtained in exposure in solution at a pH=9.5 (Fig.7). In the case of adherent corrosion products, the smallest values have been reached for the solution with a pH = 7.5 (Fig.8), but the values for

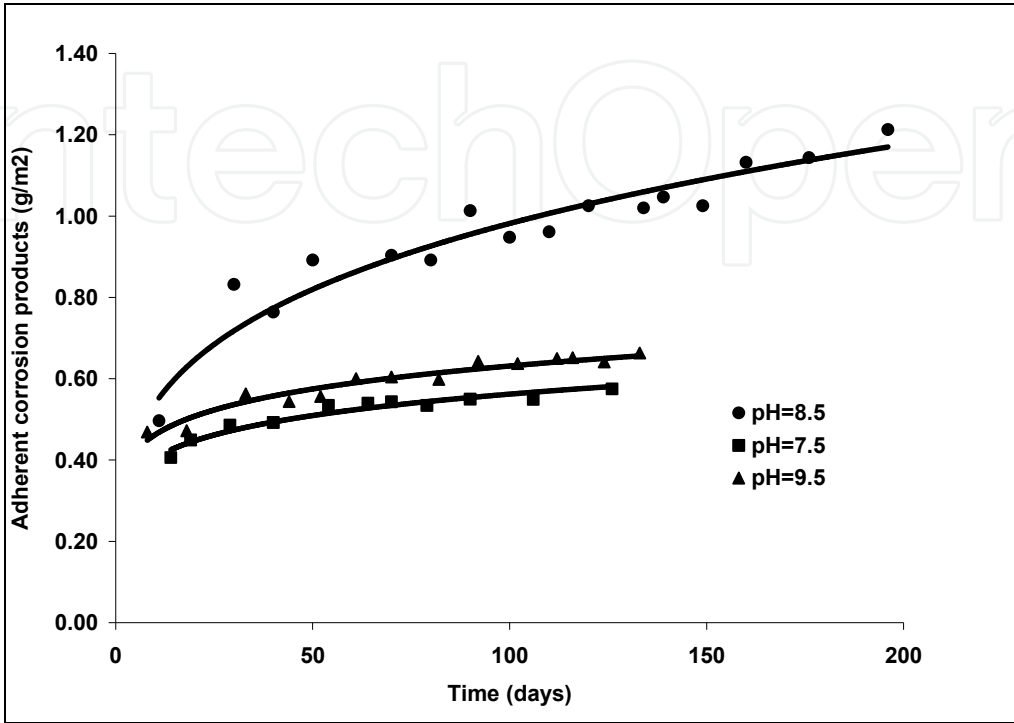
Fig. 8. Adherent corrosion products vs. time

the tests at pH = 9.5 solution are similar, without significant differences between the two cases.

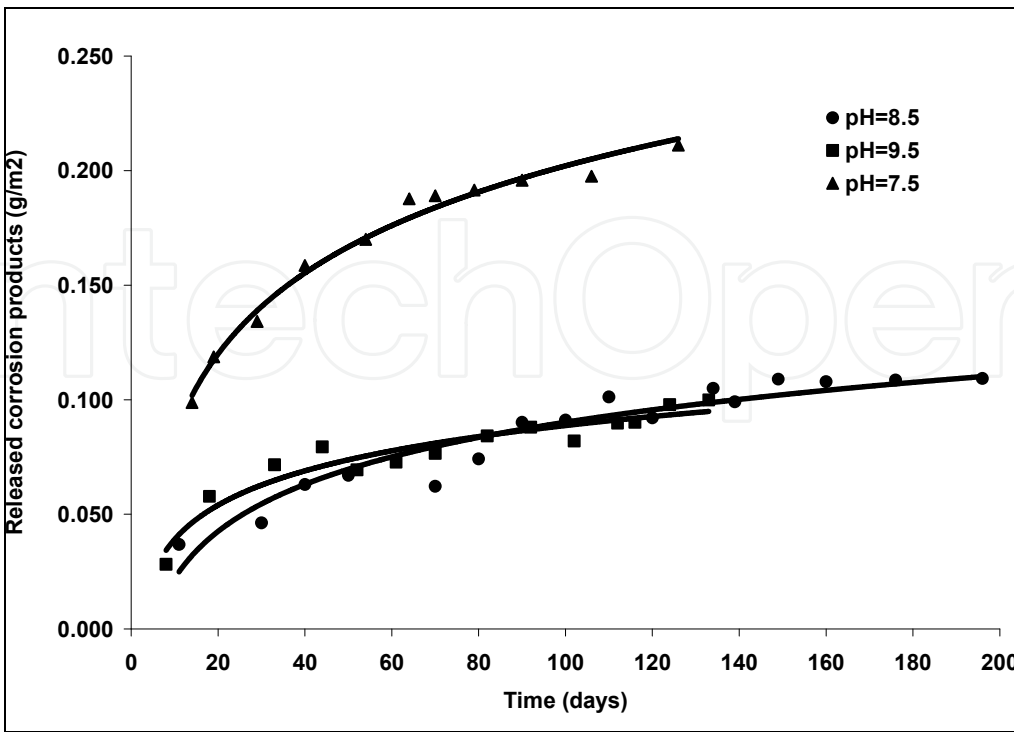
Fig. 9. Released corrosion products vs. time

In the case of released corrosion products, the release rate for products and metal the highest values are obtained for the samples tested in the solution with a pH=7.5 (Fig.9÷Fig.11). This can be explained by the fact that magnetite solubility has higher values for solutions with a smaller pH.

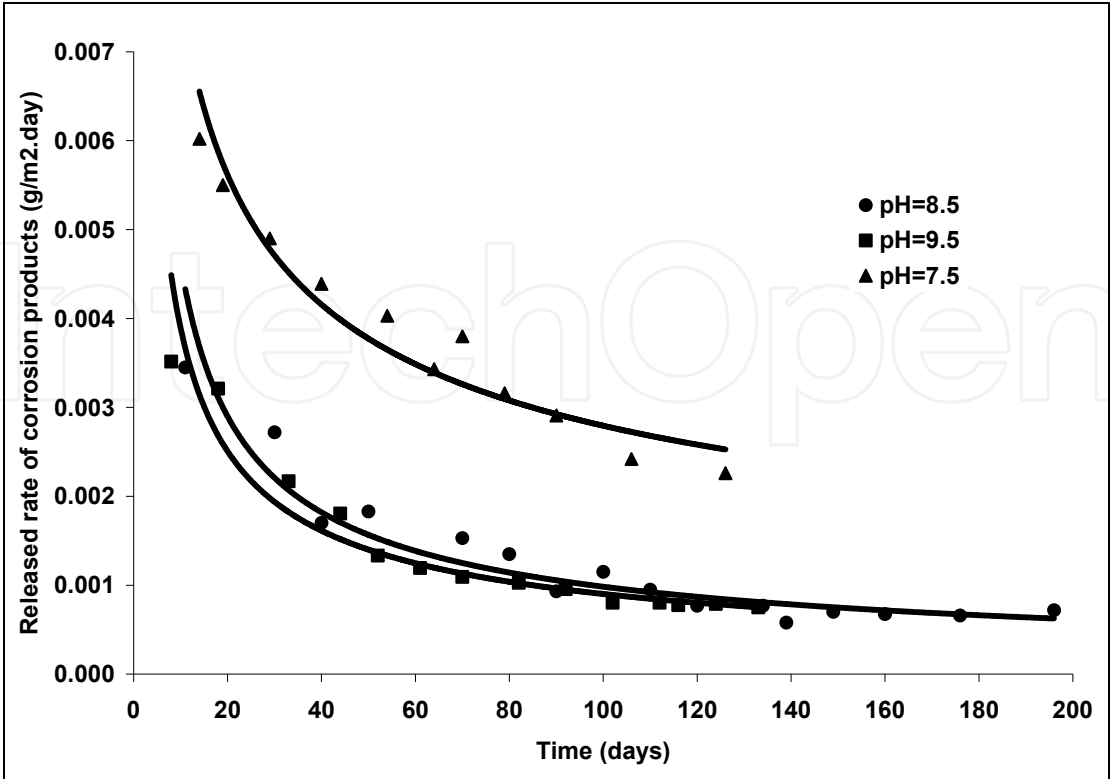
Fig. 10. Released rate of corrosion products vs. time

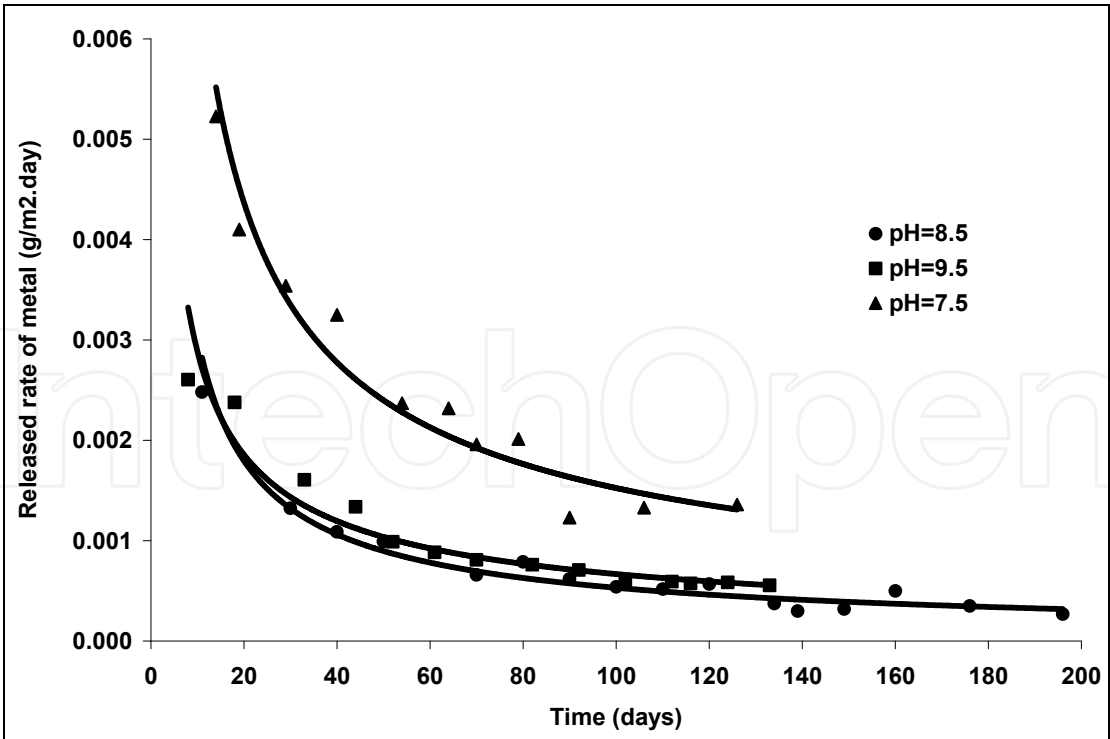
Fig. 11. Released rate of metal vs. time

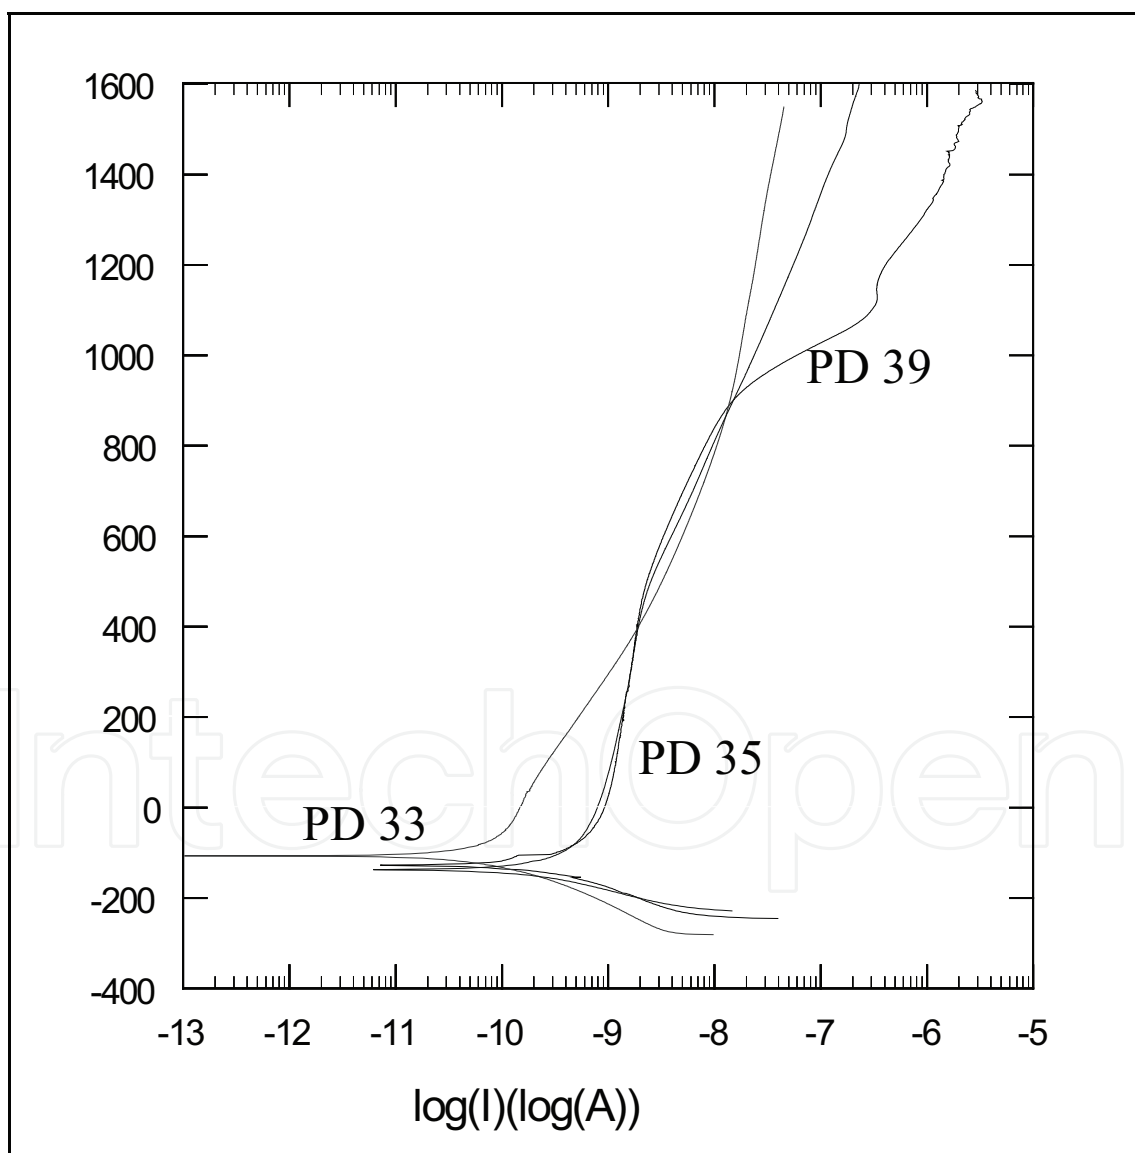
Fig. 12. Potentiodynamic curves Incoloy-800 tested pH=7.5: PD 33- as received; PD 35 – tested 10 days; PD 39 – tested 19 days

Fig.12 and Fig.13 show the results of electrochemical measurements performed by the potentiodynamic method. The electrochemical potential values measured in demineralised water at a pH=9.5 for samples tested by autoclaving at a pH=7.5: PD 35 – tested 10 days, PD 39 – tested 19 days and PD 33- initial status; and pH=8.5 for samples tested by autoclaving at a pH=8.5: PD 36 – tested 10 days, PD 37 – tested 47 days, PD 38 – tested 96 days and PD 34- initial status, show that the oxide films formed on the samples surface at higher exposure times provides them a relatively high corrosion resistance.

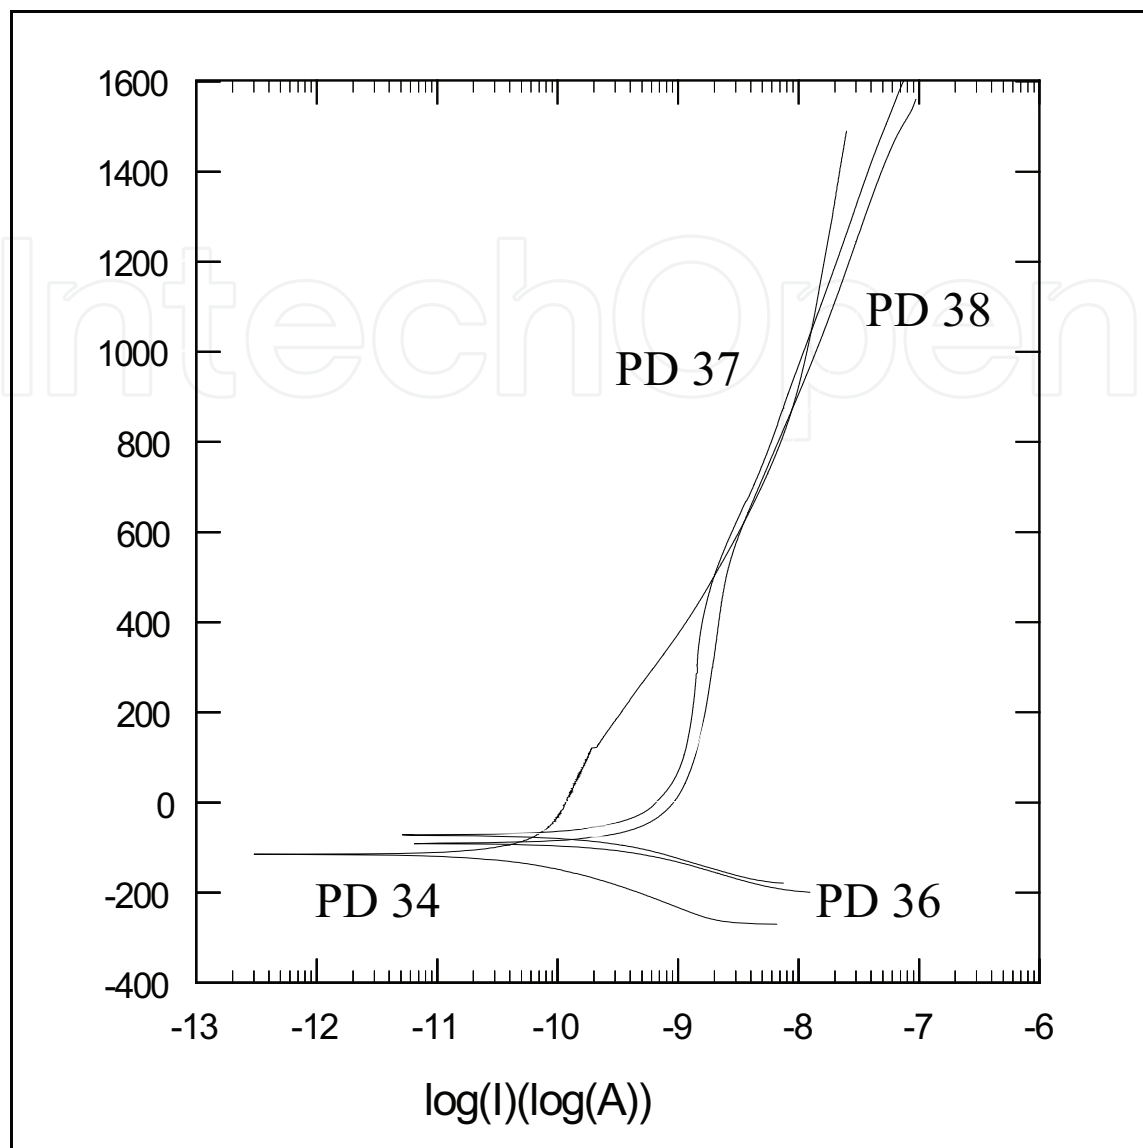
Fig. 13. Potentiodynamic curves Incoloy-800 tested pH=8.5: PD 34- as received; PD 36 - tested 10 days; PD 37 -tested 47days; PD 38 - tested 76 days
