# Surface Modification of Mg Alloys AZ31 and ZK60-1Y by High Current Pulsed Electron Beam

Gao Bo, Hao Yi, Zhang Wenfeng and Tu Ganfeng  
*School of materials and metallurgy, Northeastern University, Shenyang  
 China*

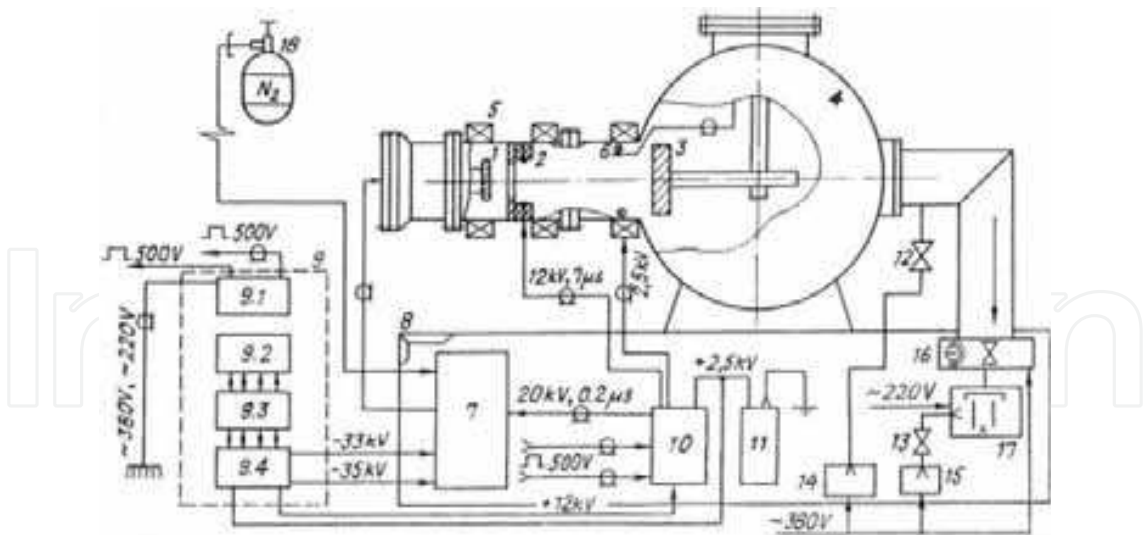
Fig. 2.1. Schematic diagram of high current pulsed electron beam (HCPEB) system

The Fig. 2.1 refers to “Nadezhda-2” type HCPEB device [27] made in Russia. It consists of four parts, such as electron gun, vacuum system, power supply control system and diagnostic system. Vacuum system includes vacuum pump set (a set of molecular pump & a set of mechanical pump), vacuum chamber, vacuum valve as well as pipes for inputting cooling water and waste gas emission. Power supply control system includes high-voltage pulse generator and magnet field triggering power supply, etc. Diagnostic system includes relevant instruments and meters, such as operating vacuum measurement, electron beam, cathode accelerating voltage and average energy density, etc. Electron gun includes cathode, anode, spark source, rogowski coil and magnetic coil, etc. The electron gun used for generating high current pulsed electron beam is the core part of the whole equipment.

1-cathod; 2-spark source; 3-collector; 4-vacuum chamber; 5-solenoid; 6-rokovsky coil; 7-pulsed high-voltage generator; 8-bracket; 9-electricity controller; 10-pulses trigger; 11-capcitor; 12, 13-manual vacuum valve 1, 2; 14, 15-pump 1, 2; 16-electromagnetism valve, 17-molecular pump, 18-nitrogen.

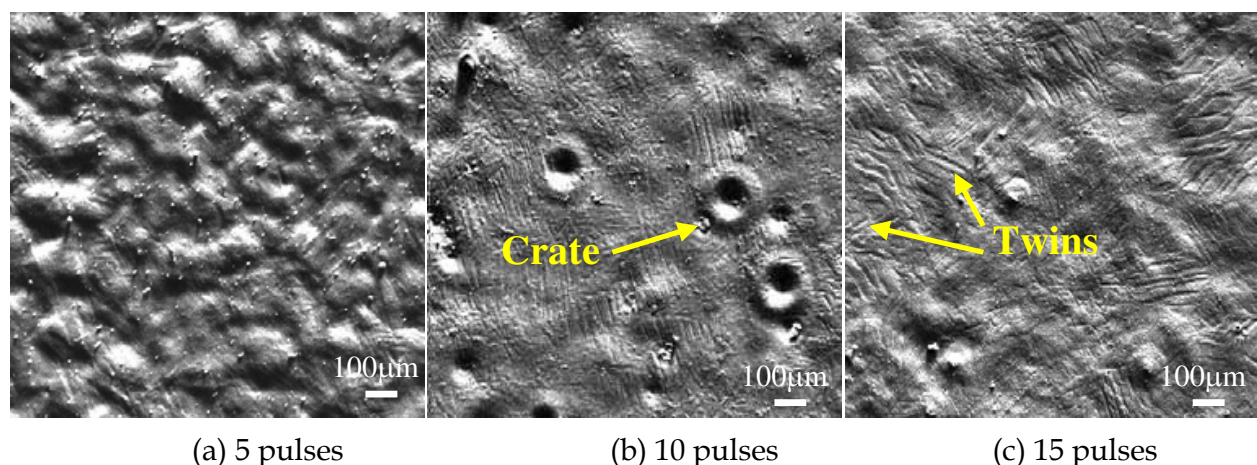
Fig. 3.1. Surface SEM morphologies of AZ31 Mg alloy after HCPEB irradiation with different pulses

Fig. 3.1 gives the surface SEM morphologies of Mg alloy AZ31 after HCPEB treatment with energy density of  $3\text{J}/\text{cm}^2$ . Fig. 3.1 (a) refers to the surface morphology of Mg alloy AZ31 after HCPEB treatment of 5 pulses. It can be apparently observed that a typical morphology emerges on the AZ31 Mg alloy surface after HCPEB treatment, namely wavy morphology after complete melting. With the pulse number increasing to 10 pulses, the “crater” morphology and few twins are found on the treated surface shown in the Fig. 3.1 (b). Fig. 3.1 (c) shows surface morphology of Mg alloy AZ31 after 15 pulse treatment, it is found that the “crater” morphology disappears after repeated melting and a large number of twins are formed. The 15-pulsed sample surface tends to be smooth. The formation of twins is possibly induced by a lot of residual stresses on the surface after HCPEB treatment [28].

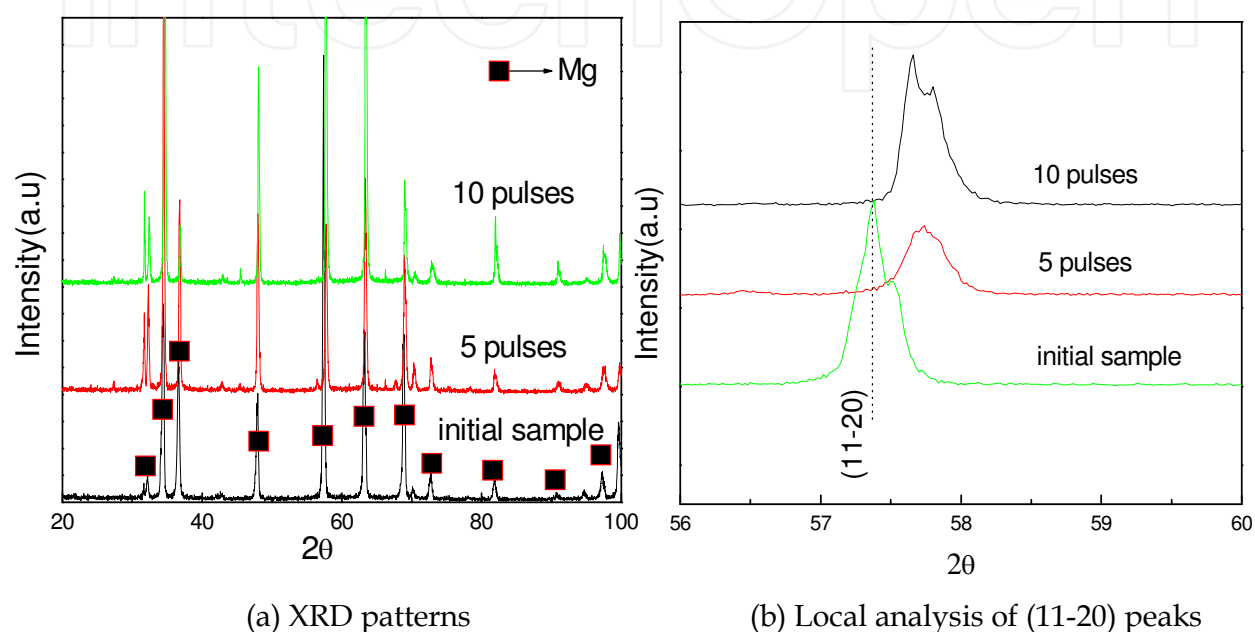
Fig. 3.2. XRD patterns of Mg alloy AZ31 before and after HCPEB treatment

Fig. 3.2 indicates XRD patterns of Mg alloy AZ31 before and after HCPEB treatment and local analysis of (11-20) peaks. From the figure, it is found that the diffraction peaks of Mg

obviously move towards high-angle direction after 5 and 10 pulse treatments, as clearly shown in the enlarged figure. The moving of Mg diffraction peaks is more obvious with the increase of pulse number. This is generated by rapid heating and cooling process induced by HCPEB on the surface of Mg alloy. The substitutional solid solution of Al atoms replacing Mg atoms is formed in the Mg lattices, and the lattice constants are reduced as increasing solid solubility. To sum up, high-angle moving of Mg diffraction peaks is attributed to the formation of saturated solid solution of Mg [29].

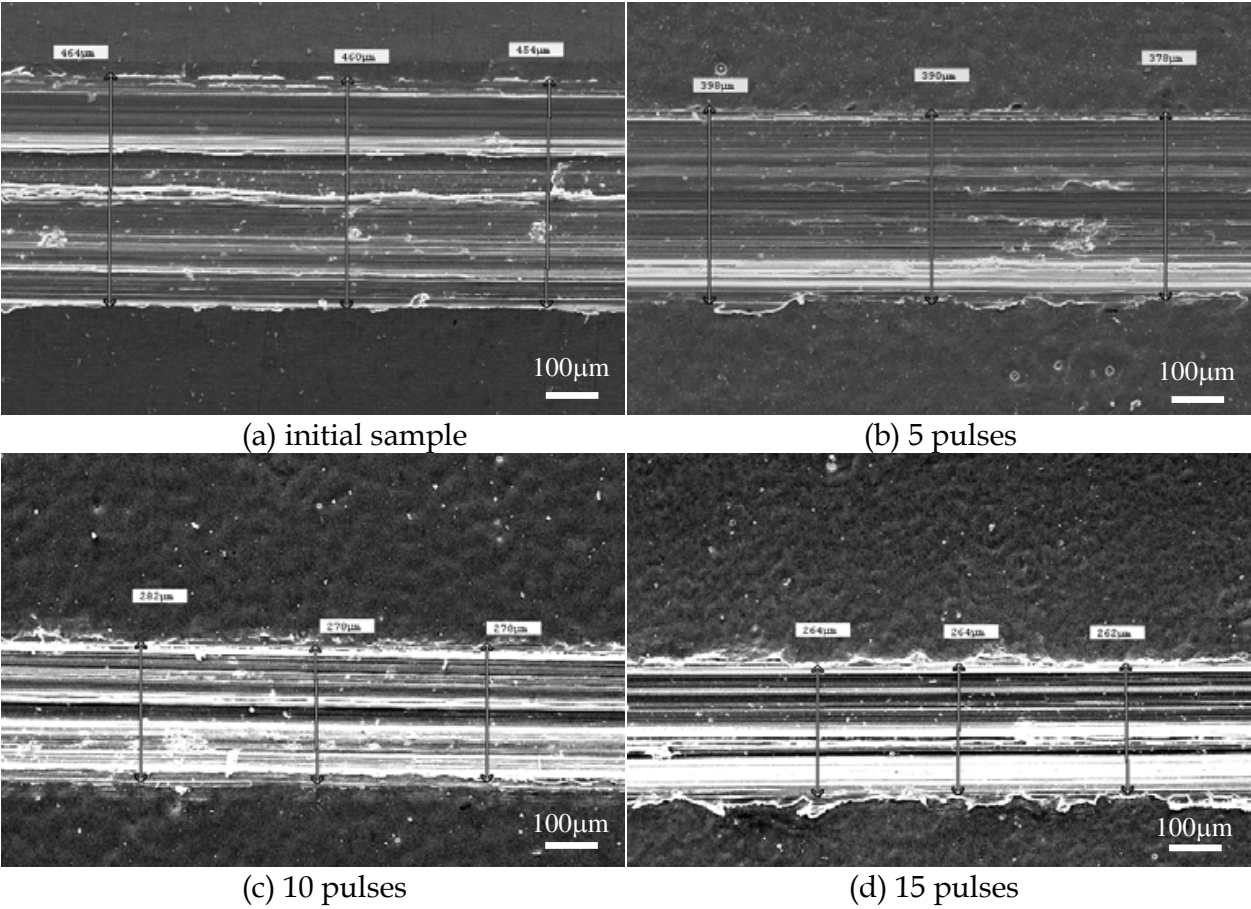
Fig. 3.4. SEM morphologies of wear grooves for Mg alloy AZ31 before and after HCPEB treatment with energy density of  $\sim 3 \text{ J}/\text{cm}^2$

Fig. 3.4 gives SEM morphologies of wear grooves on the surface of Mg alloy AZ31 before and after HCPEB treatment. Compared to wear groove morphology on the surface of initial

sample, the width of wear grooves on the surface of Mg alloy AZ31 is decreased obviously after HCPEB treatment, which is reduced from  $460 \mu\text{m}$  of initial sample to  $280 \mu\text{m}$  of 10-pulse

treated sample. The wear form is the typical abrasive wear for Mg alloy AZ31. The hardness of matrix is far smaller than that of WC grinding ball, so the cutting form is focused on the wear surface and the groove morphology is formed. After HCPEB treatment, the residual compressive stress is left on the surface, leading to the increase in hardness of HCPEB-treated Mg alloy. As a result, the wear rate and wear volume are reduced, and the width of wear grooves is also decreased. Meanwhile, the main composition of wear debris is the oxides of Mg and Al through EDS analysis of SEM. It is caused by oxidation resulting from the fact that the wear test is performed in the atmosphere, and a lot of heat is accumulated on the sample surface during the severe friction process.

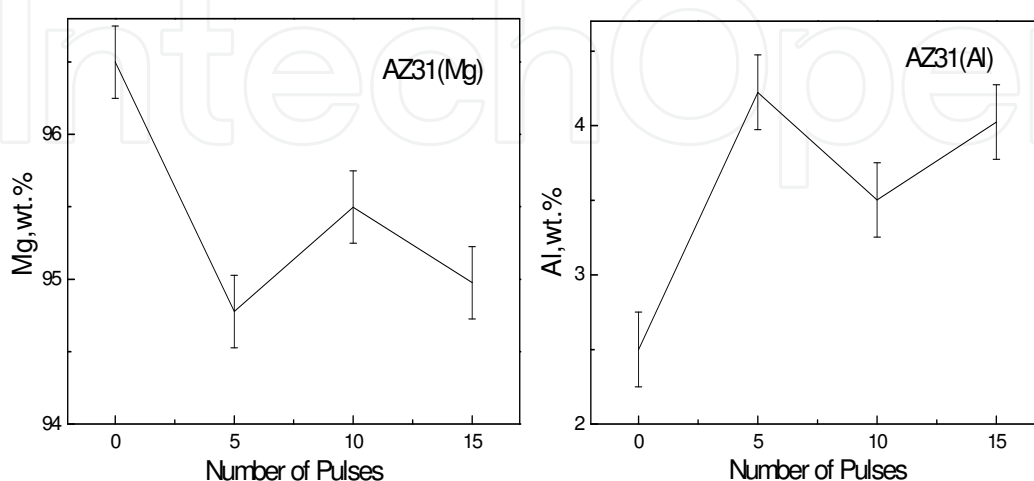
Fig. 3.5. Content of Mg and Al on the surface of Mg alloy AZ31 after HCPEB irradiation

The chemical composition of alloy surface plays an important role in corrosion process. The changes of Mg, Zn and Al elements are analyzed by SEM. It is found that the variation of Zn is very small after HCPEB treatment. The changes of Mg and Al are mainly given in Fig. 3.5. It can be seen that the content of Mg on the surface is reduced after HCPEB treatment and reaches maximum reduction after 5 pulse treatment, which is due to Mg evaporation in the molten state. As the number of pulse increases to 10 pulses, the melted layer is thickened. The Mg contained underneath new melting liquid will spread or evaporate to the upper layer, so the Mg content on the surface of Mg alloy AZ31 will rise again. With further increase in pulse number, the Mg at the surface layer loses balance as well as the Mg inside the equipment, and the Mg at the surface layer evaporates, so the content of Mg is reduced again. But, the change of Al content is on the contrary to that of Mg. The increased Al content at the surface layer will be undoubtedly favorable to the formation of compact oxide film and the enhancement of corrosion resistance on the alloy surface. Therefore, in order to acquire the surface that contains high content of Al, it is crucial to choose proper pulse number and energy density.

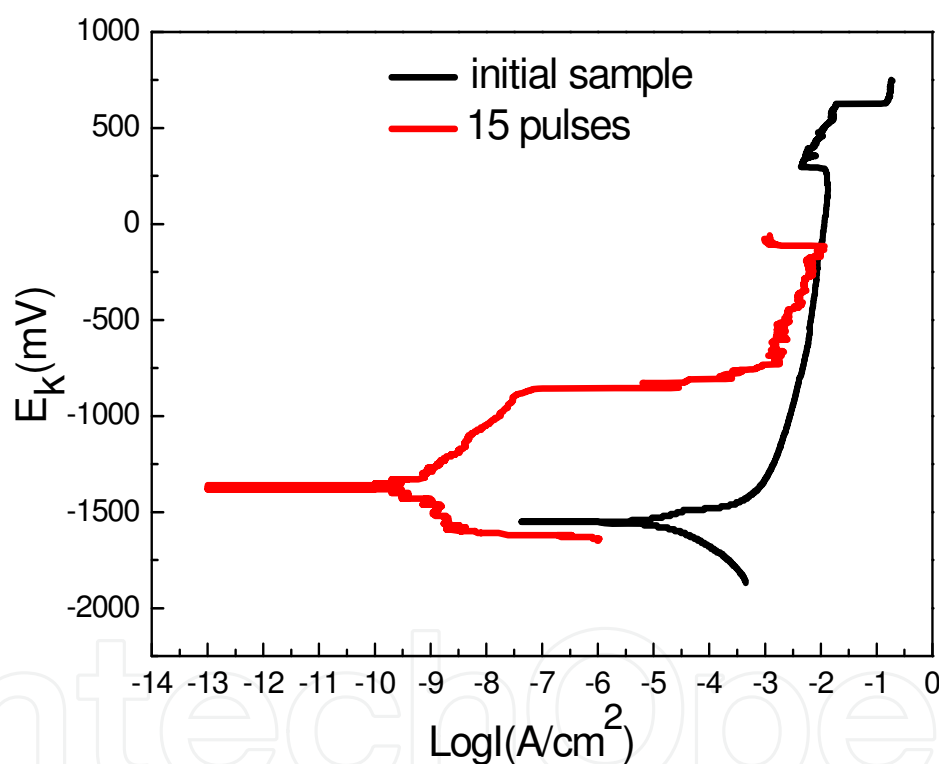
Fig. 3.6. Potentiodynamic polarization curves of Mg alloy AZ31 before and after HCPEB treatment (15 pulses)

Fig. 3.6 shows the potentiodynamic polarization curves of Mg alloy AZ31 before and after HCPEB treatment. From the measuring result, we can see that the  $E_{\text{corr}}$  of modified sample is moved to  $-1360\text{mV}$ . Through Tafel straight line fitting of cathode and anode, it is discovered that the corrosion current is reduced but the polarization resistance is increased. The reason is that HCPEB treatment leads to rich Al on the AZ31 Mg alloy surface and the formation of compact oxide film. Compared to the initial sample, the corrosion resistance of HCPEB-treated sample is increased. It can be also discovered that the overpotential (the difference between applied potential and  $E_{\text{corr}}$ ) reaches about  $300\text{mV}$ , namely breakthrough occurs. For one thing, the surface protective film is comparatively thin. For another thing, the applied etching solution is  $5\%$  NaCl, in which chloride ion has strong penetrability. Hence the protective film is punctured rapidly. It also illustrates that HCPEB treatment can not be solely applied as the final process of the sample treatment, but it should be applied practically together with other processes.

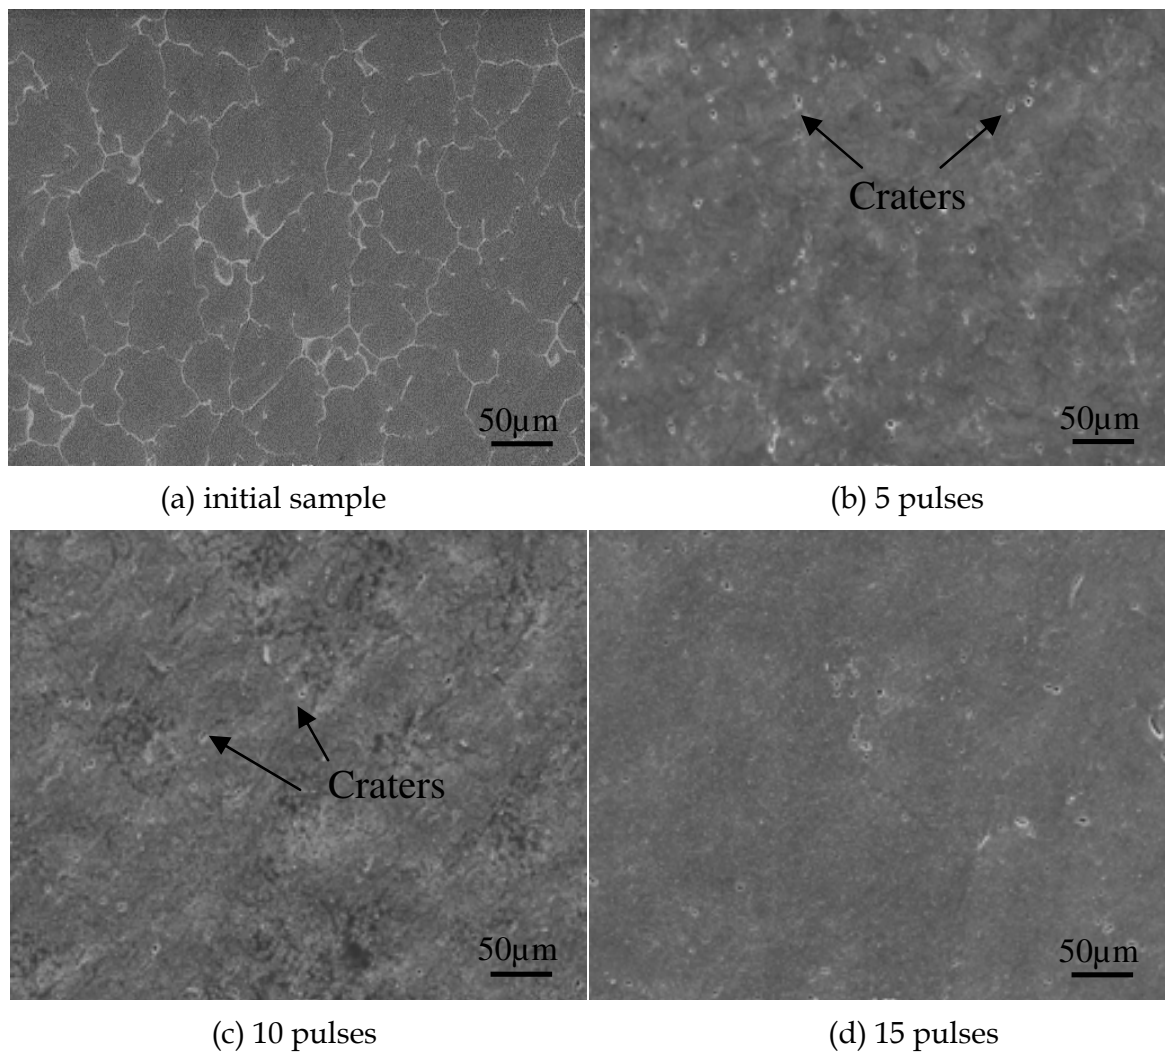
Fig. 3.7. Surface SEM morphologies of Mg alloy ZK60-1Y before and after HCPEB treatment

Fig. 3.7 refers to surface SEM morphologies of Mg alloy ZK60-1Y before and after HCPEB treatment. Before electron beam treatment, the original structure of Mg alloy ZK60-1Y is composed by eutectic structure and matrix  $\alpha(\text{Mg})$ , and the eutectic structure shows discontinuous distribution (white contrast in the figure), as shown in the Fig. 3.7 (a). After HCPEB treatment, the crystal boundaries on the surface of Mg alloy ZK60-1Y become less obvious, and the composition tends to be uniform. It is because that the HCPEB bombardment results in melting of the alloy surface, and it is too late to be redistributed and solidified for the elements owing to subsequent rapid solidification. At the same time, the typical "crater" morphology is formed on the surface of Mg alloy (Fig. 3.7 (b)). It is due to the ZK60-1Y Mg alloy surface is under the action of pulsed beam current, the subsurface is melted first and liquid is erupted outwards from inside, which is similar to the volcanic eruption. It is one reason for the formation of "crater" morphology [31]. With increasing pulse number, more energy is absorbed by the surface of Mg alloy, as a result, the "crater" quantity is reduced and the surface becomes much smoother, as shown in the Fig. 3.7 (c-d).

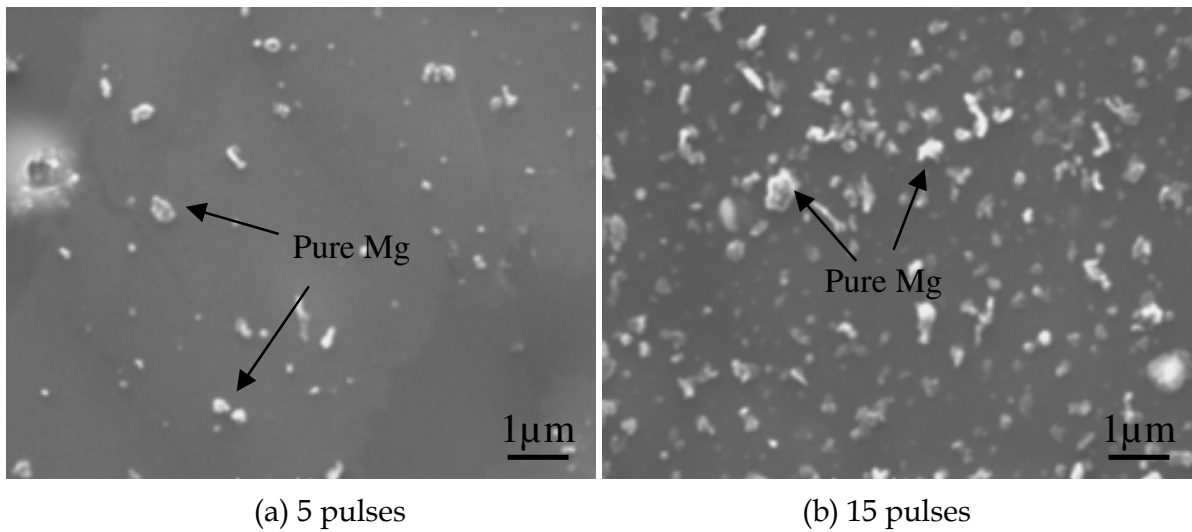
Fig. 3.8. Pure Mg particles on the surface of Mg alloy ZK60-1Y after HCPEB treatment with accelerating voltage of 27kV

Fig. 3.8 shows pure Mg particles on the surface of Mg alloy ZK60-1Y after HCPEB treatment. From the figure, it can be seen that the pure Mg particles (the result of EDS analysis) are distributed on the surface of Mg alloy after HCPEB treatment and more pure Mg particles emerge on the alloy surface after 15 pulse treatment. The reason can be explained as follows: Mg belongs to the low melting point metal and its vapor pressure is also very low compared with Zr and Y elements. Under HCPEB bombardment, the temperature of matrix Mg rises swiftly due to the momentary energy deposition, resulting in melting of Mg at the surface layer. As the surface temperature reaches the boiling point, the vaporization goes ahead within a certain range at the surface layer and a lot of droplets sputter out. Because the target material surface parallels to the direction of gravity, the spilled droplets will not return to the surface under the action of gravity but will be charged with negative electricity under the action of electron beam current. As the target is the anode, the droplets with negative electricity will slow down and be drawn back to anode under the action of electric field force. Consequently, the droplets fall on the entire surface at certain speed. After solidification, we can see the pure Mg particles as shown in the Fig. 3.8.

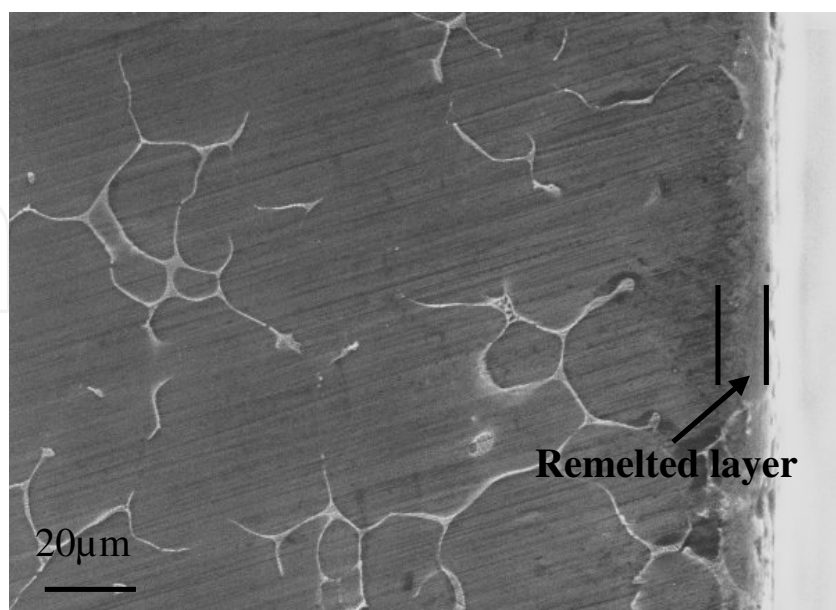
Fig. 3.9. Cross sectional SEM image of Mg alloy ZK60-1Y after HCPEB treatment after HCPEB treatment

Fig. 3.9 refers to cross sectional SEM image of Mg alloy ZK60-1Y after HCPEB treatment. From the figure, it can be observed that remelted layer with thickness of  $\sim 12\mu\text{m}$  is formed on the surface layer. Compared to the matrix, the remelted layer is more compact and the crystal boundary become less obvious. It can mainly be explained as follows: the second phase existing in crystal boundaries melts and diffuses due to the rapid melting process induced by HCPEB treatment, while the crystal boundaries disappear in the melting liquid. When the electron beam bombardment terminates, the rapid solidification occurs immediately on the surface owing to good thermal conductivity of the metal material. Under the action of high solidification rate ( $\sim 10^8\text{K/s}$ ), great temperature gradient is generated on the surface of the material and non-equilibrium freezing occurs in the melting

layer. For the solidification time is too short, the actual temperature of the liquid at the frontier of solid liquid interface is lower than the liquidus temperature, so there is no way to provide continuous driving force for the growth of crystal grains. The nucleation rate of crystal is greater than the growth rate, so the crystal grains in the surface layer are refined and the inter-grain boundaries of the refined crystal grains become indistinct. In addition, the segregation phenomenon of alloying elements existing in grain boundaries is improved, and Zn and Zr better dissolve into the Mg matrix and form supersaturated solid solution. As a result, the element is uniformly distributed on the modified surface of Mg alloy ZK60-1Y.

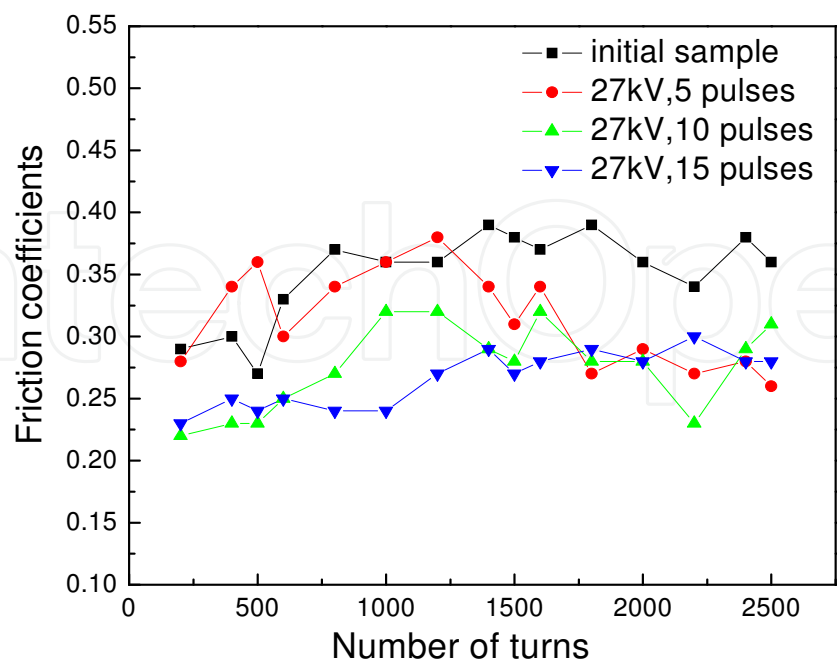
Fig. 3.10. Evolution of friction coefficients with the number of friction turns for Mg alloy ZK60-1Y before and after HCPEB treatment

Fig. 3.10 indicates the evolution of friction coefficients with the number of friction turns for Mg alloy ZK60-1Y before and after HCPEB treatment. From the figure, it can be seen that the friction coefficients of initial sample maintain around 0.28 at the initial friction stage. However, the friction coefficients of the sample are relatively high at the initial friction stage after 5 pulse treatment, around 0.35. It mainly because the sample surface is not even and the pure Mg particles are distributed on the modified surface, so the surface roughness is increased and the friction coefficients become higher. On the other hand, there is a layer of oxide film on the surface of the initial sample, and the surface roughness is smaller compared to that of the HCPEB-treated sample. Therefore, the friction coefficients of the initial sample are lower at the initial friction stage. With the increase in the number of friction turns, the friction coefficients of the initial sample present rising trend. Upon 1200 cycle friction, the friction coefficients maintain between 0.34 and 0.38. It is because that the oxide layer on the surface is worn away after a period of friction, therefore the matrix gradually touches stainless counterpart discs and shows high friction coefficients.

After 1400 cycle friction, the friction coefficients of the sample treated by HCPEB are lower than that of the initial sample, showing better wear resistance. The reason can be summarized as:1) the grain structure in the remelted layer after HCPEB treatment is refined, namely fine-grain strengthening effect; 2)the enrichment phenomenon of alloying elements is improved, and the chemical composition is distributed evenly and the mechanical property is further enhanced on the ZK60-1Y Mg alloy surface. With the progressing of wear test (after 1800 cycle friction), the friction coefficients of HCPEB treated sample are much lower. It is because the surface at the remelted layer has been worn away basically. Then the remelted layer in this layer has better wear resistance. In the whole friction test, the friction coefficients of the alloy don't fluctuate drastically and maintain between 0.23 and 0.30 after 15 pulse treatment under the accelerating voltage of 27kV. With the increase of pulse number, the times of rapid solidification occurred on the treated sample surface is increased accordingly, thus the alloying elements are distributed evenly and the mechanical property of the alloy surface is more stable. To sum up, compared to the initial sample, the surface of Mg alloy ZK60-1Y has better wear resistance after HCPEB treatment.

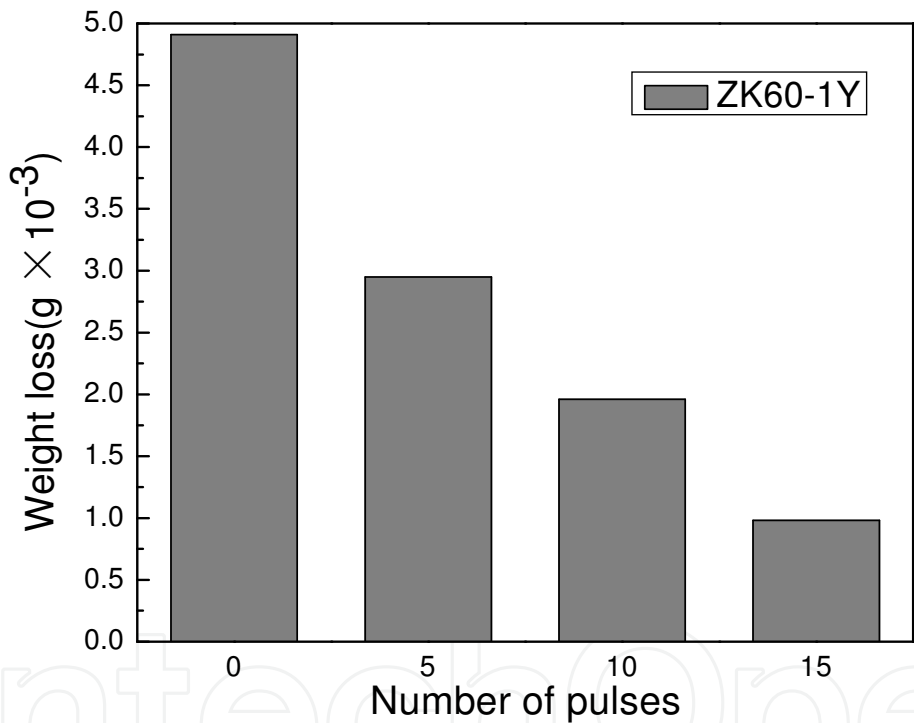
Fig. 3.11. Evolution of weight loss with the number of pulses for Mg alloy ZK60-1Y before and after HCPEB treatment

Fig. 3.11 refers to the evolution of weight loss with the number of pulses for Mg alloy before and after HCPEB treatment. From the figure, it can be seen that the weight loss of the sample is reduced from  $4.91 \times 10^{-3}$  g of initial sample to  $0.98 \times 10^{-3}$  g after 15 pulse treatment. It indicates that the wear resistance of the sample by HCPEB treatment is greatly improved under same friction condition. The weight loss of the sample by 5, 10 and 15 pulse treatments is reduced by 39.9%, 60.1%, 80% respectively compared to that of the initial sample. That means the wear resistance of the sample is the best after 15 pulse treatment under the accelerating voltage of 27kV and the relative wear resistance is improved by a factor of 5. It can be attributed to the changes in the microstructure of ZK60-1Y Mg alloy
