# New Non-Destructive Methods of Diagnosing Health of Gas Turbine Blades

Józef Błachnio<sup>1,2</sup>, Mariusz Bogdan<sup>2</sup> and Artur Kułaszka<sup>1</sup>

<sup>1</sup>*Air Force Institute of Technology, Warszawa,*

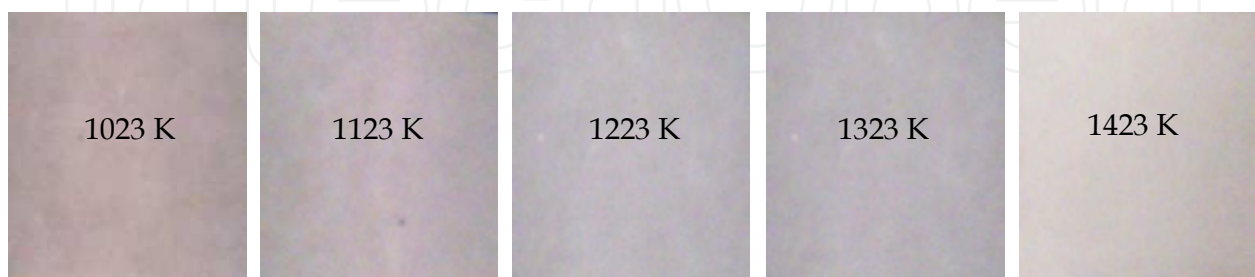
Images of surfaces of blade specimens were acquired both before and after specimens soaking in the furnace. The photos were taken on a purpose-built workbench (Bogdan & Błachnio, 2007; Błachnio & Bogdan, 2008;) with a digital photo camera, while the surfaces were illuminated with scattered white light. Repeatability of the obtained results was proved by taking multiple photos of the same specimens, under the same conditions with appropriate settings of parameter of the digital photo camera. The soaking of blade specimens in the furnace led to alterations in colour of the surfaces. An exemplary set of images is shown in Fig. 7.

Fig. 7. Images of surfaces of specimens soaked at various temperatures
