Crystallographic Observation and Delamination Damage Analyses for Thermal Barrier Coatings Under Thermal Exposure

Kazunari Fujiyama
Meijo University,
Japan

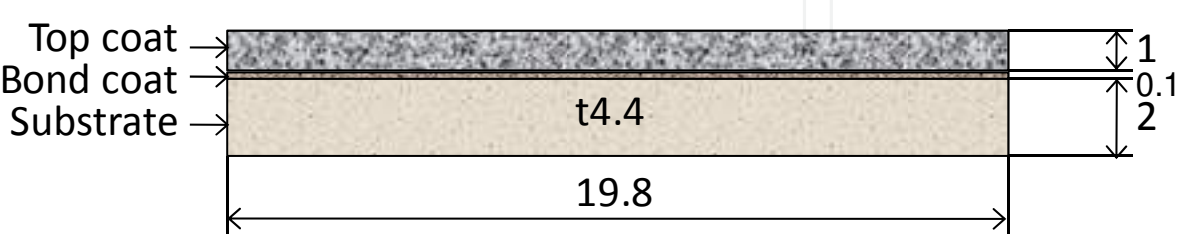
Top coat : 8wt% Y₂O₃-ZrO₂(1mm thick); APS(Atmospheric Plasma Spraying)
Bond coat : CoNiCrAlY(100µm thick); LPPS(Low Pressure Plasma Spraying)
Substrate : MA263(2mm thick)

Fig. 2. TBC specimen geometry.

Atmospheric plasma sprayed ceramic coatings are widely used as the thermal barrier coating (TBC) in high temperature components typically in gas turbine hot gas path sections. The TBC samples tested here are consisted with three layers: top coat, bond coat and substrate as shown in Fig.2. The top coat is consisted with Yttria- Partially Stabilized Zirconia(PSZ). The thickness of top coat region is 1mm, considerably thicker compared with the commercial TBC system in actual gas turbines.

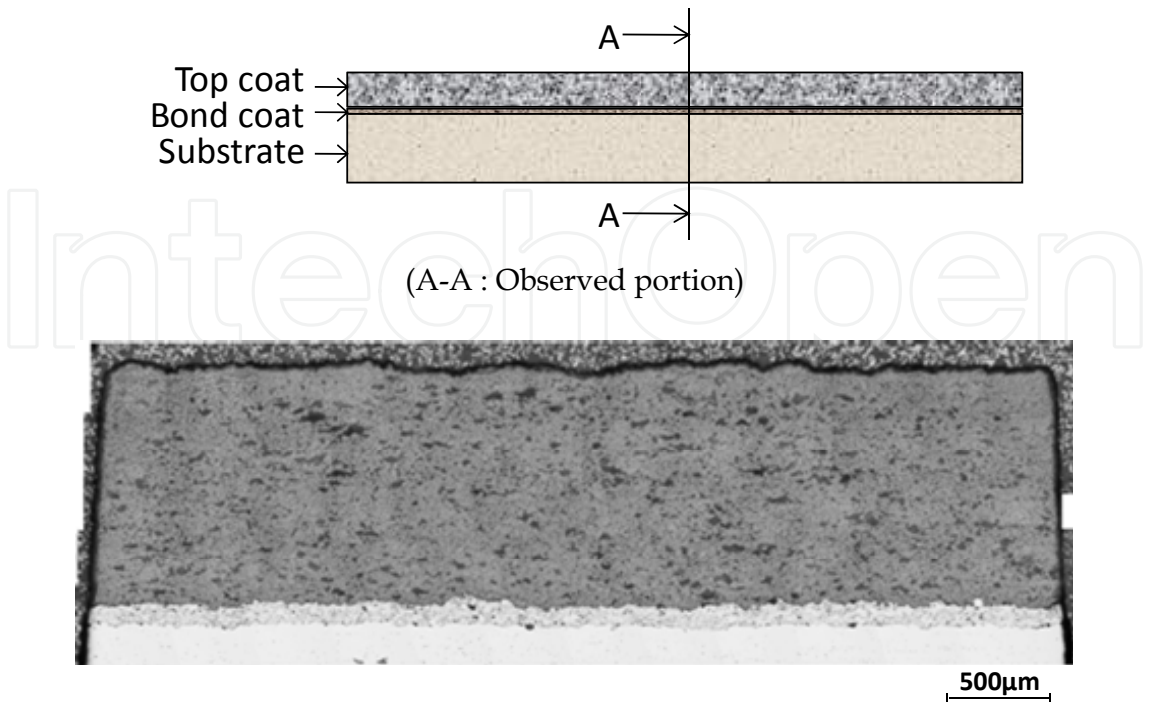
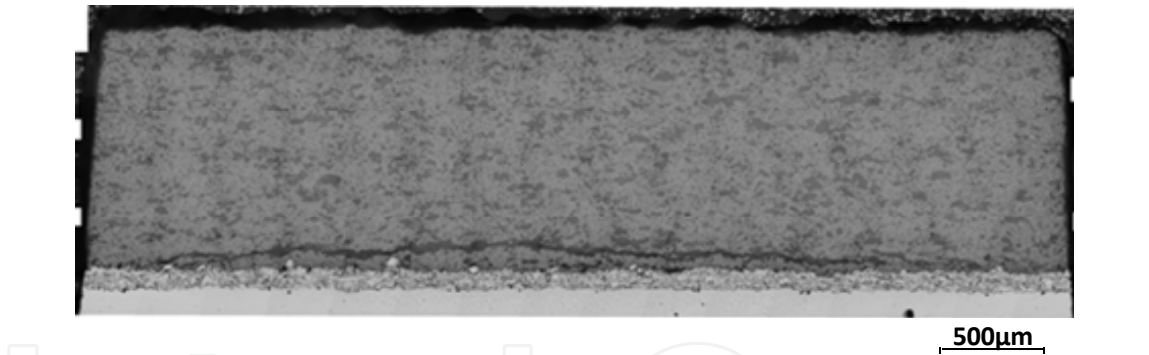
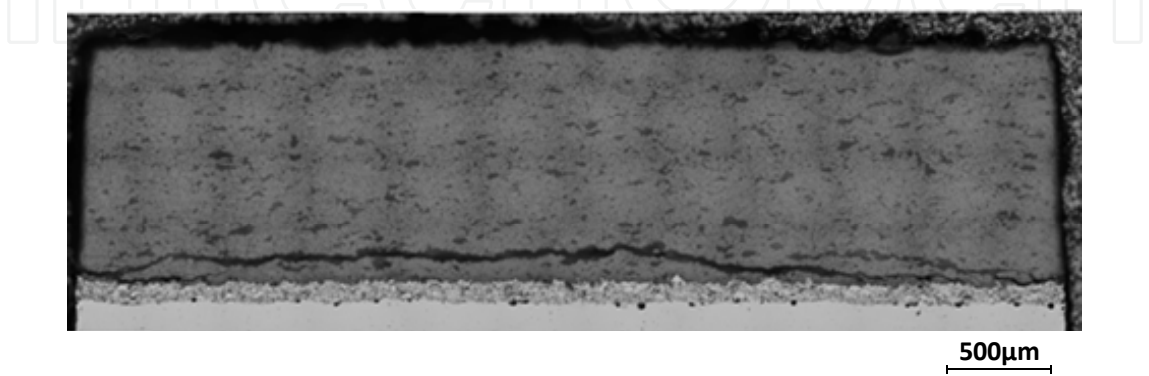
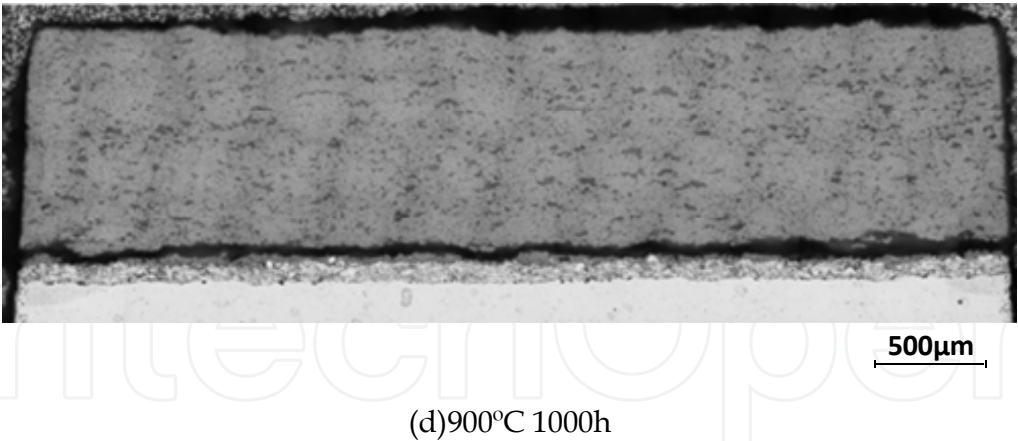
(a)As sprayed

(b)900°C 100h

(c)900°C 300h

Fig. 3. Optical microscope observation of the cross section at 900 °C exposure tests.

Figure 3 shows the delamination process exposed at 900°C. Macro cracks grow laterally in the top coat just above the bond coat. The surface macro crack is located at the interface between top coating and bond coat besides at the mid section crack is located above the bond coat within top coat. Fig.4 shows the cross section exposed for 50hours at1000°C. The delamination was clearly found in this case.

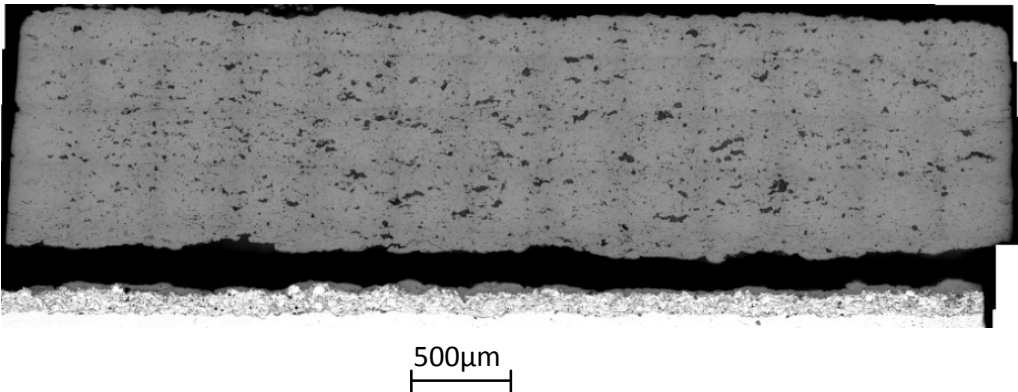
Fig. 4. Optical microscope observation of the cross section at 1000 °C-50h exposure test.

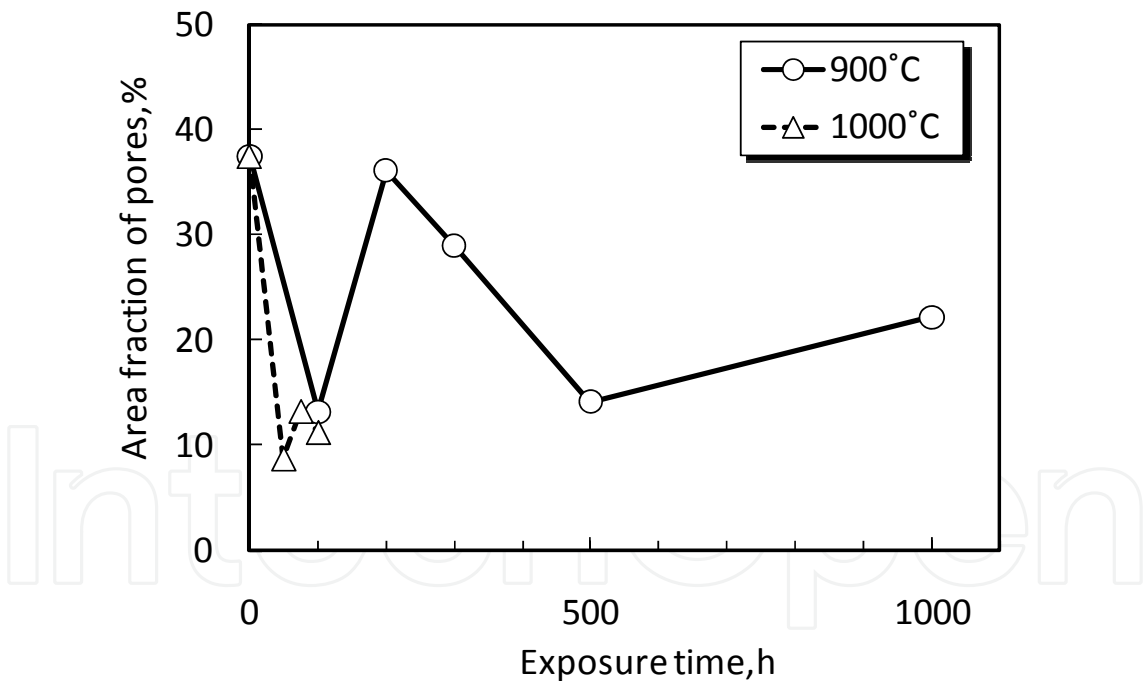
Fig. 7. The trend of area fraction of pores in top coat against exposure time.

Figure 7 shows the trend of area fraction of pores against thermal exposure time. Reduction in area fraction of pores was observed at the initial stage of heating but the decreasing trend was not monotonic. The area fraction of pores showed similar levels exposed at 900°C for 500h and at 1000°C for 75h.

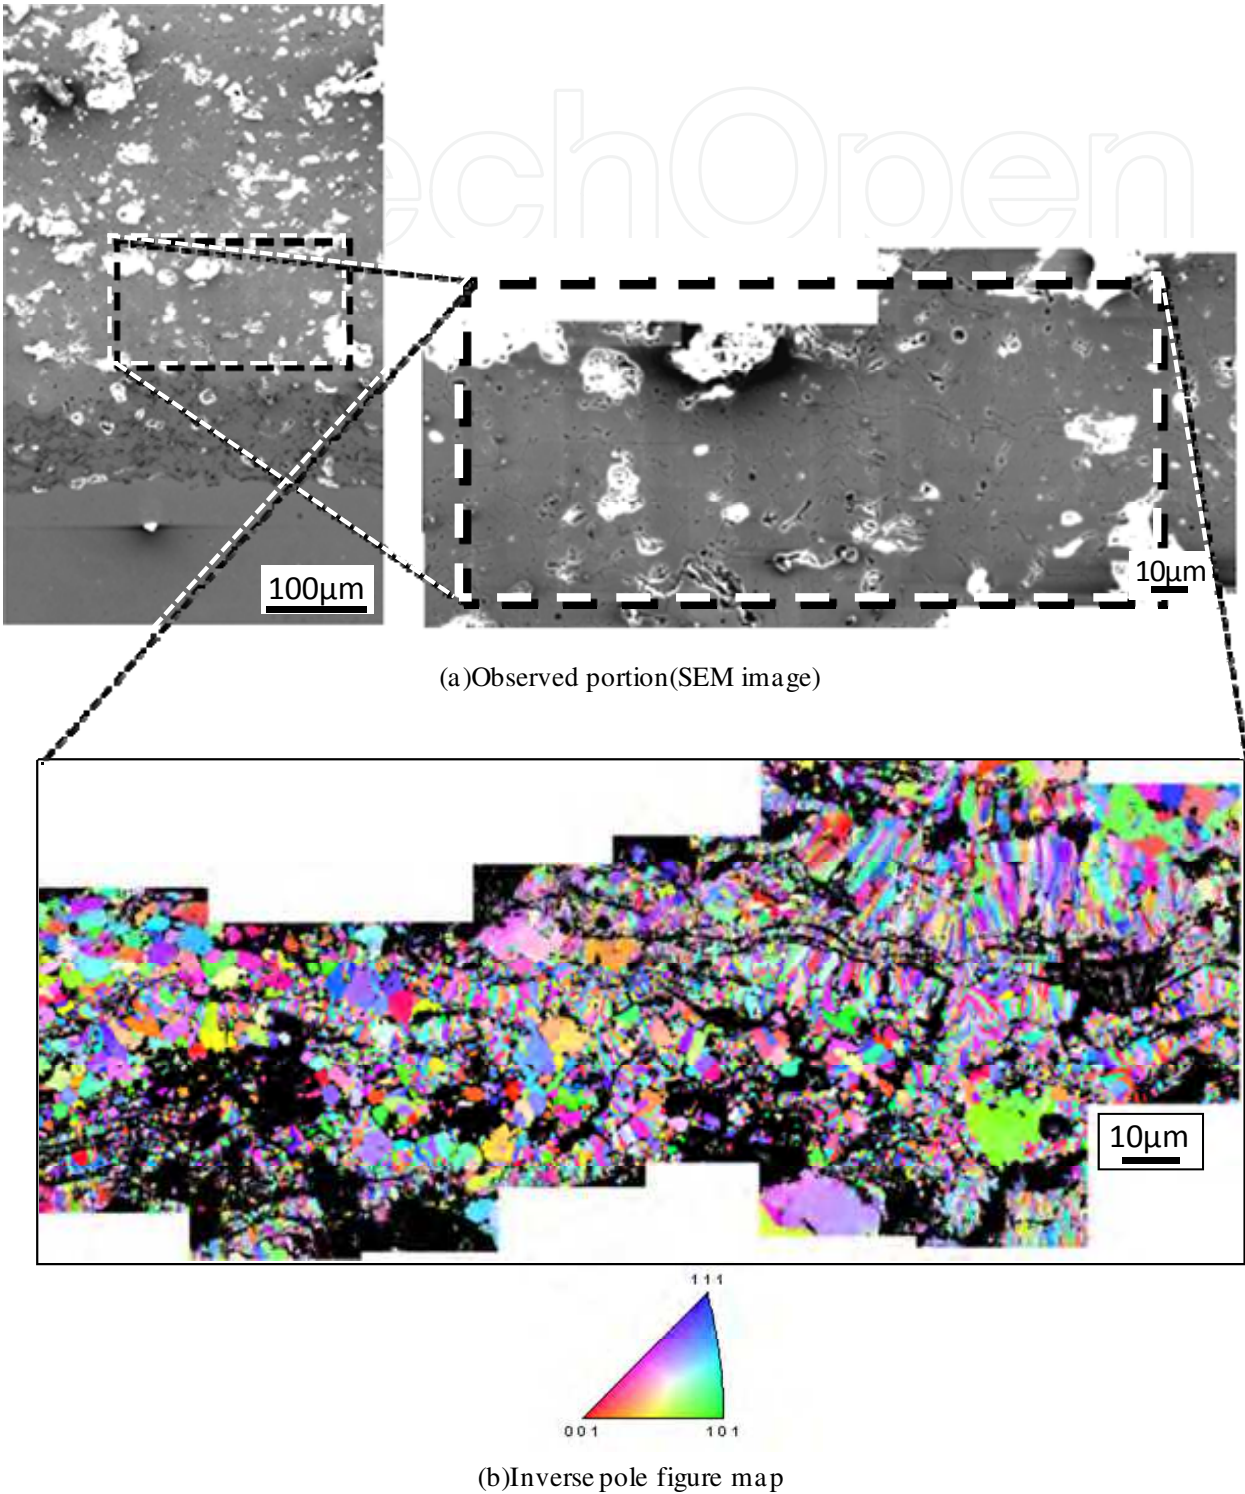
Fig. 8. Matching of SEM observations and IPF map of as-sprayed sample.

Figure 8 shows the matching of SEM image and EBSD IPF maps near bond coat for as-sprayed samples. The splat particle morphologies were clearly observed by IPF maps, which cannot be obtained from the SEM image. The splat morphologies are classified into two typical groups. One is large granular type particles which might not be melted completely at the spraying process, and the other is the cluster of small columnar particles which might be formed by crystallization from completely melted particles. Cracks are found to be affected by splat microstructures after crystallization completed.

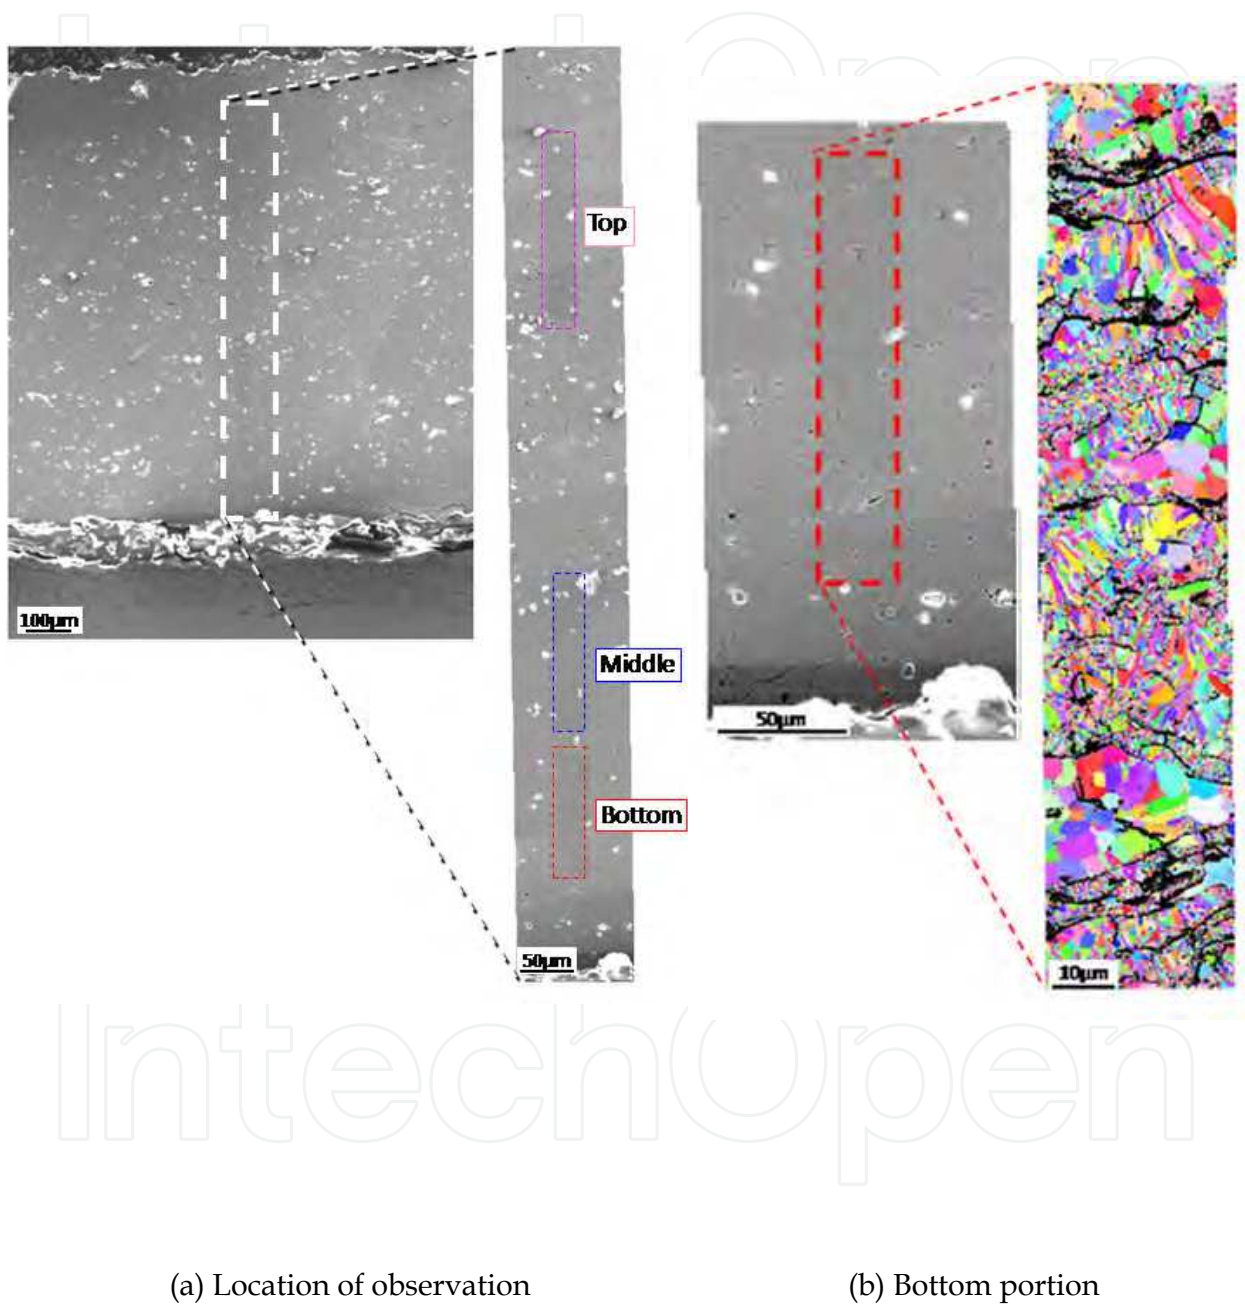
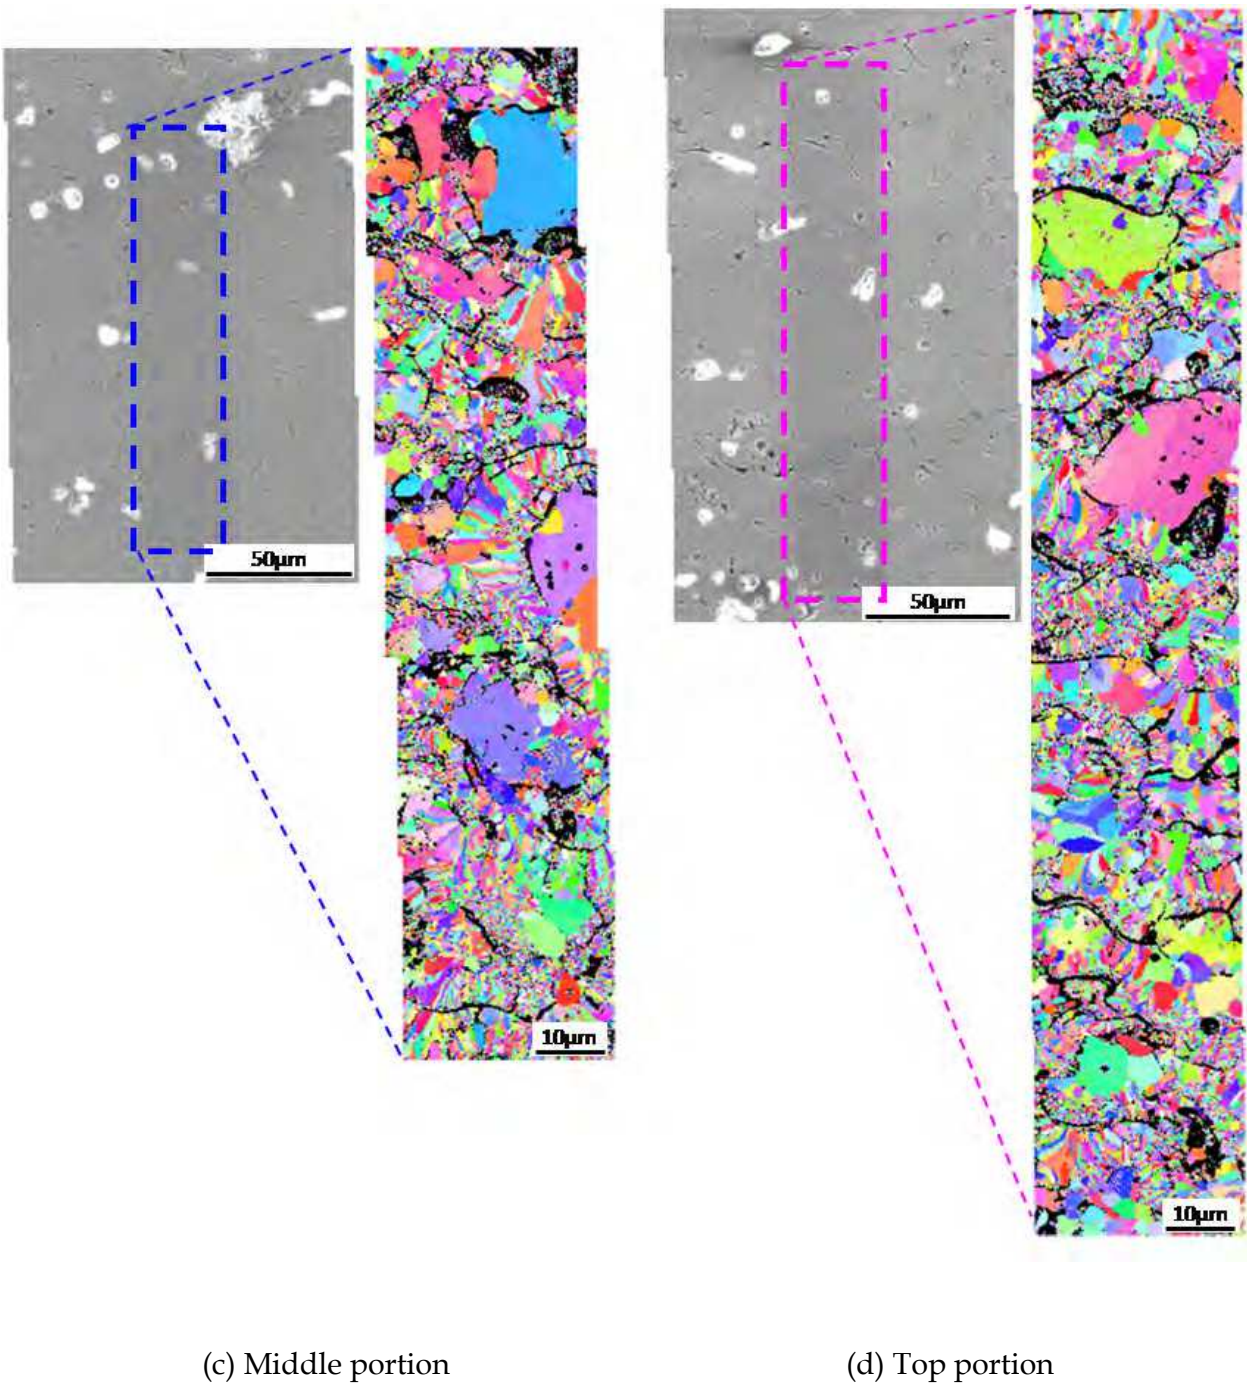
Fig. 9. Matching of IPF maps and SEM image for the sample exposed at 900°C for 500h.

Fig. 9. Matching of IPF maps and SEM image for the sample exposed at 900°C for 500h (continued).

Figure 9 shows the matching of SEM image and IPF maps from bottom to top region of top coat for samples exposed at 900°C for 500h. Though there is no significant difference in crystallographic features and crack morphologies in test samples and locations, subsequent crack growth and reduction of pores can be seen by comparing with as-sprayed sample shown in Fig.8.

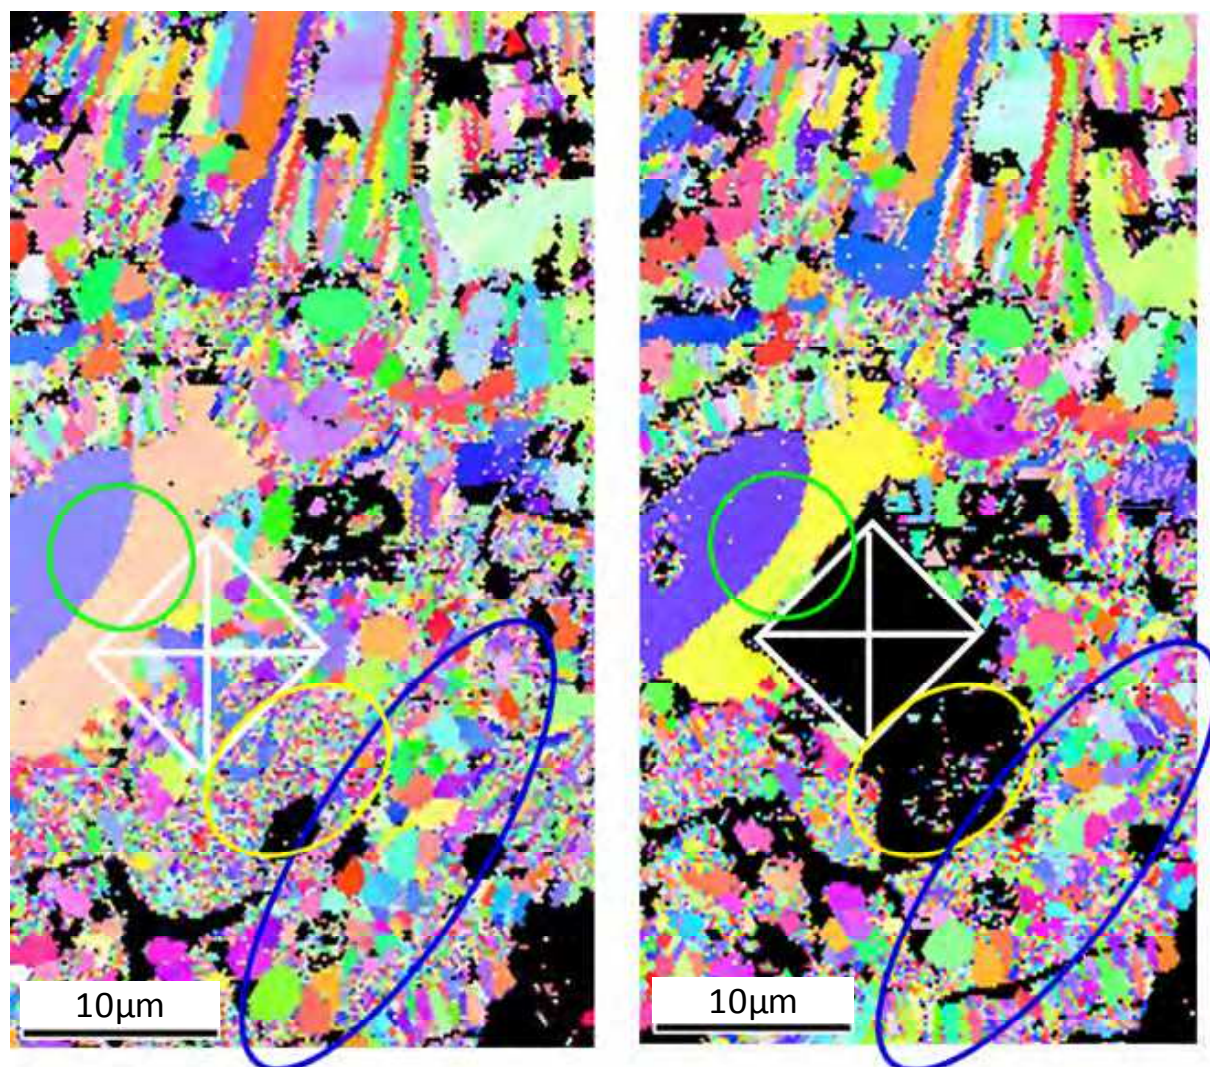
(a) Before indentation test

(b) After indentation test

Fig. 12. IPF maps for as sprayed top coat sample before and after the indentation test.

Figure 12 shows the comparison of IPF maps before and after indentation tests for as-sprayed sample. Indentation tests were conducted by 500mN load. Cracks or pores were emanated from the corner of the diamond shaped indentation and showed the apparent tendency that cracks developed along the intergranular path along relatively larger splat particles and the extensive drop out occurred at the small particle zones. This result suggested the very low resistance at small particle (or amorphous) zones and particle boundaries but relatively higher resistance at larger particles. Fig.13 shows the local zoomed up IPF maps with SEM image of green circle region in Fig.12 before and after indentation test. This map clearly indicated the transgranular cracking path from the indentation corner and coalesced with the pre-existing crack across relatively large particles.

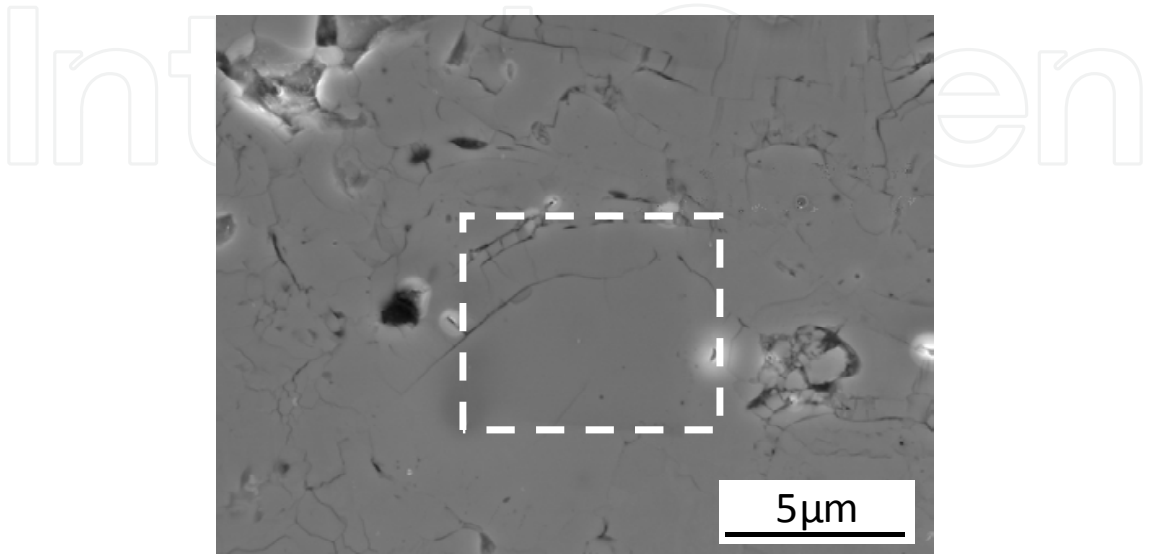
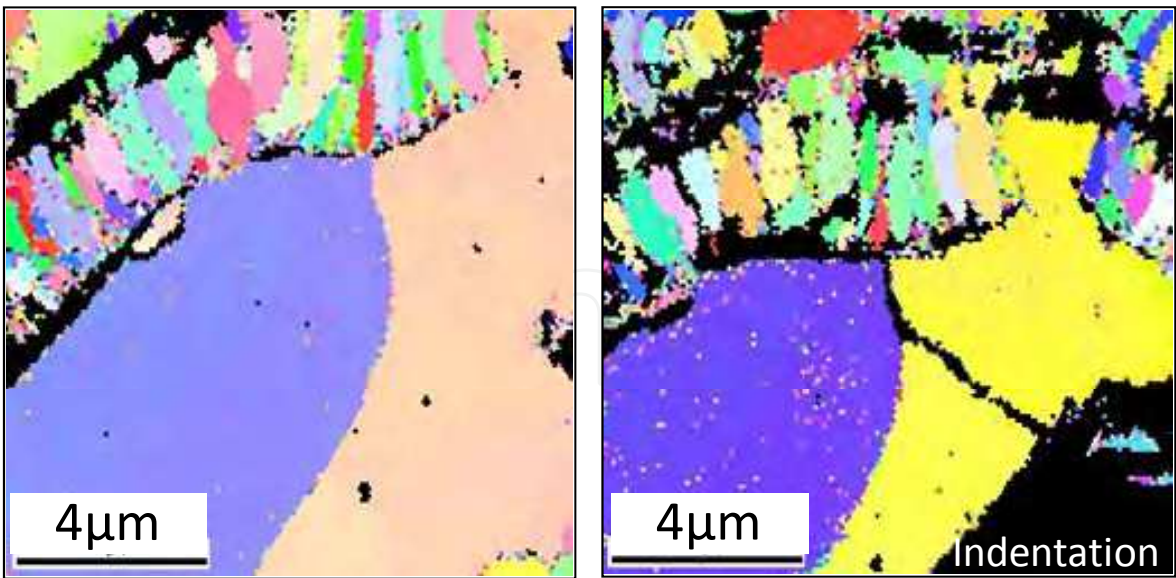
(a) Observation area in SEM image

(b) IPF map before indentation test

(c) IPF map after indentation test

Fig. 13. IPF maps for as sprayed top coat sample before and after the indentation test in higher magnification of Fig. 12.

Figure 13 shows the IPF maps of heated sample at 1000°C/75hours before and after indentation test. The features of cracking showed no significant difference in the cracking morphologies with as sprayed samples shown in Fig.12. Fig.14 shows another view of IPF map with SEM image after indentation test for the same sample in Fig.13. The tendency of intergranular cracking in columnar particles is apparent but some cracks propagate across the particles. As a crack emanated from the bottom corner of the indentation is arrested at the splat boundary, the higher resistance for transgranular cracking than intergranular cracking is strongly suggested.

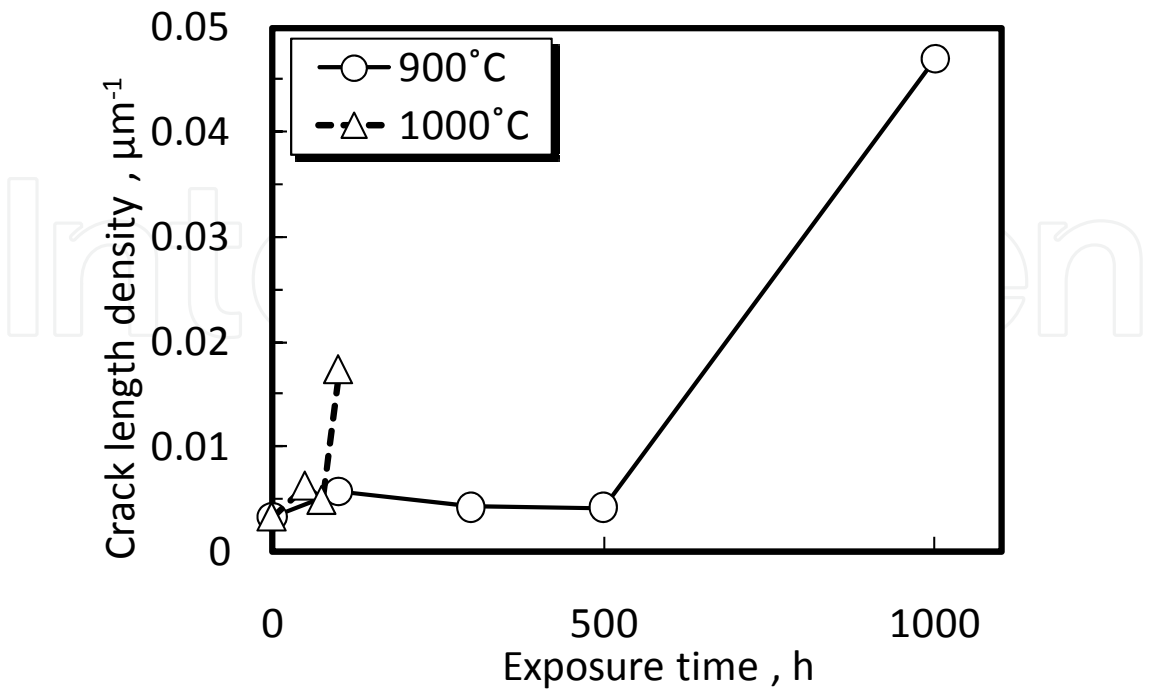
Fig. 17. Crack length density in top coat against exposure time.

Figure 17 shows the trend of crack length density against exposure time. Significant increase in crack length density was observed at the final stage of delamination for both exposure temperatures.

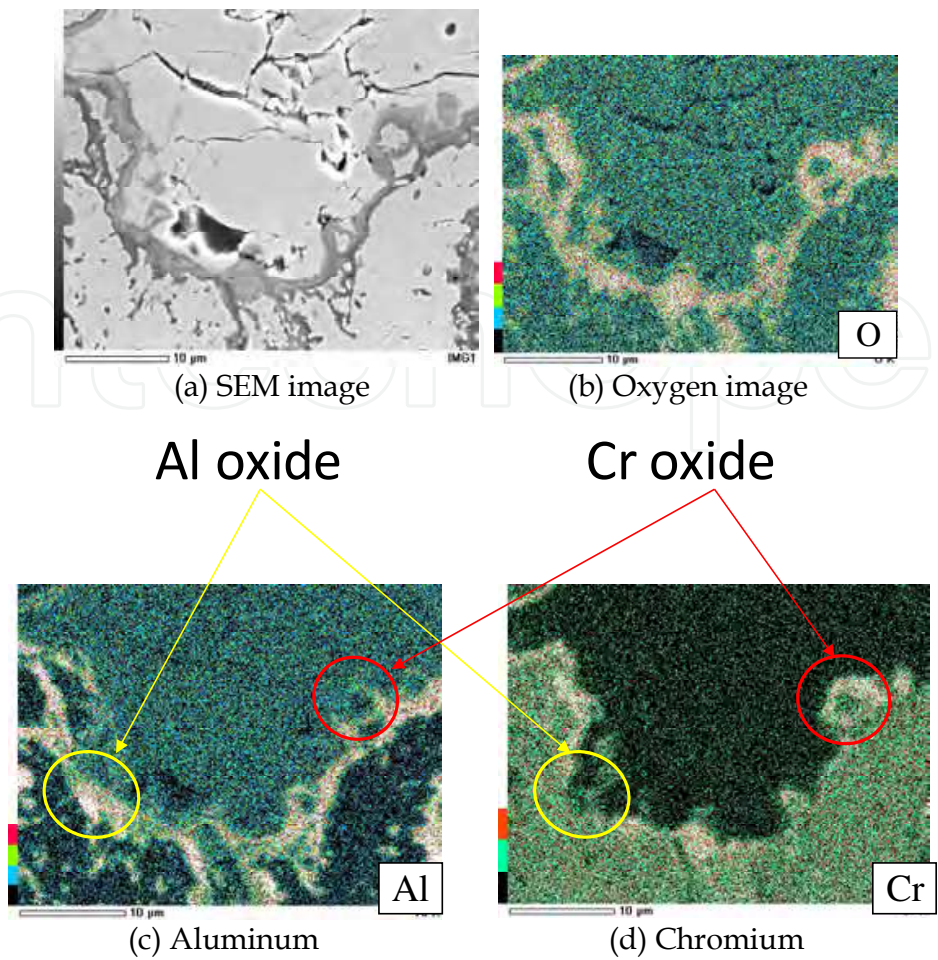
Fig. 18. Observation and element analysis of TGO.

EDS analysis showed Al oxides and Cr oxides at TGO as shown in Fig.18. Cr oxides bulged toward top coat from TGO film consisted of Al oxides and enhancing top coat cracking. The initial significant increase and successive constant trend of TGO thickness was observed. The time to attain around 5% area percent of Cr oxide in TGO total area was corresponding to the intensive cracking in top coat. Thus, the Cr oxide growth enhanced the cracking of top coat strongly.

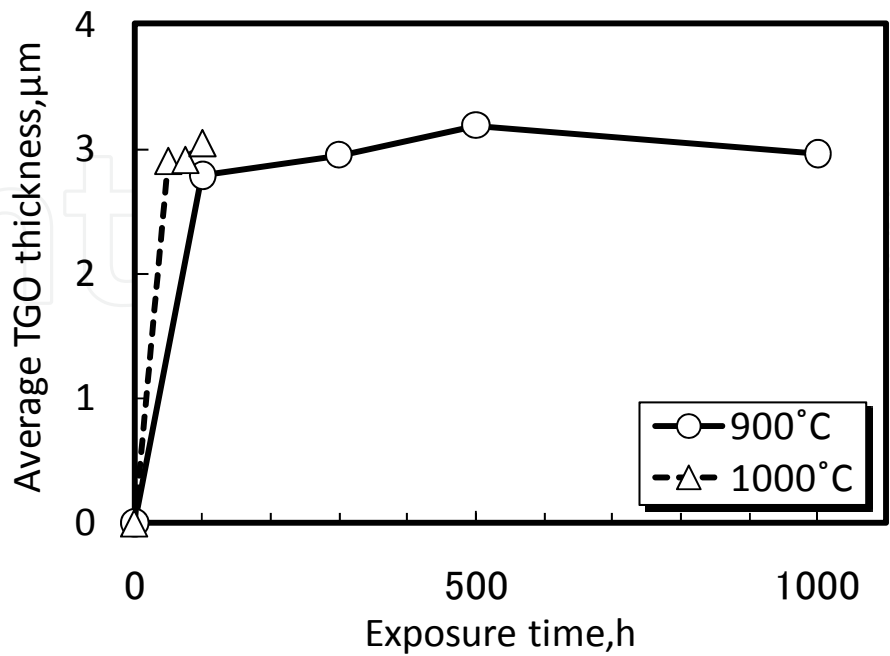
Fig. 19. Trend of average TGO thickness against exposure time.

Figure 19 shows the trend of average TGO thickness against exposure time. The initial significant increase and successive constant trend of TGO thickness was observed for both exposure temperatures. Fig.20 shows the area fraction (%) of Al oxide and Cr oxide to total (Al + Cr) oxide area against exposure time. For Al oxide, the growth trend is almost similar

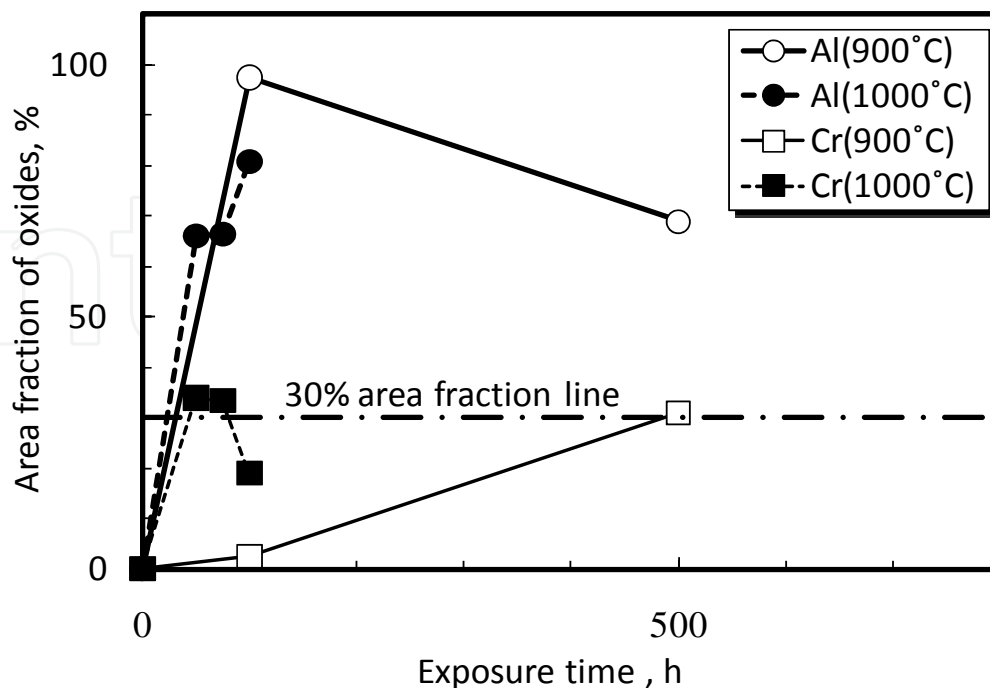
Fig. 20. Relationship between the area fraction of oxides and exposure time.

in both exposure temperatures but for Cr oxide the growth trend is quite different. The time to exceed 30% area fraction might corresponding to the onset of intensive cracking in top coat. Thus, the Cr oxide growth was thought to be an enhancing factor of cracking in top coat.
