Behaviors of Nuclear Fuel Cladding During RIA

Sun-Ki Kim

*Korean Atomic Energy Research Institute
Republic of Korea*

Advances in Nuclear Fuel

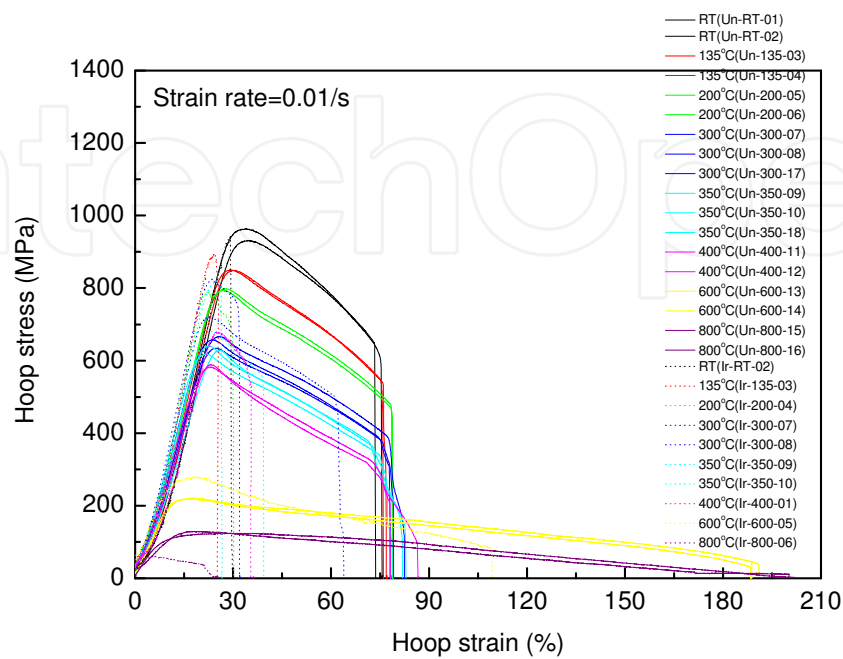
evaluated for the ductility. The hoop stress-strain curves at various temperatures are shown in Fig. 1.

Fig. 1. Hoop stress-strain curves at various test temperatures

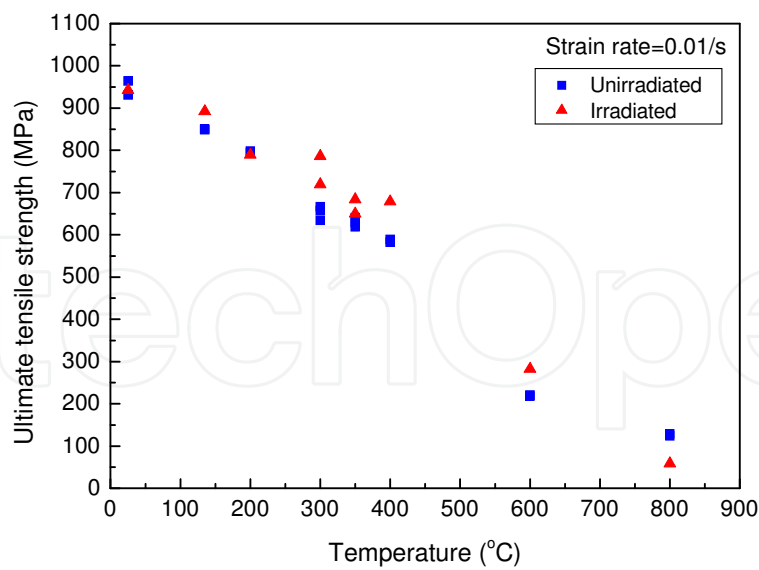
The evaluation results of the yield strength and the ultimate tensile strength are shown in Fig. 2 and 3.

Fig. 3. Ultimate tensile strength of the un-irradiated and high burn-up fuel cladding

The results show that the 0.2% offset yield strength and the ultimate tensile strength abruptly decrease with an increasing temperature. The ultimate tensile strength was evaluated to be 942.70 MPa at RT, 678.83 MPa at 400°C, but, it is abruptly diminished to 282.64 MPa at 600°C, which is achievable in the RIA condition. Especially, it decreases to 58.30 MPa at 800°C, an extreme condition, which corresponds to 6% of the ultimate tensile strength at room temperature. This means that the mechanical strength of the high burn-up Zircaloy-4 nuclear fuel cladding sharply decreases in the RIA-relevant temperature ranges. The evaluation results of the uniform elongation and total elongation are shown in Fig. 4 and 5.

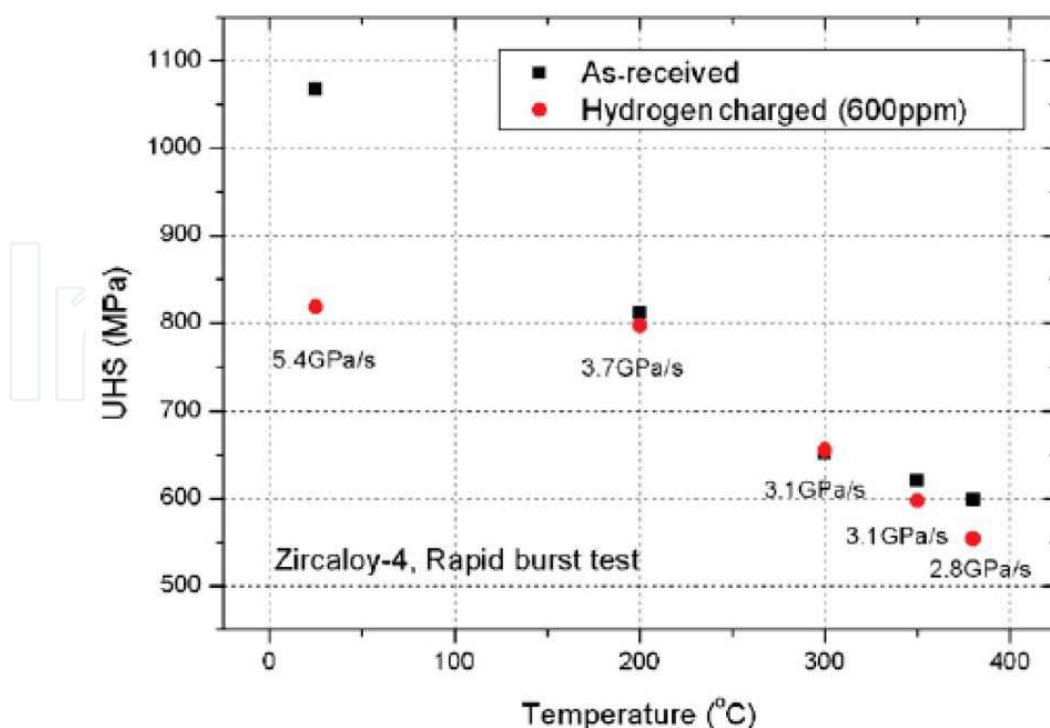
Fig. 13. Maximum hoop stress vs. test temperature

As the test temperature increases, the expansion of the cladding as well as the decrease in the viscosity of the hydraulic oil makes the pressurization rate become lower, which is regarded it as unavoidable. At room temperature, UHS of the as-received condition was 23.2% larger than that of the 600 ppm-charged specimen. When the temperature increases above 200 °C, their difference cannot be discriminated. At room temperature, the solubility limit of hydrogen is negligible and most of the hydrogen is located in the zirconium hydrides precipitates within the zirconium matrix. These hydrides are responsible for material embrittlement. When it strained at room temperature, separation between the hydride and the metal matrix as well as the failure of a brittle hydride itself will occur to reduce the strength of the zirconium cladding (Kim et al., 2006). When the test temperature increases, the property of the zirconium metal will be changed in that the ductility increases due to an increase in the test temperature. Thus it induces a similar mechanical behavior between the hydrogen-charged cladding and the as-received one. This is also implied from the fracture appearance as shown in the Fig. 14.

pressurization profile of the hydrogen-charged Zircaloy-4 cladding. UHS of the 300 ppm-charged specimen did not differ from the as-received condition except that the failure time was more or less shortened. In the case of the 600 ppm-charged specimen, it was so brittle that it failed at the elastic region. However, the effect of the hydrogen was soon eliminated when the test temperature was increased. Fig. 13 shows the UHS of the as-received and 600 ppm-charged specimens with the test temperature.
