# **A Review on Sediment Erosion Challenges in Hydraulic Turbines**

Sailesh Chitrakar, Hari Prasad Neopane and  
Ole Gunnar Dahlhaug

## **Abstract**

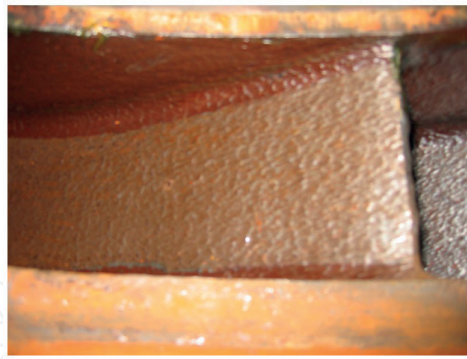
**Figure 9.** Erosion in stay vanes at Jhimruk HPP.

In stay vanes, the erosion occurs due to turbulences formed due to high velocity. **Figure 9** shows the eroded surface of a stay vane at Jhimruk HPP. Although the velocity in stay vanes
