# Self-healing of Structural Composites Containing Dendrimers as Healing Agent

Vassilis Kostopoulos and Athanasios Kotrotsos

## Abstract

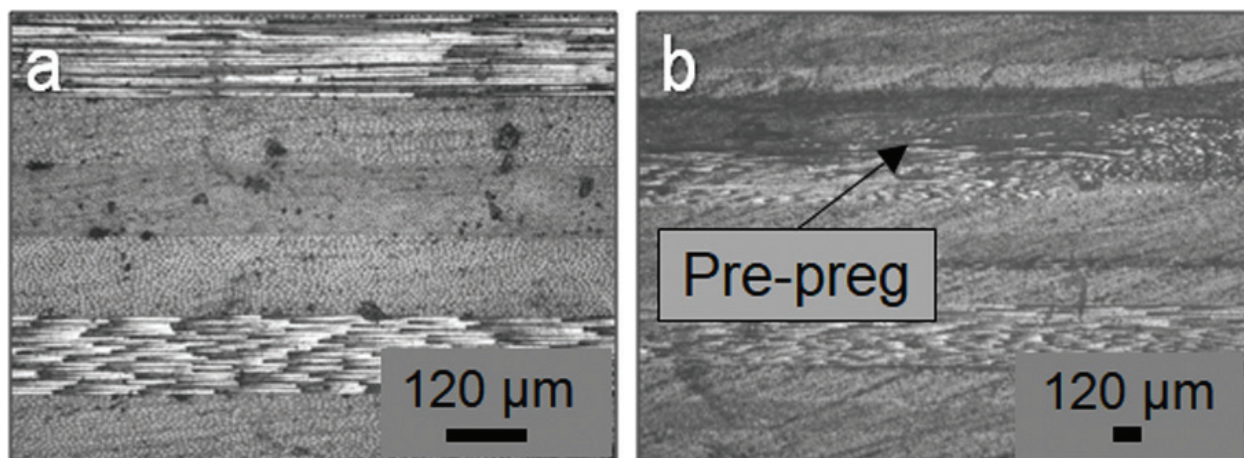
**Figure 21.** Optical microscopy photographs of (a) the cross-section area of reference CFRPs, (b) the cross-section area of modified CFRPs with SP prepregs in which the SHA area is also clearly illustrated.

The handling of the CF/SP prepreg plies at RT and the incorporation of them into composite laminate did not create any concerns. SP prepreg seem to combine characteristics of both traditional thermoplastics (good processability, softening and flow at elevated temperatures). The modified prepreg UD plies had an average thickness of 180 µm each and thus they did not alarmingly thicken the entire CFRP laminate. The fiber volume fraction of both composite groups was calculated to be slightly lower for the modified plates (approximately 60% for the reference while approximately 59% for the modified ones, respectively). They also did not disrupt the fiber architecture. In **Figure 21**, optical microscopy cross-section photographs of reference and modified CFRPs with SHA based on SP are illustrated. Optical microscopy photograph of the modified CFRPs show the location where the SHA has been incorporated symmetrically.
