Influence of Chemical Properties of Soil on the Corrosion Morphology of Carbon Steel Pipes

Muhammad Wasim and Shahrukh Shoaib

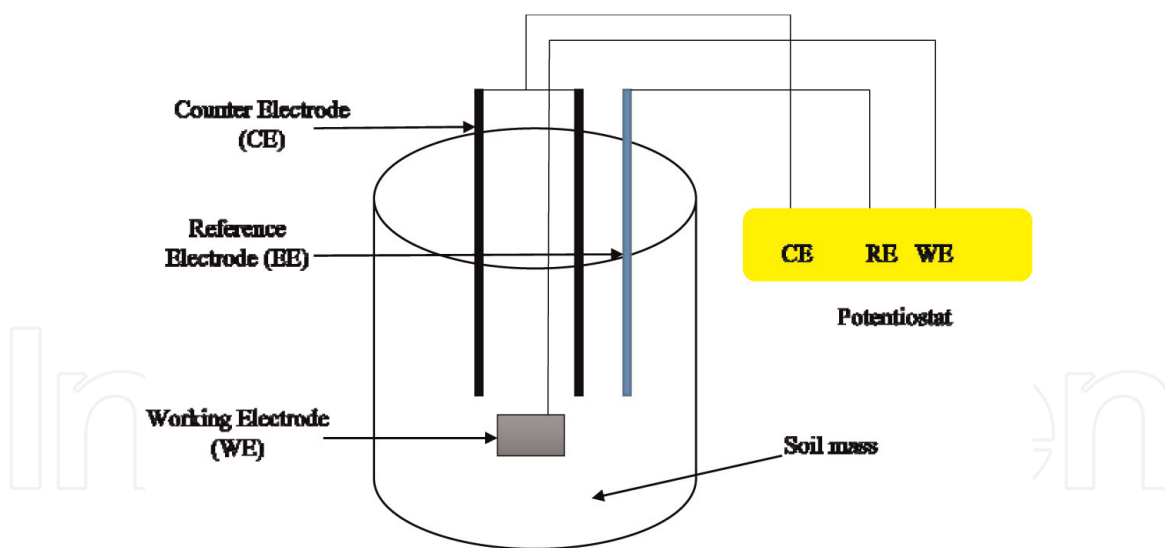
Figure 2.
 Set-up for electrochemical measurement (modified after Shoaib et al. [15]).

Experiments were performed under laboratory-controlled temperature of $27 \pm 1^\circ\text{C}$. The set-up for the electrochemical measurements consisted of three electrode cells. The schematic diagram of the experimental test set-up is shown in **Figure 2**. In this figure, the specimen is represented by rectangular shape; was a carbon steel without coating, and with zinc- and copper-electroplated coatings, respectively; and was used as working electrode. In addition, two counter electrodes made of graphite and joined through electrical connector and copper/copper sulphate (Cu/CuSO_4) solution as reference electrode (RE) were used, respectively, for corrosion measurement of each specimen used in the current research. The surface area ratio between working electrode/counter electrode was kept at 0.909.

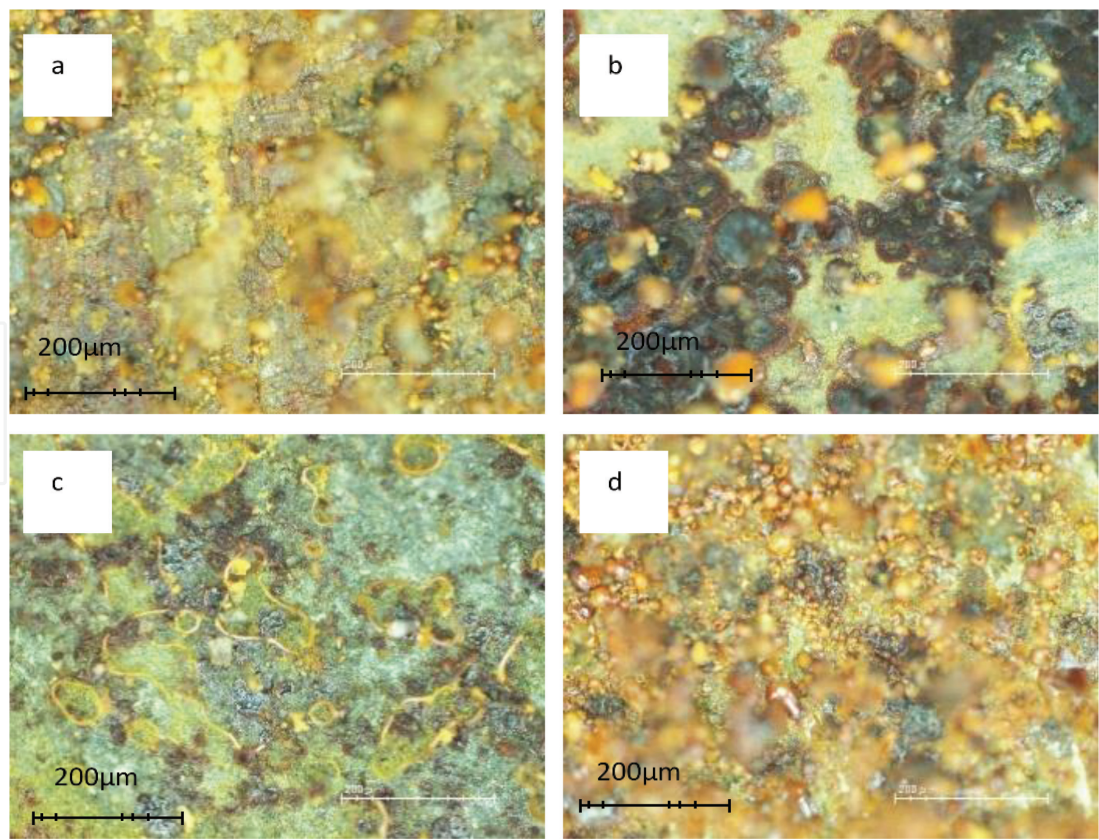
Figure 6.
Corrosion morphology of carbon steels tested in soil with 10 wt.% chloride (a = 20 wt.% MC; b = 40 wt.% MC; c = 60 wt.% MC; d = 80 wt.% MC).

First, the coupled effects of varying moisture and chloride on corrosion were measured [15]; then their subsequent impact on the microstructure of specimens was investigated using Olympus laser microscope. Corrosion patterns on specimens after exposure to various corrosive soils are shown in **Figures 4–6**; from these figures red rust can be seen on all samples. Interestingly, there was a further addition of red rust with the increase of chloride contents indicating the presence of iron oxides on the surface. Moreover, optical images also confirmed that the addition of chloride promoted corrosion progress. With further addition of chloride, more red rust was observed.

Two kinds of corrosion behaviour were observed in specimens, i.e., general and localised corrosion. Carbon steel sample exposed to soil containing 60 wt.% moisture and 5 wt.% chloride showed localised corrosion, while the samples buried in soil of 80 wt.% moisture and 10 wt.% chloride suffered general corrosion. **Figure 7** shows the corrosion morphology of copper-electroplated and zinc-electroplated steel samples. However, for copper-electroplated steel samples, there was no clear pattern of corrosion. On the other hand, zinc-electroplated steel indicated localised corrosion.

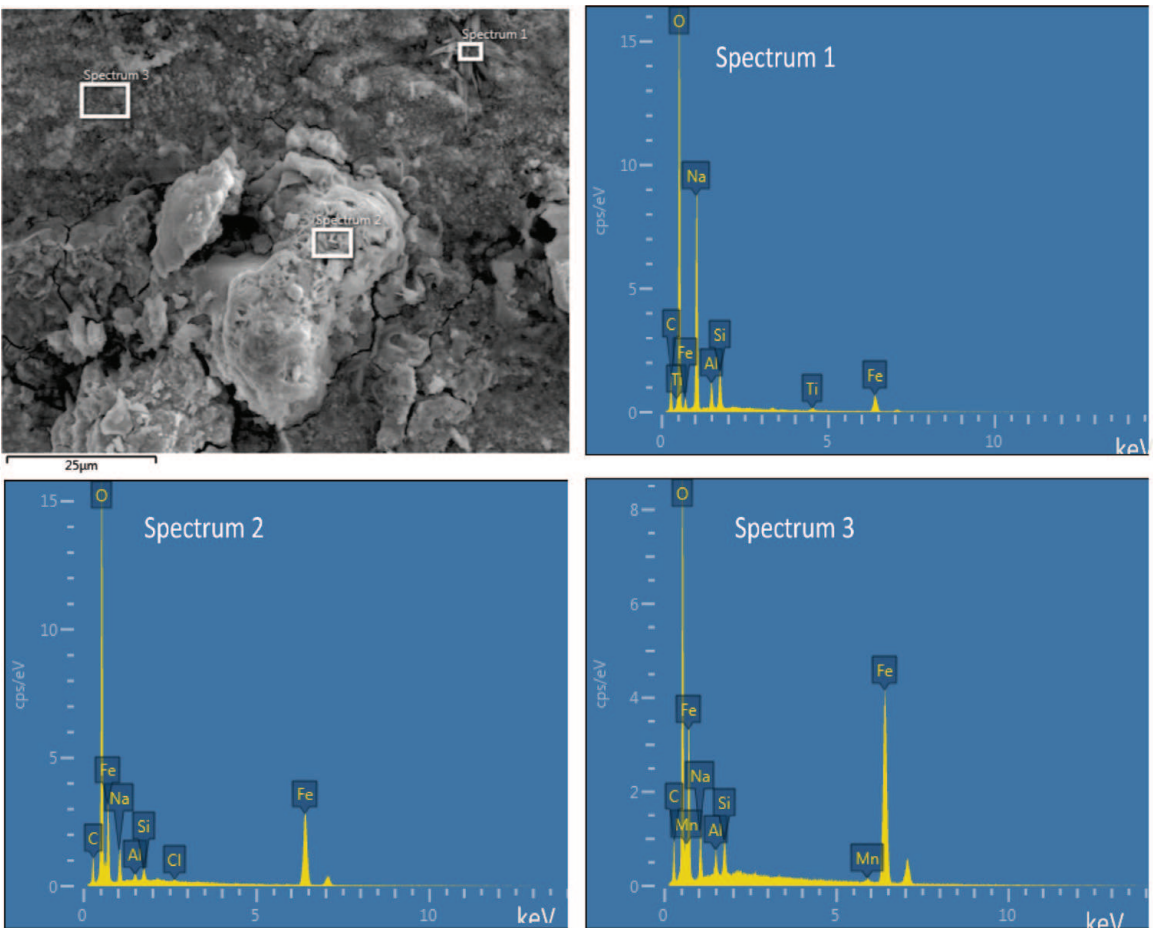
Figure 9.
EDS spectra of carbon steel tested in soil with 60 wt.% moisture and 5 wt.% chloride.

SEM analyses were performed after the samples were corroded to various soil conditions. **Figure 8** shows the SEM micrographs of low and high magnifications of carbon steel. From this figure, a porous and honeycomb-like structure appeared, which is also reported by earlier researchers [16]. **Figure 9** shows EDS spectra of elements present in corrosion product of carbon steel, while the elements in the corrosion layer of carbon steel are shown in **Table 1**. The presence of sodium (Na) on a metallic surface, indicating that cation in soil penetrated through corrosion product layer and reached the sample's surface. As a result of this penetration, the corrosion process is accelerated. However, it has been reported in literature that the

Element	Spectrum 1	Spectrum 2	Spectrum 3
Fe	9.5	40.1	56.6
O	51	43.7	26.5
Na	20.4	4.1	3.6
C	13.7	10.6	10.1
Si	2.8	0.8	1.4
Al	2	0.6	1
Mn	—	—	0.8
Cl	—	0.2	—
Ti	0.6	—	—

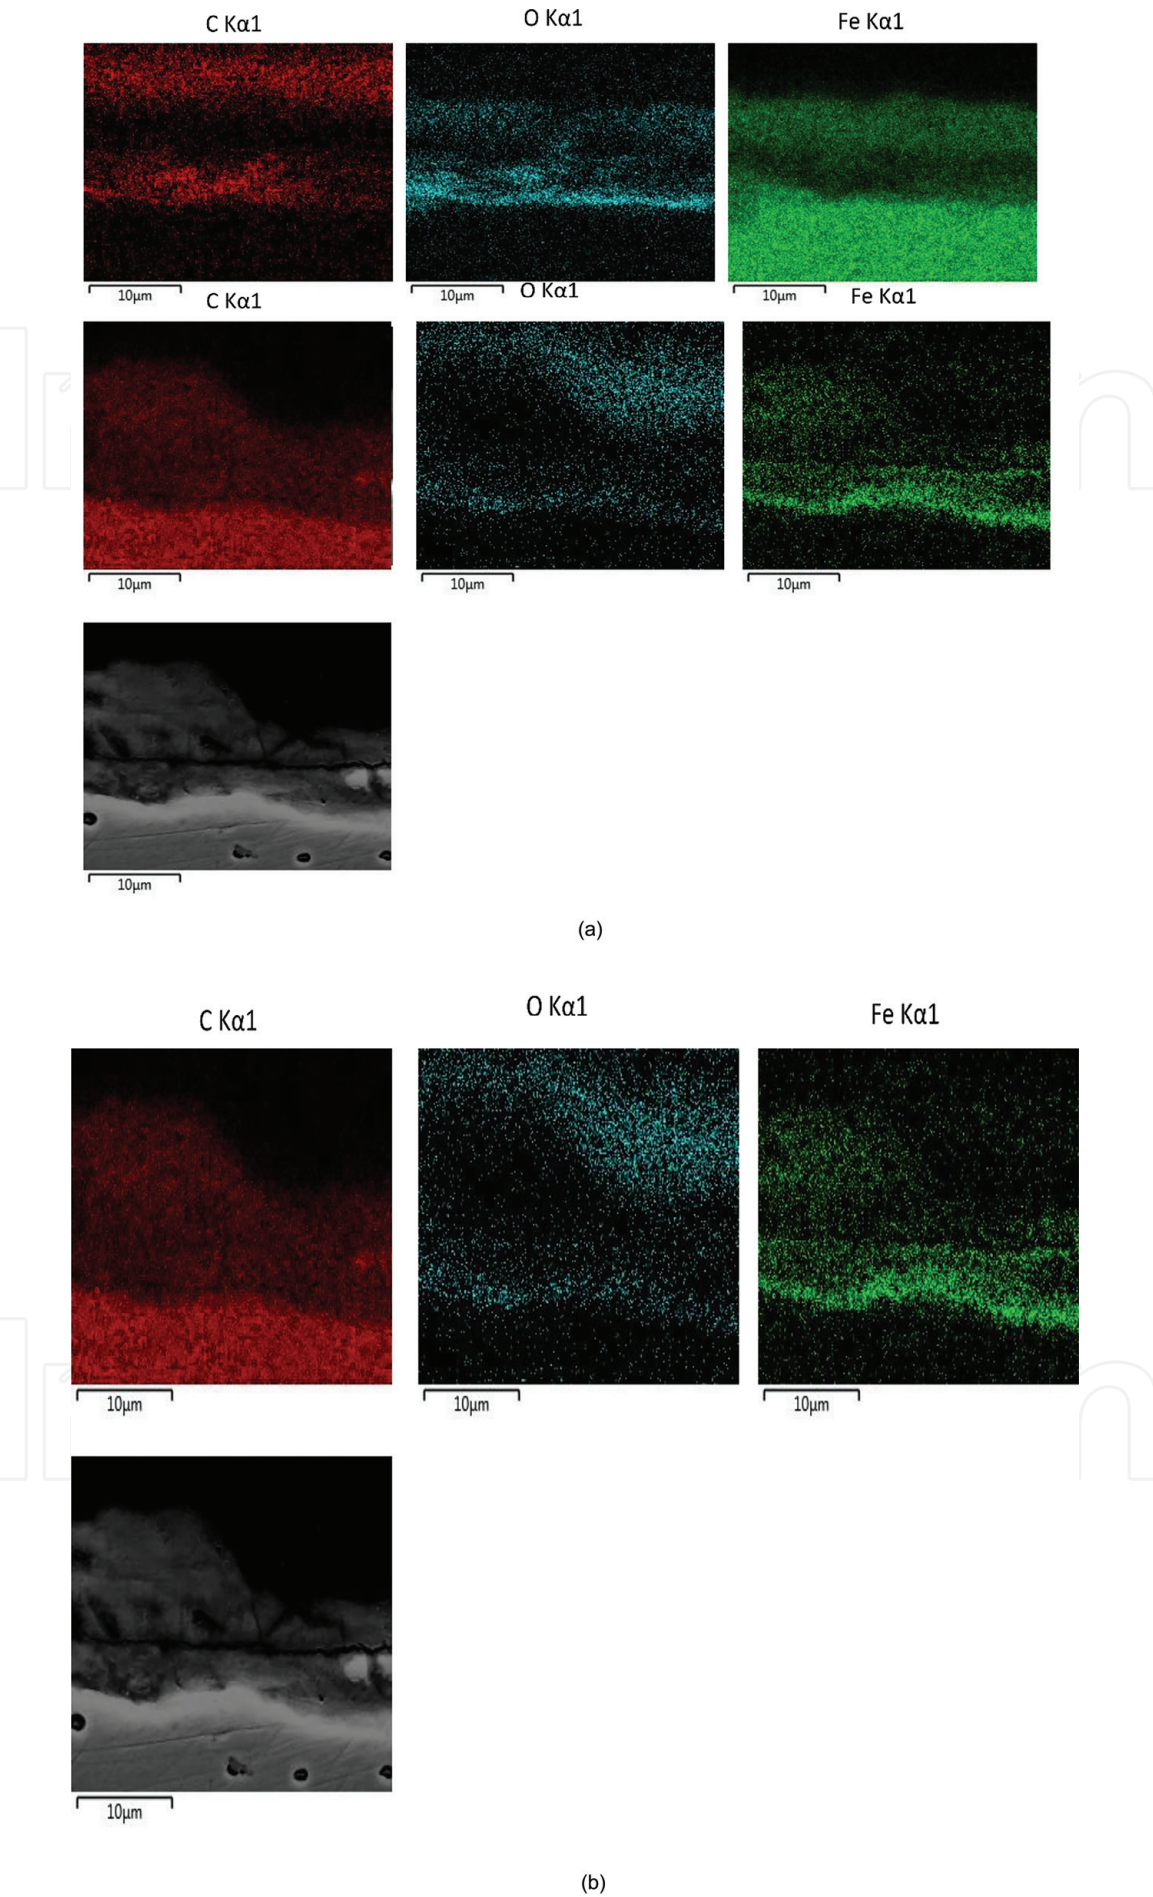
Figure 14.
(a) EDS map of carbon steel exposed to soil containing 80 wt.% moisture (site 1). (b) EDS map of carbon steel exposed to soil containing 80 wt.% moisture (site 2).

Cross-sectional EDS map of specimens buried in soil containing 80 wt.% moisture is shown in **Figure 14a** and **b**. In **Figure 14a**, O-K and Fe-K element maps show that oxygen and iron are uniformly distributed. The co-existence of O and Fe elements demonstrates that oxides of iron are present in corrosion products. Generally, α -FeOOH and γ -FeOOH are observed as corrosion products of steel buried in the soil environment. A C-K element from epoxy resin has a non-uniform distribution. At site 2 (**Figure 14b**), there is an excessive concentration of C-K due to the epoxy resin, and there is less concentration of O-K and O-K at this site.
