Examination of Lightning-Induced Damage in Timber

Jingxiao Li and Jing Li

Abstract

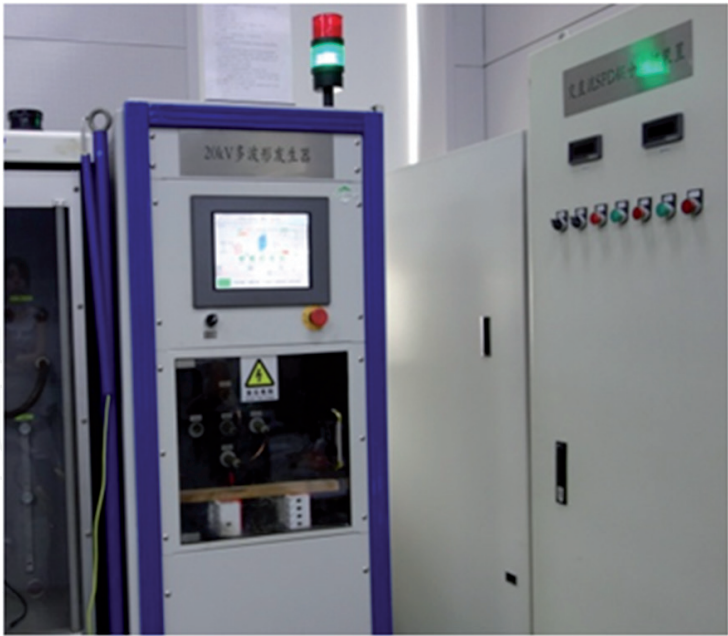
Figure 4.
The multi-waveform lightning generator with the voltage of 20 kV.

Figure 4 shows the waveform generator (GTPS30-20kV, GrandTop Eletric, China) which is used to produce 10/350 μ s of direct lightning current waveform with a maximum of 25 kA. The experimental current range was about 10 kA to 20 kA. Because the lightning hitting the timber was not generally the lightning induced wave, a 10/350 μ s direct lightning current waveform was selected. Another reason is that there is no changes for the timber surfaces in the case of the selected 8/20 μ s induced current waveform. The electrical generator mainly includes a charging device, a capacitor unit, a controllable trigger discharge device and a control system. The current voltage and charge–discharge state are displayed on the screen in real time. The digital fluorescent oscilloscope of a lightning current waveform (DPO3054, Tektronix, USA) can not only precisely display the lightning current peak, wave front time, transfer electric charge and other parameters, but also directly store the lightning current waveforms. In addition, a video camera was used to record the entire process of the lightning strike. For the experiment carried out in Beijing Lightning Protection Device Test Center, the temperature was 26 °C - 28°C and the relative humidity 42% - 45% in the laboratory with altitude of 32.5 m.

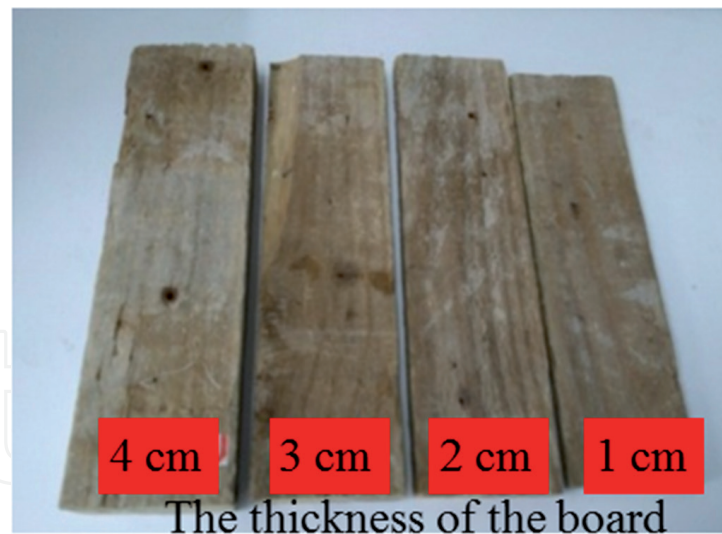
Figure 6.
 The timber board of ancient building with different thicknesses.

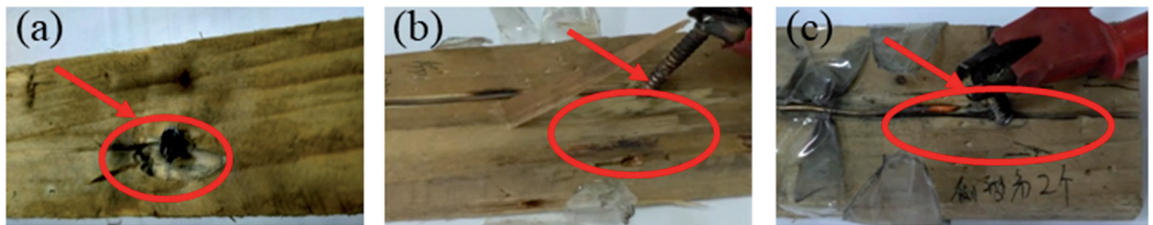
Figure 9.
Impulse damage map of the timber with the water content of (a) 42.2%, (b) 47.6%, (c) 52.7%. (The red ovals represent the damage locations, and the red arrow faces toward Screw 2).

The timber board morphology after the lightning strike was used to observe the lightning damage. As shown in **Figure 9**, for the dry timber with low water content, it was easily burnt when encountering the lightning arc. And it was more likely to show damage pits or splitting for the timber with high water content. With the increase of the water content, the hit damage pit or crack became deeper and the depth for the lightning current entering into the timber increased. The reason might be that the energy conversion process at the contact between the lightning channel and the timber could be similar to the phenomenon of spark-gap arc heating, and the temperature of the lightning arc was very high, resulting in the burn marks on timber. However, due to the short action time, the energy was limited and the instantaneous high temperature might not ignite the timber. In the cases of low water content, the heating of the lightning struck timber was mainly decided by
