Neutron Irradiation Effects in 5xxx and 6xxx Series Aluminum Alloys: A Literature Review

Murthy Kolluri

Abstract

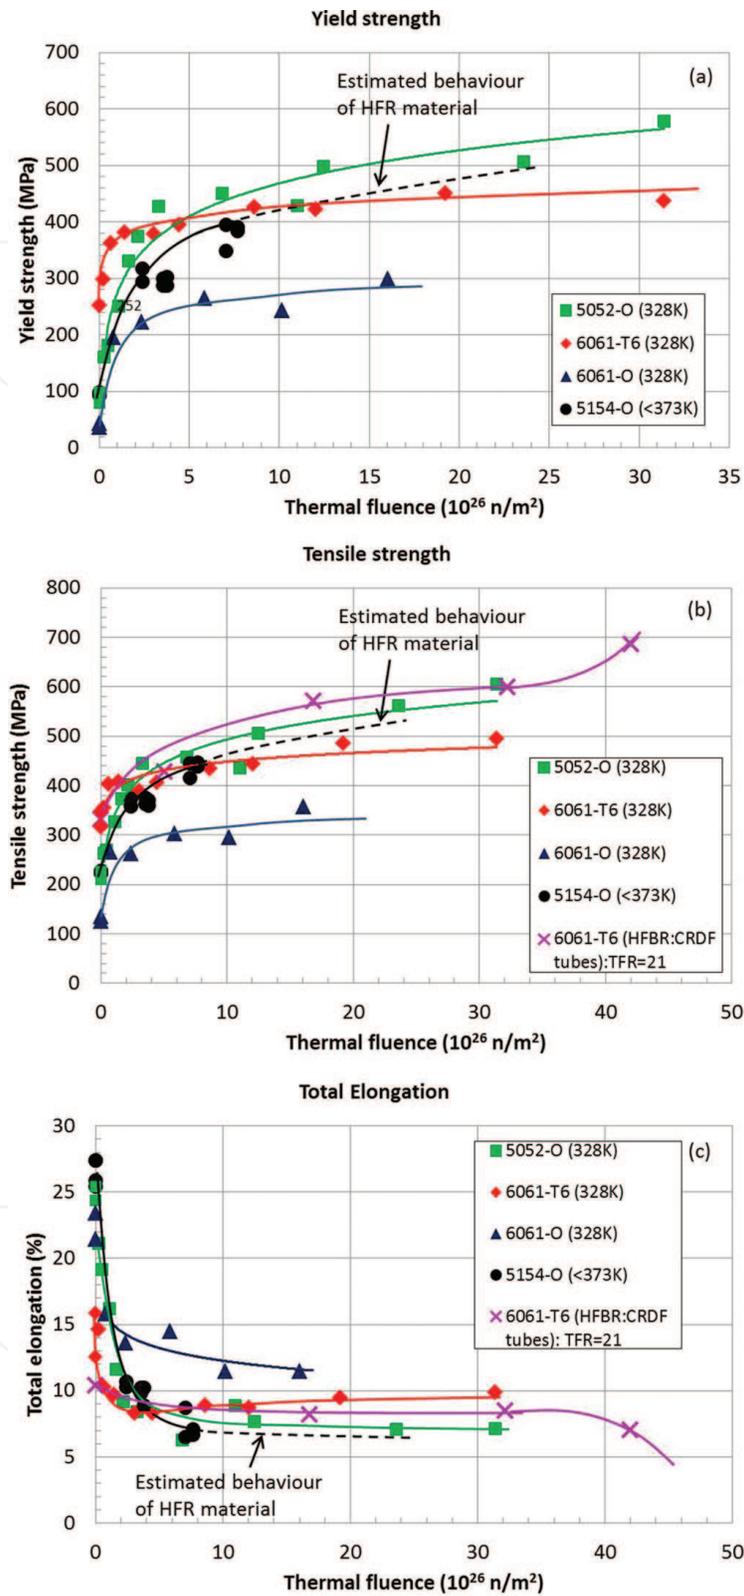
Figure 1. Literature tensile data of irradiated Al alloys in comparison with HFR SURP data. (a) Yield strength versus thermal fluence, (b) tensile strength versus thermal fluence and (c) total elongation versus thermal fluence.

Farrell et al. [3] published data on tensile behavior of 5052-O aluminum alloy (Al-2.2% Mg) heavily irradiated in HFIR to fluences greater than 10^{27} n/m^2 in contact with cooling water at 328 K (see **Figure 1**). HFIR is predominantly a thermal reactor with a strong fast neutron component. The thermal neutron fluence ($E < 0.0025 \text{ eV}$) of the samples ranged up to $\sim 31 \times 10^{26} \text{ n/m}^2$ to produce 7.15 wt.% Si. The fast neutron fluence ($E > 0.1 \text{ MeV}$) is a factor of 1.7 (=TFR)

lower than the thermal fluence, and results in a damage value of 260 displacements per atom (dpa). Associated gas generation due to fast neutrons was estimated to be 8.5×10^{-5} atomic fraction He and 5×10^{-4} atomic fraction H. It is important to notice that this data is very relevant to the HFR SURP program because of the (i) similar chemical composition of 5052 and 5154 alloys, except that Mg in 5154-HFR alloy is 3.2% instead of 2.2% in 5052 and (ii) similar irradiation conditions, including temperature, TFR, and high fluence values. Farrell et al. [2] also published tensile data on heavily irradiated 6061-O and 6061-T6 alloys irradiated at 328 K up to $\sim 31 \times 10^{26}$ n/m² and tested at three different temperatures (323, 373 and 423 K). **Figure 1** shows only results at 323 K due to their relevance to HFR operating conditions. Additionally, tensile strength data from a 6061-T6 type alloy tested from CRDF A-2 tubes of HFBR, published by Weeks et al. [5] are also shown in **Figure 1**.

Comparison of yield and tensile strength properties of all these alloys including HFR-SURP tensile data, shown with added trend lines in **Figure 1 (a, b)**, reveals specific trends in irradiation hardening and embrittlement behavior. Each of these alloys showed a rapid hardening regime (and corresponding drop in ductility) at the beginning, followed by a transition regime toward a relatively slow hardening (and stable ductility) regime. A brittle regime is observed in some alloys at the end, as shown schematically in **Figure 2**. Depending on whether an alloy is of 5xxx or 6xxx series, a single or multiple irradiation damage mechanism can be active, determining the hardening rates in each of these regimes.

In case of 6xxx series Al alloys, rapid hardening observed at the onset of irradiation (regime 1), for example, curves of 6061-O and 6061-T6 alloys (**Figure 1 (a, b)**), can be attributed to irradiation-induced dislocation damage. It is known that the irradiation-induced dislocation density rapidly increases at the beginning and reaches a saturation value (see Section 3.1) at relatively low fluence values. For steels irradiated at 603 K ($\sim 0.35T_m$), this saturation dislocation density is expected to reach around a fast fluence of $\sim 2 \times 10^{26}$ n/m² [15]. For Al alloys irradiated at temperatures about 323 K ($\sim 0.35T_m$), it is expected that saturation is reached at lower fluences due to the low effective displacement energy of Al (~ 25 eV) compared to Fe (~ 40 eV) [9].

The differences in irradiation hardening trends in all four regimes of 5xxx and 6xxx series alloys are depicted schematically in **Figure 2**. Both 5052-O and 5154-O alloys show similar irradiation hardening and embrittlement behavior (**Figure 1**) due to similar alloy microstructure and irradiation conditions. The unirradiated strength values of 5052-O and 5154-O alloys are lower, and ductility is higher than 6061-T6 alloy (**Figure 1**) due to the absence of Mg_2Si precipitates before irradiation. In the rapid hardening regime, the magnitude of irradiation hardening and embrittlement in 5xxx series alloys is observed to be much higher than 6xxx series, because both dislocation hardening (due to displacement damage) and precipitation hardening (due to the formation of Mg_2Si precipitates from transmutation Si) occur simultaneously in 5xxx alloys (see Section 3.1).

Similar to 6xxx alloys, a rough estimation of the total irradiation hardening contribution is performed for 5052-O and 5154-O alloys using Eq. (2) for the dislocation-hardening contribution and Eq. (3) for contribution from precipitation hardening. An average precipitate size of 10 nm and linear planar spacing between precipitates of 10 nm is used from the microstructure data presented in [3] on 5052-O alloy irradiated to a thermal fluence of 31×10^{26} n/m². This resulted in a total yield strength of 547 MPa (including unirradiated yield strength value of 85 MPa) for 5052-O, matching very well with the data presented in **Figure 1 (a)**. Similar analysis for 5154-O at a thermal fluence of 9.81×10^{26} n/m², with an average precipitate size of 8 nm and linear planar spacing between precipitates of 20 nm (obtained from **Figure 5**) [13] resulted in a total yield strength of 410 MPa, again matching with the trends seen in **Figure 1 (a)**.

In the rapid hardening regime (regime 1), the fracture toughness value drops rapidly in line with the observed hardening and ductility behavior of 5xxx alloys (**Figure 3** vs. **Figure 1 (c)**).

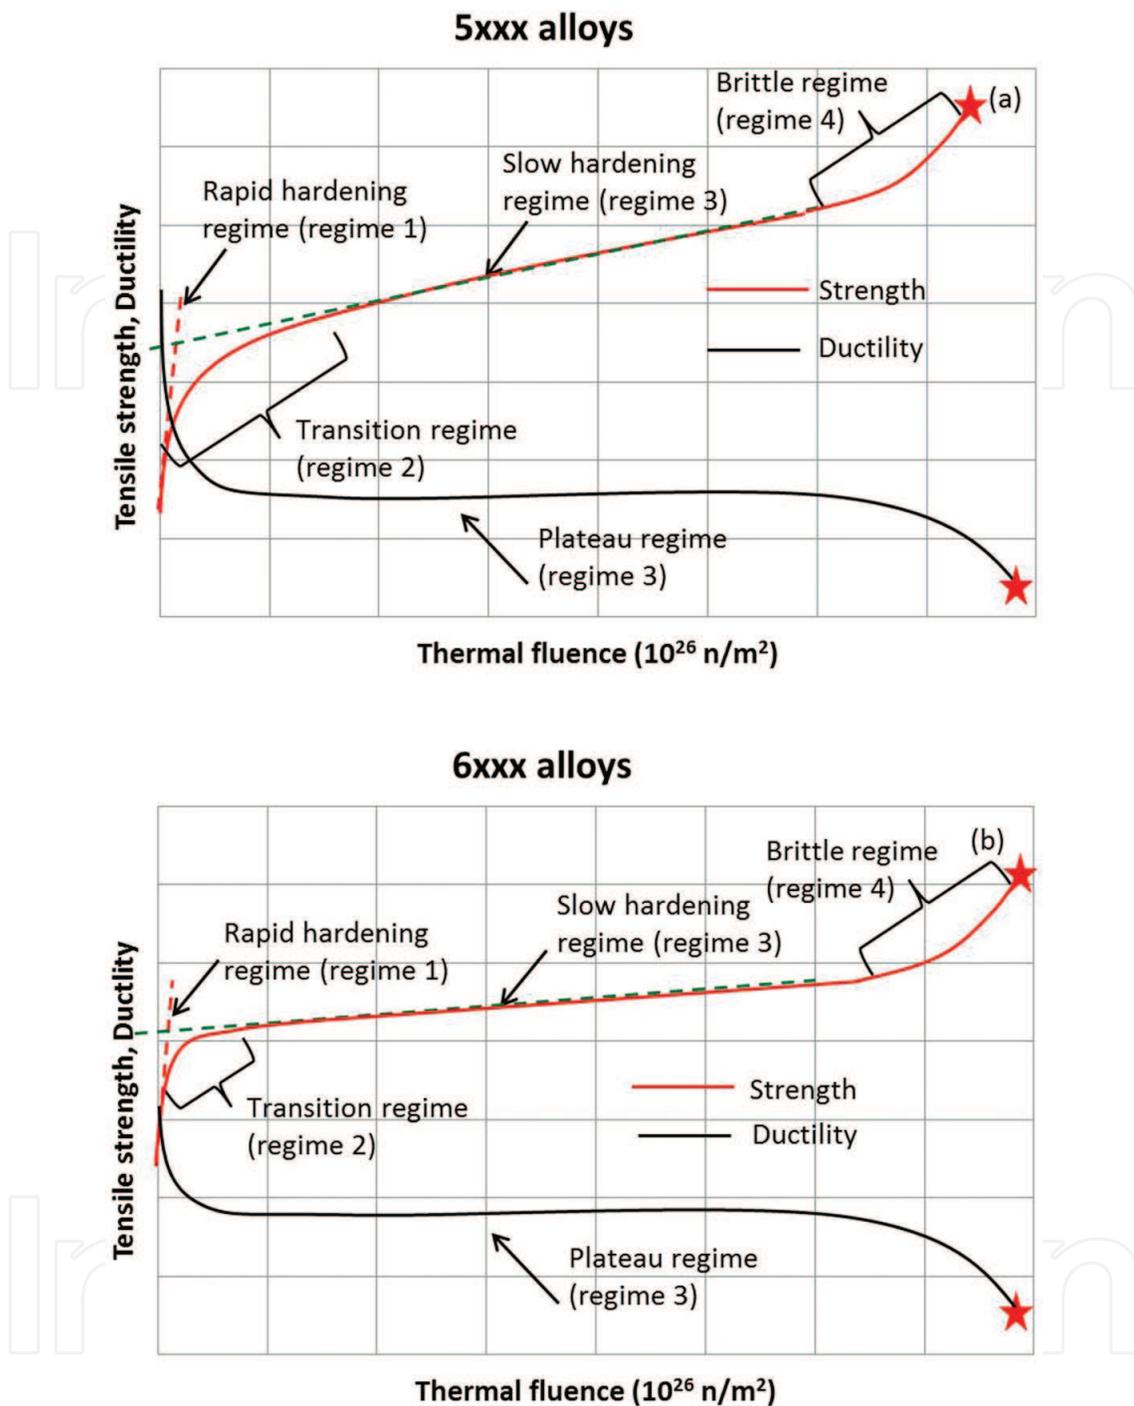
Figure 2. Schematic diagram showing various regimes in irradiation hardening behavior of (a) 5xxx and (b) 6xxx series Al alloys.

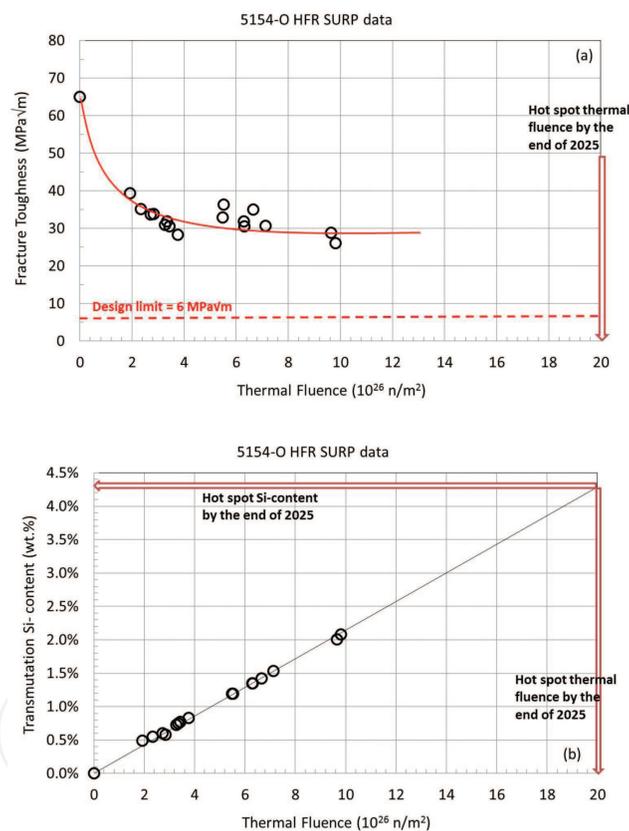
Figure 3. (a) HFR SURP fracture toughness data as a function of thermal neutron fluence. (b) Transmutation Si values as a function of neutron thermal fluence of fracture toughness samples tested in HFR SURP program. Note that the projected hotspot thermal fluence and Si content are based on the assumption that the irradiation conditions at the HFR hotspot are kept unchanged as they are in 2015.

No additional data on fracture toughness properties of 5xxx Al alloys was found in the literature except the data from 5154-O alloy from HFR SURP [13]. The fracture toughness properties of the HFR surveillance specimens are periodically measured to assess and predict the hotspot behavior of HFR vessel in comparison with the vessel's fracture toughness design limit of $6 \text{ (MPa)}\cdot\text{m}^{1/2}$ [22]. Fracture toughness properties of surveillance specimens from the current HFR vessel tested until 2010 are plotted as a function of thermal neutron fluence in **Figure 3 (a)**. The thermal neutron fluence is taken as an indicator for the measure of irradiation damage in HFR vessel material, because thermal neutrons are the major cause of damage by producing Si through transmutation, as explained in the previous sections. **Figure 3 (b)** shows the relation between the thermal fluence and transmutation Si in fracture toughness specimens tested in SURP.

After that, the fracture toughness of 5154-O reaches a plateau at a thermal fluence of $\sim 4 \times 10^{26}$ n/m² after which no further increase in dislocation and precipitate density is expected (**Figure 3**). In fact, a small decrease in particle density may occur later in this regime due to particle coalescence during their growth. The opposite effects of a small decrease in particle density and a slow hardening due to precipitate growth on embrittlement could be compensating each other leading to a plateau in the fracture toughness behavior (similar to ductility) in regime 3. The behavior of 5154-O alloy is expected to be similar to 6xxx series alloys in this regime at similar irradiation conditions. This is because within this regime the irradiation hardening in both alloy types occurs primarily due to the growth of existing precipitates by newly produced transmutation Si. A close agreement between the fracture toughness data of 6061-T6 alloy irradiated in HFIR at <373K and HFR SURP data in the plateau regime (see **Figure 4**) confirms this theory.

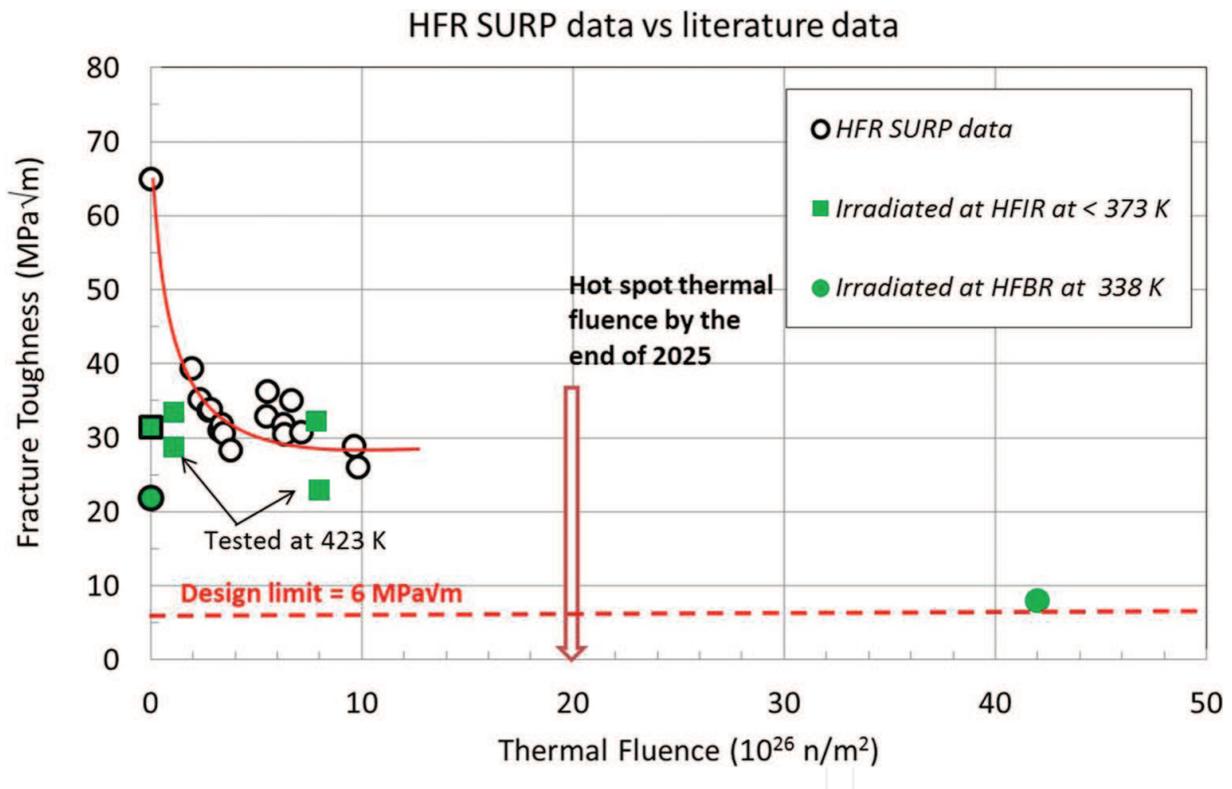
Figure 4. HFR SURP fracture toughness data in comparison with literature data [5,10].

Only limited data was published on fracture toughness properties of irradiated Al alloys [5, 8, 10]. The most relevant data for the HFR (irradiation temperatures $< 373 \text{ K}$) is plotted in

Figure 4 in comparison with HFR SURP data. Data from 6061-T6 alloy irradiated at < 373 K in the High Flux Isotope Reactor (HFIR) in Oak Ridge National Laboratory, USA matches quite well with the HFR SURP data. As it can be seen from **Figure 4**, there is one high fluence data point published by Weeks et al. [5] beyond the current surveillance data of the HFR vessel. This data is from the CRDF A-2 tubes of the HFBR in Brookhaven National Laboratory, USA, produced from 6061-T6 alloy, irradiated at 338 K up to a thermal fluence of 42×10^{26} n/m². The corresponding fast fluence of this data point is 2×10^{26} n/m², which gives a high TFR of 21, compared to the HFR hotspot TFR value of maximum 1.4. The total measured Si at this fluence was found to be ~8 wt.%, including 0.6% of initial Si content. The reported thermal fluence and Si content of this data point are approximately two times the estimated thermal fluence ($\sim 20 \times 10^{26}$ n/m²) and Si (~4.3 %) content of the HFR hotspot by the end of 2025. Note that this data is from the same material and at the same irradiation conditions for which the tensile data at very high thermal fluences ($\sim 42 \times 10^{26}$ n/m²) is also available (see **Figure 1**).

This is because the hardening-induced embrittlement causes the decrease in both ductility and fracture toughness properties. In this regime, the magnitude of the drop in 5xxx alloys is high compared to 6xxx alloys, because both dislocation damage and precipitation damage mechanisms are active in 5xxx alloys, whereas only dislocation damage dominates in 6xxx alloys. This explains the sharp drop observed in fracture toughness of 5154-O alloy at the onset of irradiation compared to a shallow decrease in fracture toughness properties of 6061-T6 alloy in this regime (see **Figure 4**).

CRDF A-2 tubes of HFBR produced from 6061-T6 alloy have shown a fracture toughness value of ~ 8 (MPa) $\cdot\text{m}^{1/2}$ after irradiation to a much higher thermal neutron fluence of $\sim 42 \times 10^{26}$ n/m² at 338 K (see **Figure 4**). The decrease in fracture toughness from an unirradiated value of 21.75 (MPa) $\cdot\text{m}^{1/2}$ for this alloy is primarily attributed to the following: (i) formation of very fine (~ 8 nm) Si-rich precipitates in the grains due to high TFR of 21 (as explained in Section 4.4) and (ii) large silicon flakes occupying about one-fifth of the grain boundary area at this high transmutation-produced Si content of 8 wt.% [5]. Fracture surface of this alloy revealed substantial intergranular separation with some residual ductility indicating that the contribution of grain boundary fracture mechanisms is increased at such high fluence values to enter into the brittle regime (regime 4).

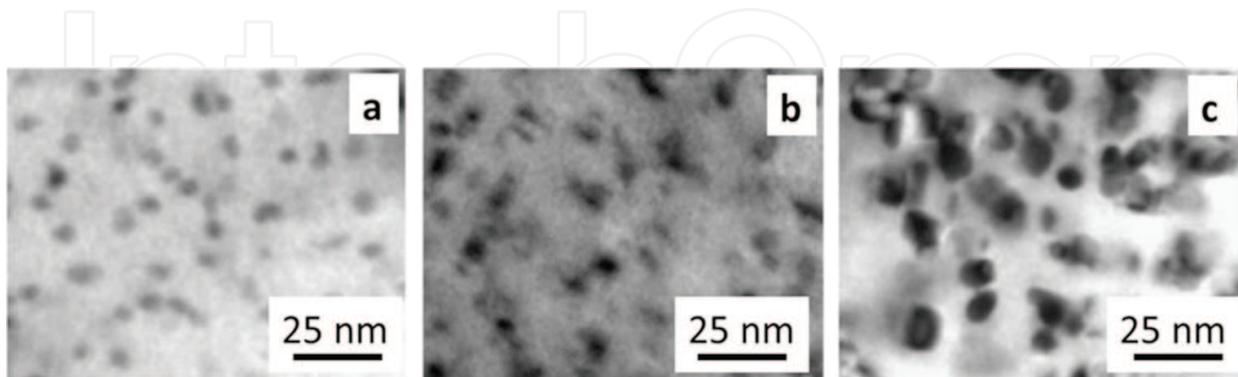
Figure 5. TEM images showing the evolution of precipitate size with thermal fluence in 5154-O Al alloy (HFR SURP specimens). (a) 2.73×10^{26} n/m², 0.68 wt.% Si, (b) 3.76×10^{26} n/m², 0.88 wt.% Si and (c) 9.81×10^{26} n/m², 2.21 wt.% Si. (Photograph courtesy N.V. Luzginova et. al. [13])

As the irradiation continues, both the dislocation density and the Mg_2Si precipitate density evolve toward a saturation limit describing the slow decrease of fracture toughness toward a plateau in the transition regime. Transmission electron microscopy results of precipitate microstructure reported in [13] are shown in **Figures 5** and **6**. From these results it can be seen that the saturation density is achieved at $\sim 3 \times 10^{26}$ n/m² of thermal fluence for 5154-O alloy of HFR vessel. Note that these pictures were taken using a “JEOL JEM-1200ex STEM/TEM” machine operating at 120 keV, located in JGL laboratory at NRG.

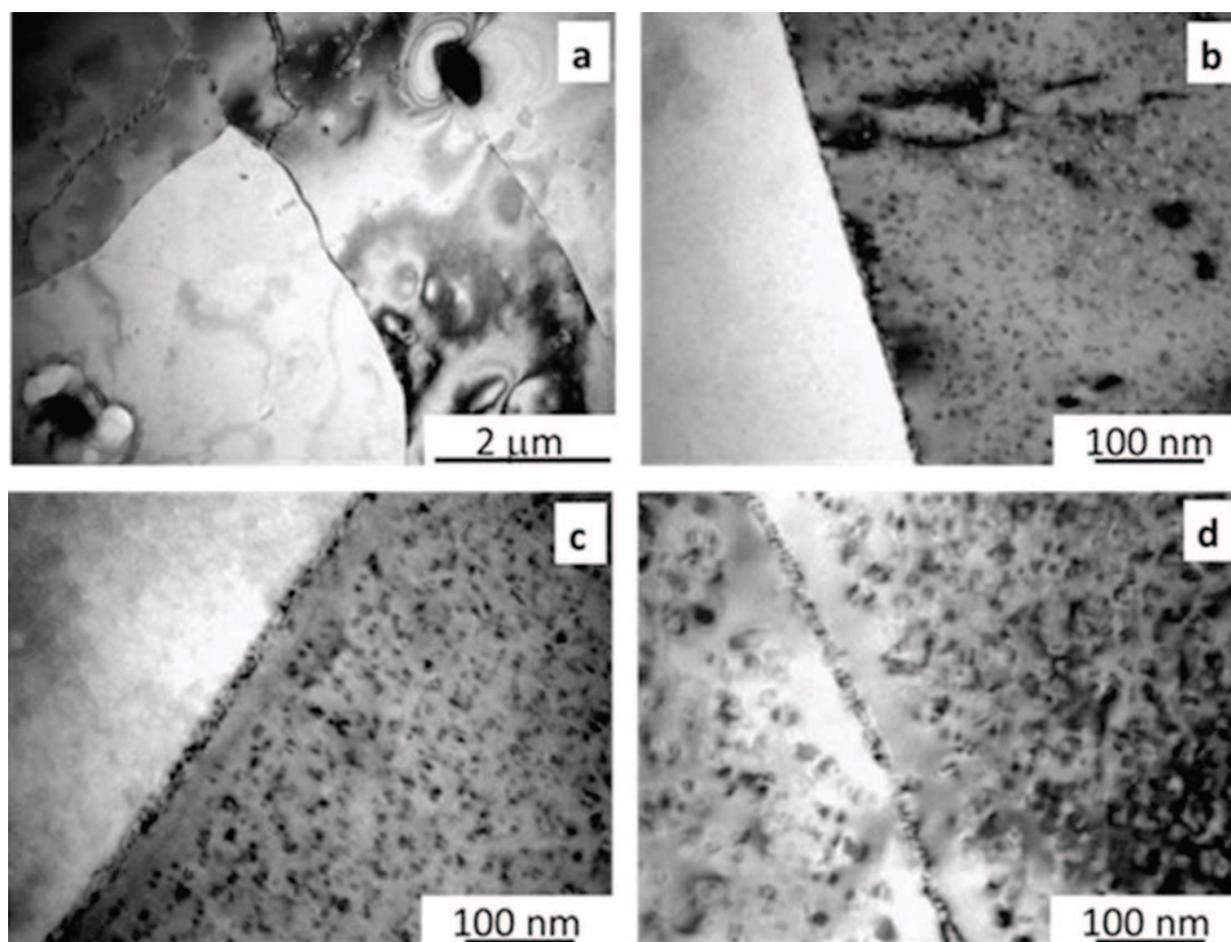
Figure 6. TEM images showing the evolution of precipitate microstructure with thermal fluence in 5154-O Al alloy (HFR SURP specimens). (a) Unirradiated, 0.04 wt.% Si, (b) 2.73×10^{26} n/m², 0.68 wt.% Si, (c) 3.76×10^{26} n/m², 0.88 wt.% Si, and (d) 9.81×10^{26} n/m², 2.21 wt.% Si. (Photograph courtesy N.V. Luzginova et al. [13].)

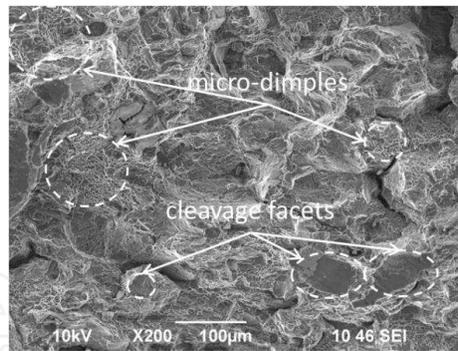
Figure 7. Fracture details of 5154-O alloy with a crack-tip thermal fluence of 9.81×10^{26} n/m². Figure shows fracture surface characterized by dominant microdimples and some cleavage facets [13].

It is important to understand how long the plateau in the fracture toughness (or regime 3) will continue. This depends on the location of the precipitation of the transmutation Si. As already mentioned in Section 3.2.2, further increase in Si production to high values can lead to Si precipitation at grain boundaries. Fracture toughness value drops when the precipitation of Si at the grain boundaries cumulates to an extent that the dominant deformation and fracture mechanisms shift from the bulk microstructure to the grain boundaries. A heavy discontinuous precipitation observed at the grain boundary in 5052-O alloy at a thermal fluence of 31×10^{26} n/m² [3] has resulted in no substantial effects on ductility of this alloy. This suggests that the nature of fracture at these high fluence is still controlled by bulk deformation mechanisms (instead of mechanisms controlled by grain boundaries). Due to the similarity in 5154-O and 5052-O alloys (and irradiation conditions), the ductility and fracture toughness properties of the 5154-O alloy are also expected to show a plateau until such high fluences. Indeed, the observation of significant amount of micron-scale dimples on the fracture surface of 5154-O alloy irradiated to a thermal fluence of 9.81×10^{26} n/m² (Figure 7) proves that similar behavior can be expected from the 5154-O alloy [13].
