Electrochemical Characterization of an Optical Fiber Laser-Treated Biomaterial

Eurico Felix Pieretti, Olandir Vercíno Corrêa, Marina Fuser Pillis and Maurício David Martins das Neves

http://dx.doi.org/10.5772/intechopen.72653

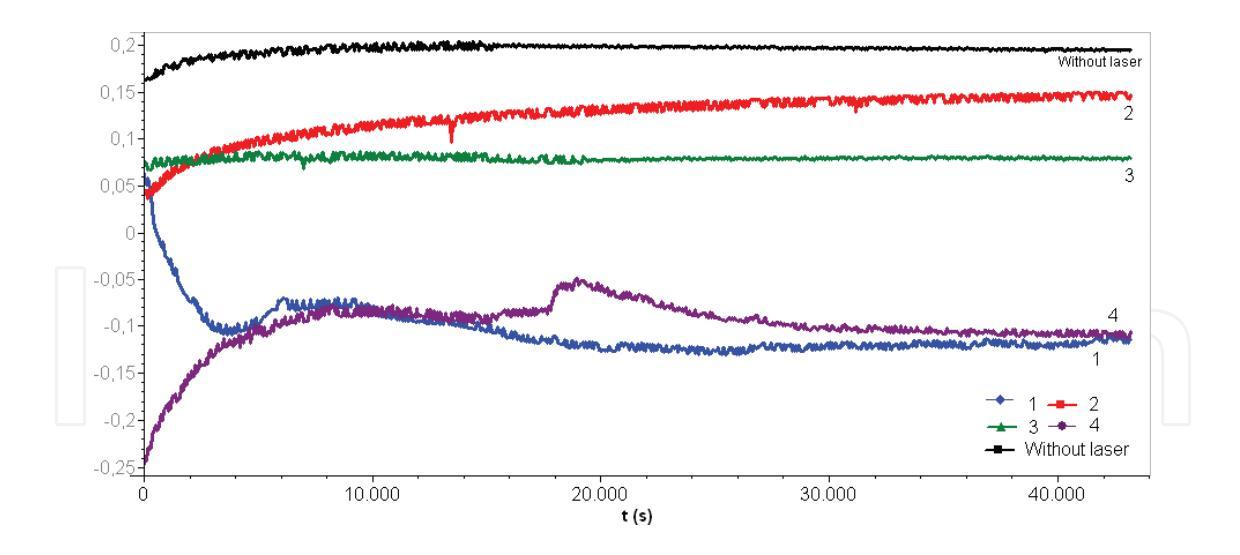
The corrosion resistance of the ISO 5832-1 stainless steel, greatly used for biomedical applications, was measured by electrochemical methods. **Figure 1** shows the variation of the open circuit potential as a function of immersion time for the four different types of laser marked surfaces and the blank (without laser), at 37°C, during a period of 12 h, which was reasonable time for the stabilization of corrosion potential. The tests were carried out for 10 specimens of ISO 5832-1 austenitic stainless steel, for each of the following conditions: unmarked and laser marking, changing the pulse frequencies in four levels. The analysis of **Figure 1** allows the understanding of some phenomena that have been repeated for several specimens depending on the type of surface evaluated.

The curve presented in black color, referring to the steel without markings, is representative of the amount of 10 tests performed and presents a more constant open circuit potential for the period evaluated, which suggests the existence of a more stable passive film on the steel. From the first 4000 s of immersion, there is an increase in potential, which with the passage of time, exhibits more uniform behavior until reaching a value of the order of 0.18 V (SCE) in 12 h of test.

Figure 1. Open circuit potential variation with time of immersion for unmarked and Yb-optical fiber laser marked surface, in different frequencies, during 12 h of immersion in phosphate buffer solution (PBS).

Most of the specimens marked by laser beam with parameters 2 and 4 showed a trend of increasing in potential for nobler and more stable values. Specimen 1 showed a drop in open

circuit potential for the first immersion times, around 4000 s. This potential drop can be associated with the attack of more active regions of the surface due to the formation of microplates related to defects generated by the laser marking process. The attack of the more active regions can be considered as a partial "cleaning" of the surface by corrosive attack that is followed by a more homogeneous surface responsible for the recovery of potential in the final moments of the immersion. Specimen 3 presented values of more uniform potentials throughout the open circuit immersion period.

For longer immersion times in this solution, around 25,000 s, all specimens with and without laser markings, exposed in **Figure 1**, show uniform behavior of the corrosion potential, indicating the formation of a stable passive film.

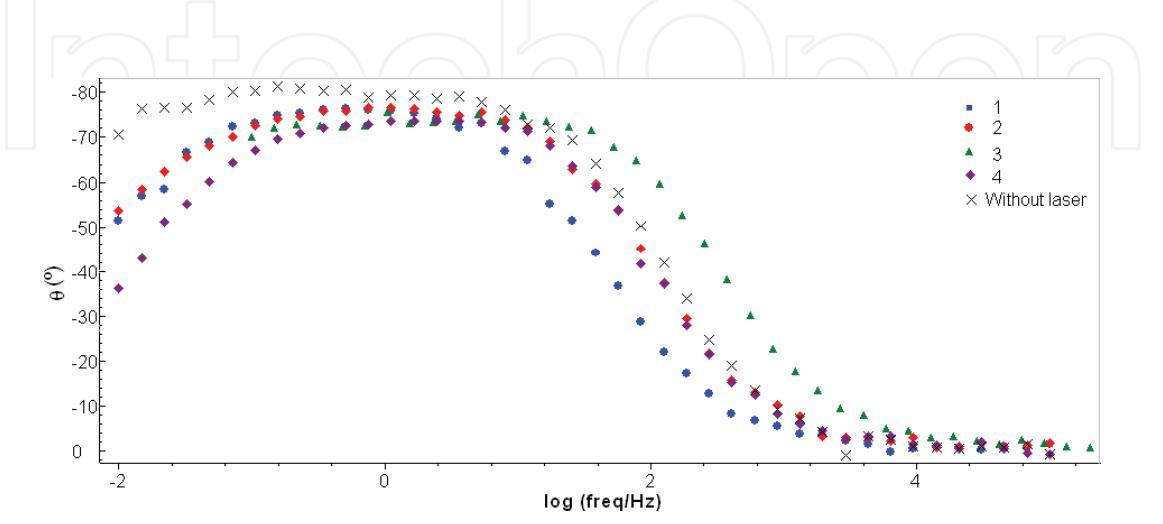
Figure 2. Bode diagram (phase angle) obtained after OCP for austenitic stainless steel ISO 5832-1 in PBS at 37°C.

Figure 2 presents the Bode (phase angle) diagram for the laser marked specimens and without marks, with phase angle values between -35° and -80° , in the low-frequency region, which corresponds to that of passive metals [18, 29–32], and the samples without laser treatment had the lowest values and the highest values were obtained for the samples marked in condition 4.

The diagram shows two constants. One is in the region of high frequencies, identified with a slope between 0.01 and 0.1 Hz. The other in the region of low frequencies, characterized by a slope between 1 and 10 Hz for the surface corresponding to specimen 1 and between 10 and 100 Hz for the other conditions of marked surfaces (specimens 2, 3 and 4) and without laser. This behavior was observed for stainless steels and associated with the constant at high frequencies at the external-medium oxide interface and the constant at mean frequencies at the internal metal-oxide interface [29–31].

The electrochemical impedance spectroscopy (EIS) diagrams for the biomaterials under the conditions studied, obtained at 37°C in PBS solution, immediately after the potential monitoring corrosion are shown in **Figure 2**.

In **Figure 2**, the Bode diagrams show a narrow plateau for the laser-labeled specimens under all conditions evaluated with phase angle values around -70° , in the medium frequency range, and a wide plateau with phase angle values close to -80° over a wide frequency range, from averages to low, for specimens without laser treatment, typical of passive materials [18, 29, 30].

Higher phase angles at low frequencies for unlabeled specimens suggest passive and more protective films. The drop in the phase angles at the lowest frequencies for the labeled specimens is an indicative of the deterioration of the passive film properties. In the laser-etched samples, the peak phase angle occurs at lower frequencies compared to the untreated specimens, suggesting that the outermost layer of the oxide is less protective than the others [18, 24].

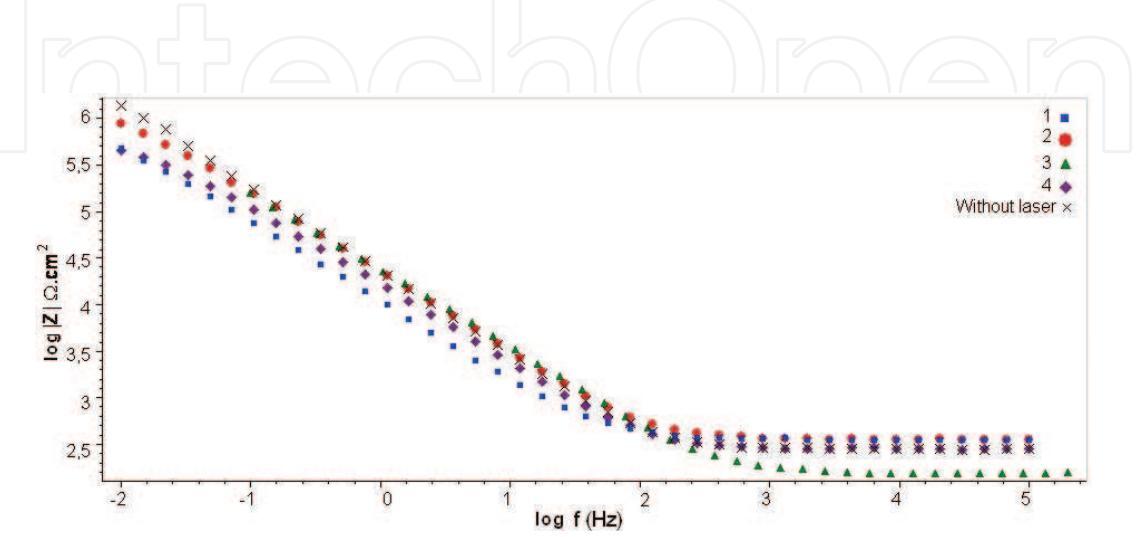
The Bode diagrams, shown in **Figure 3**, represent the reproducibility obtained in 10 tests for each condition and suggest that the change in the laser beam parameters used for the markings has a small influence on the impedance in the low-frequency region, the lowest values obtained for the specimens marked in conditions 1 and 4, and the highest for the material without laser treatment, in this frequency range. This fact evidenced a slight decrease in the protective capacity of the passive film for the treated specimens.

Figure 3. Bode diagram (Z-module) obtained after OCP for austenitic stainless steel ISO 5832-1 in PBS at 37°C.

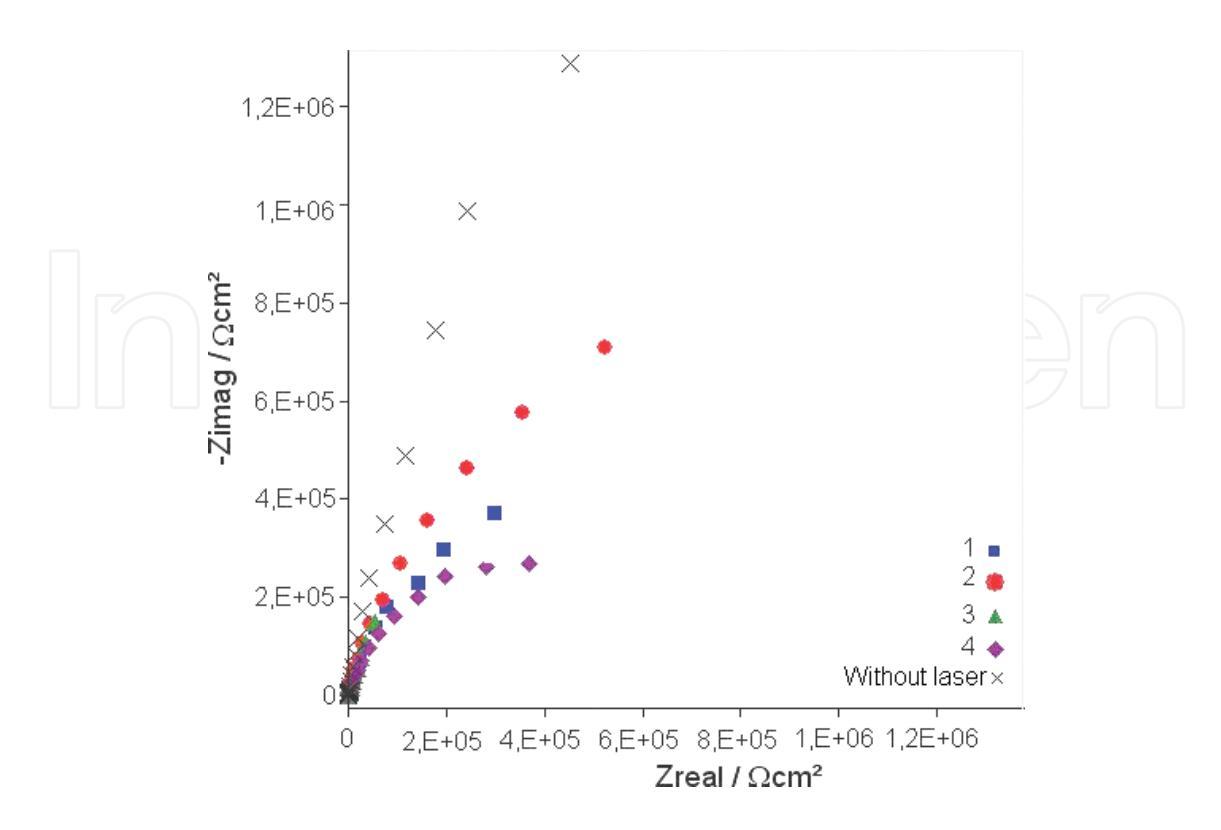
For the same period of immersion from the open circuit corrosion potential, Nyquist impedance diagrams exhibit capacitive behavior, typical of passive materials, and showed lower-Z imaginary values for the specimens with laser treatment; when compared to the specimens without laser beam application. In **Figure 4**, for the same frequency value, the lower impedances were associated with the laser labeled specimen in condition 3, followed by the marking conditions with parameters 4, 1 and 2.

Figure 4. Nyquist diagram obtained after OCP for austenitic stainless steel ISO 5832-1 in PBS at 37°C for the specimens.

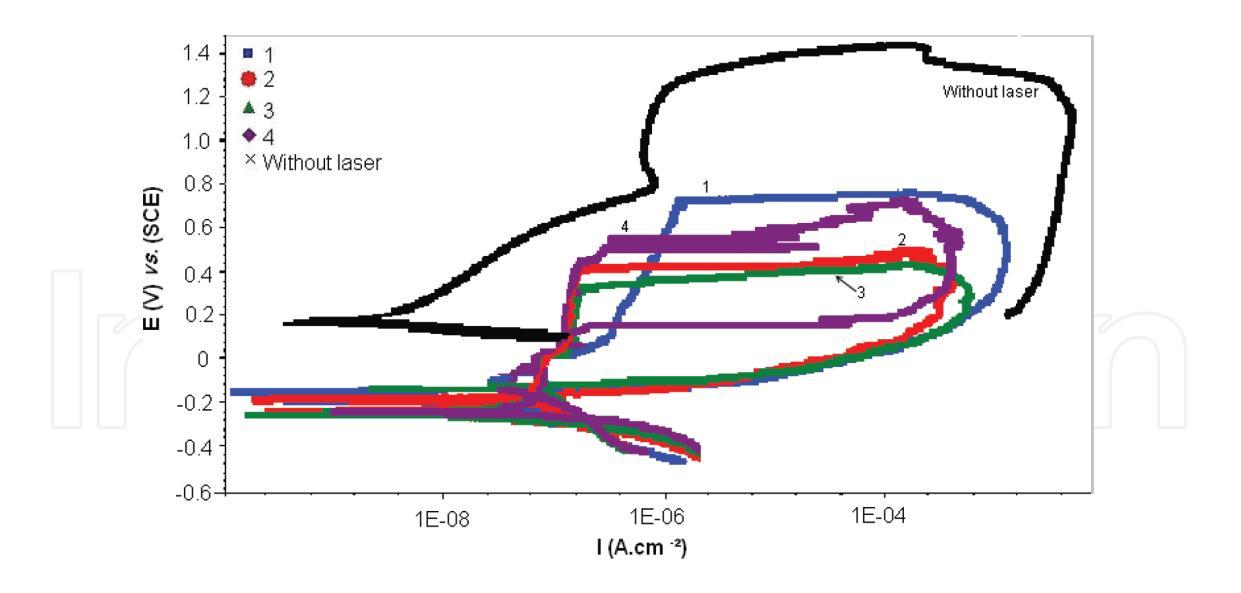
Figure 5 presents the cyclic polarization curves for specimens with and without laser marks. This result represents the laser effect on the susceptibility to corrosion of this stainless steel; the curves presented values of passive film breakdown from about +0.3 V (ECS) to +0.8 V (ECS).

This variability is expected for heterogeneous surfaces such as the specimens with markings via laser beam, where the conditions of the specimens under conditions 1 and 4 showed higher resistance to localized corrosion. It is noted that the film breaking potentials, for all laser marked conditions, are below the specimens without laser marks, that is, polished to $1 \mu m$.

Figure 5. Potentiodynamic polarization curves for unmarked and laser marked ISO 5832-1 stainless steel samples obtained in phosphate-buffered saline solution (PBS).

The EIS results were supported by the cyclic potentiodynamic polarization curves. The lower resistance to pitting corrosion was associated with the laser treated specimens; this is explained by the thermal effect of the process on the homogeneity of the microstructure of this analyzed biomaterial, which reduces the potential for breaking the passive film.

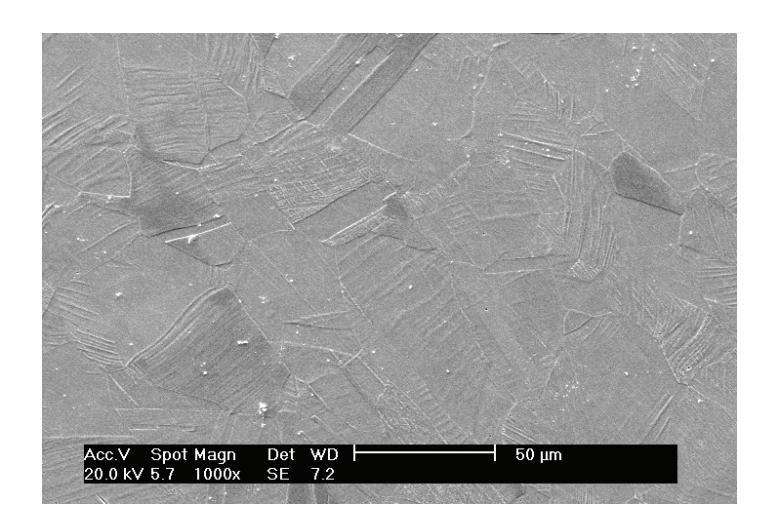
The microstructure of the ISO 5832-1 austenitic stainless steel, widely used for biomaterial application, is presented in **Figure 6**.

Figure 6. SEM microstructure of ISO 5832-1 austenitic stainless steel surface.

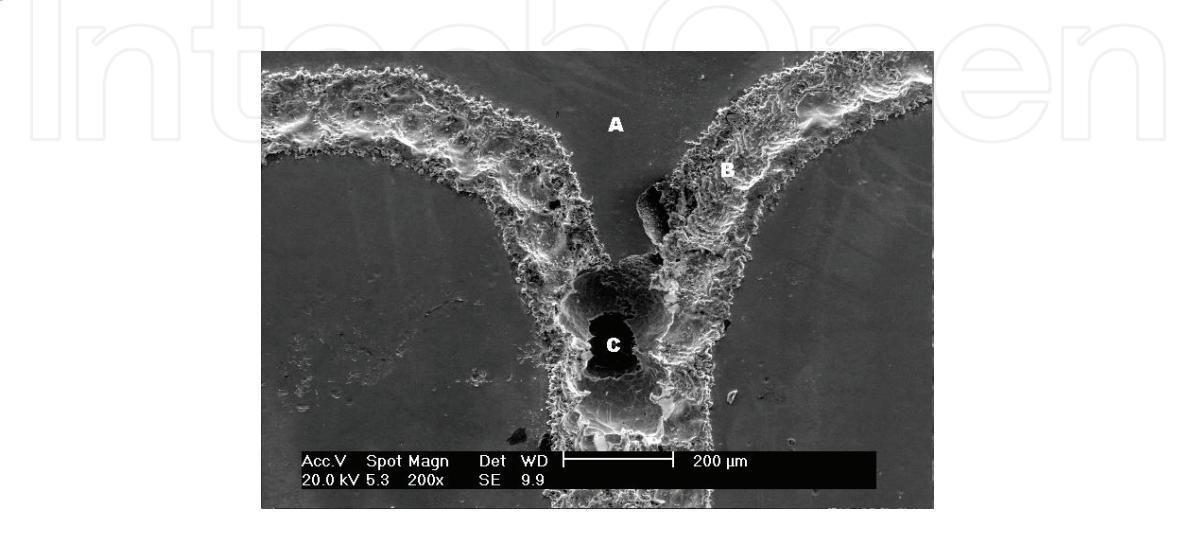
Figure 7 shows that pitting susceptibility is increased in the laser affected areas of the stainless steel surface.

Figure 7. SEM image of the ISO 5832-1 stainless steel surface after polarization tests. (A) Region without laser, (B) laser marked region and (C) laser marked region showing pits associated to the melted areas.

The results of this study showed that susceptibility to pitting corrosion increases due to the thermal effect of the laser marking process in the surface of the stainless steel comparatively to the unmarked regions. In addition, the passive films properties are widely changed by the marking process, with the frequencies used.

The lowest pitting resistance was found for the samples with laser marks. This is explained by the thermal effect of the laser marking procedure on the stainless steel microstructure decreasing pitting resistance. The laser marking occurs by melting of the surface in order to produce the desired marks, besides that a rougher nonhomogenous surface is generated, which favors the corrosion attack.
