Creep Characteristics of Engineering Materials

Janusz Dobrzański and Adam Zieliński

Abstract

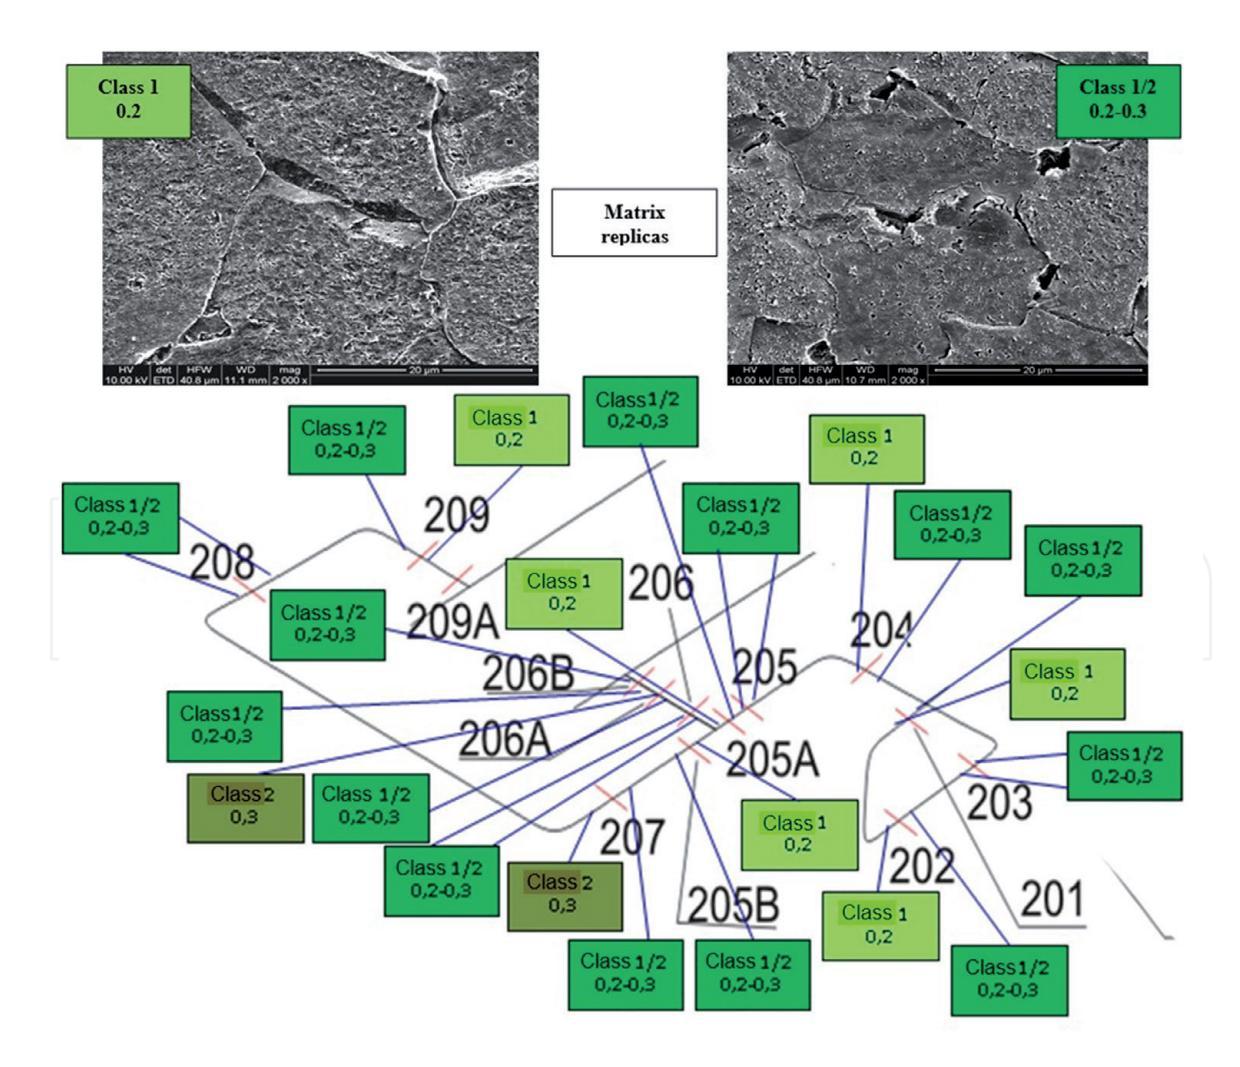
Figure 1.

The class of microstructure and exhaustion degree of the material of straight connection pipes (before the weld at the inlet side and after the weld at the agent outlet side) of the section of 200 MW primary steam pipeline unit boiler after 220 h service under creep conditions.

steam pipeline components after long-term service under creep conditions far beyond the design service time without internal damages caused by creep is shown in **Figure 1**, while those with disclosed damages in the form of voids both in the basic material and in the heat-affected zone and weld material are shown in **Figure 2**. The results of these tests allow to take decisions whether the test pipelines can be left and only some of its components need to be replaced using the joining technology by welding materials with significant changes in microstructure caused by creep with new materials.

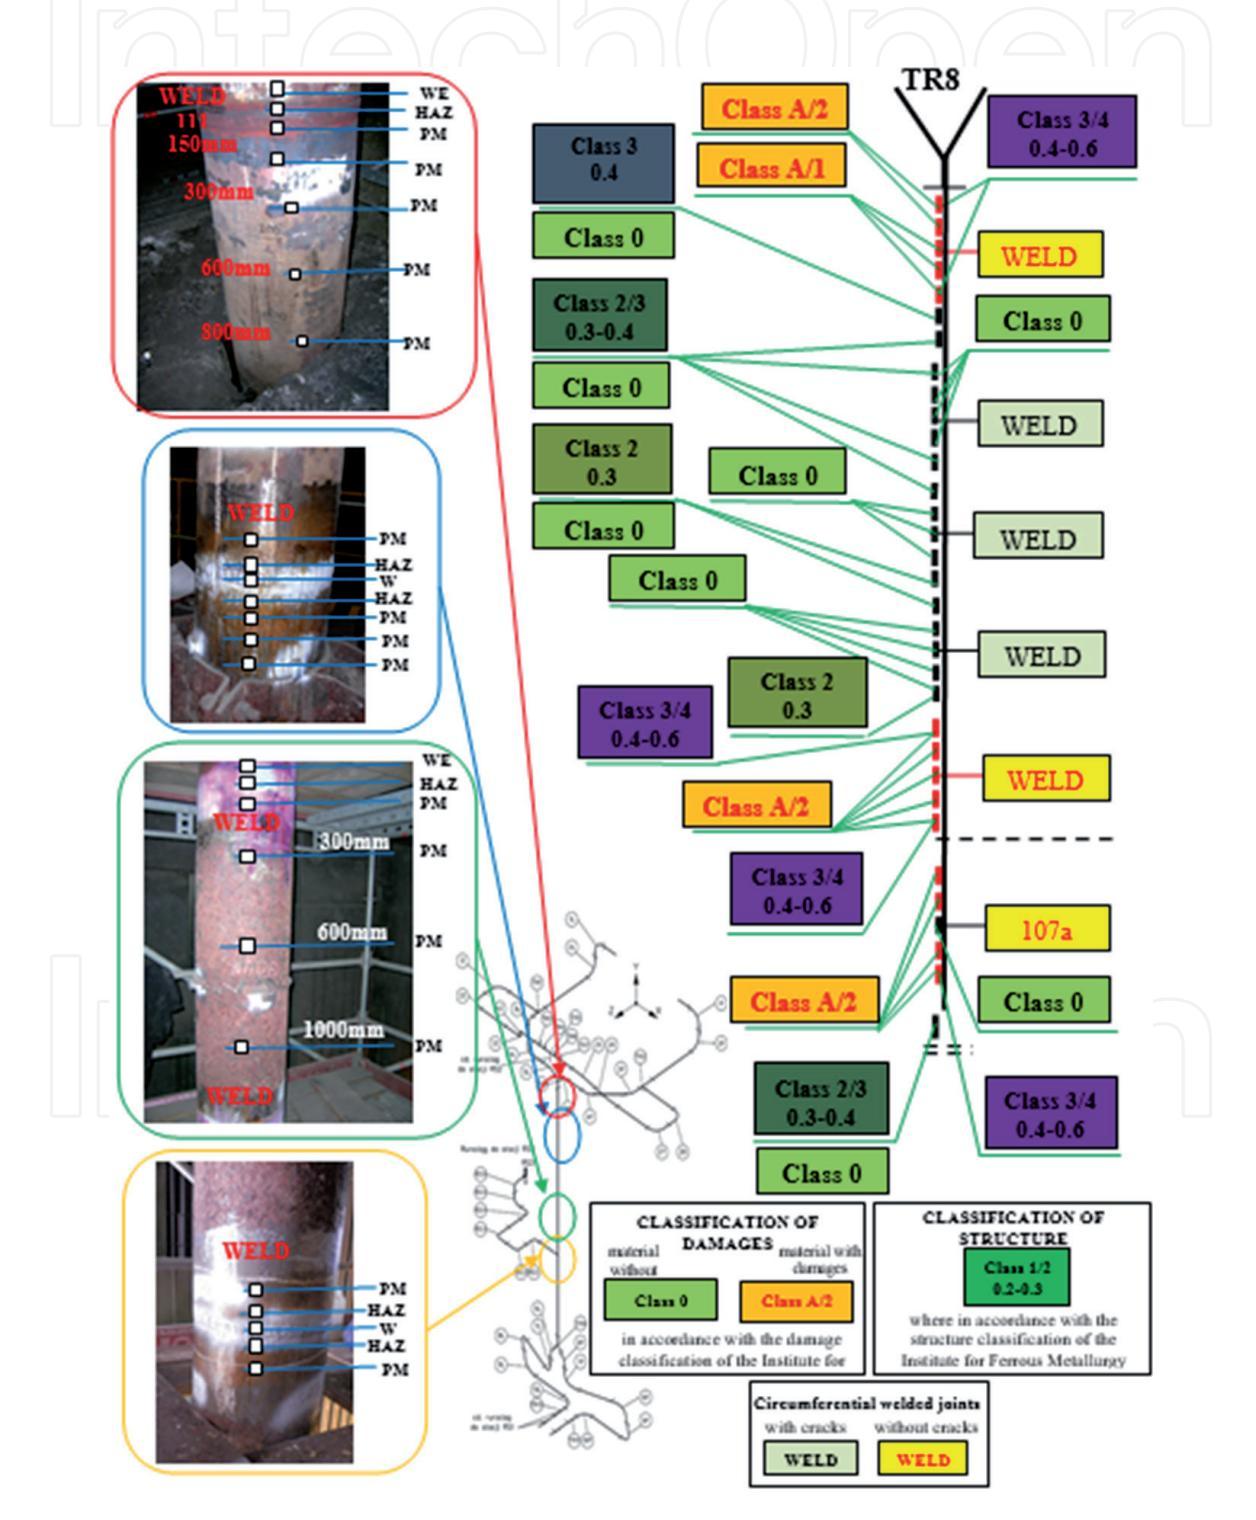
Figure 2.

Assessment of the material condition with regard to changes in the structure and occurred internal damages caused by creep of parent material and circumferential welded joints in the vertical section of the primary steam pipeline made of 14MoV6-3 steel after approximately 220,000 h service (matrix replicas, SEM).

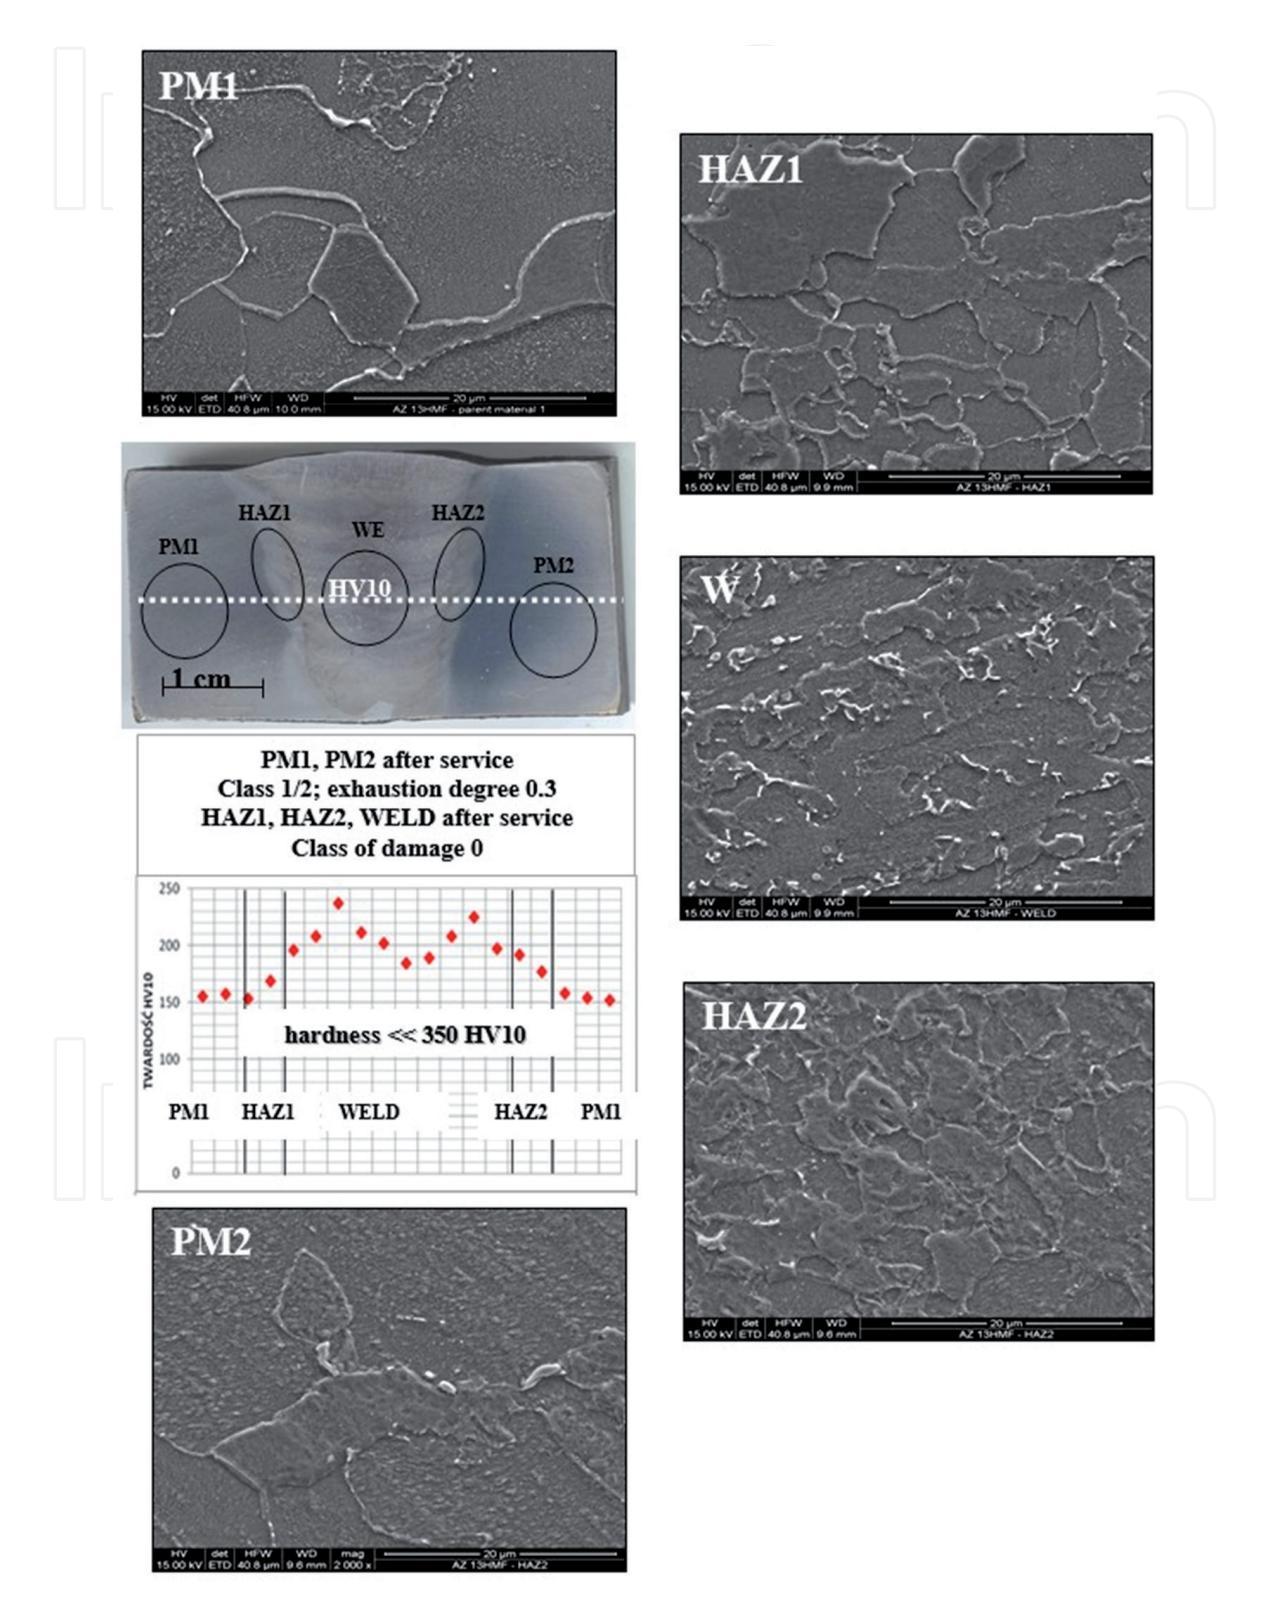
Figure 3.

Structure of the material of homogeneous butt-welded joint components of the main primary steam pipeline made of 14MoV6-3 steel after approximately 200,000 h service under creep conditions parent material marked PM1, PM2; weld material marked WELD heat-affected zone marked HAZ1, HAZ2.

The selected example showing the state of structure of homogeneous buttwelded joints after long-term service compared to the structure of the parent material of a component after service far beyond the design service life is shown in **Figure 3** and summarised in **Table 1**.

Figure 3 reveals the images of microstructure and the results of hardness measurements of components of the butt-welded joint in the main primary steam pipeline, whereas the description, state of microstructure of the parent material and its exhaustion degree as well as the class of internal damages of the heat-affected zones and weld for the selected example of welded joint are summarised in **Table 1**. The image of microstructure of the welded joint components after service, exceeding

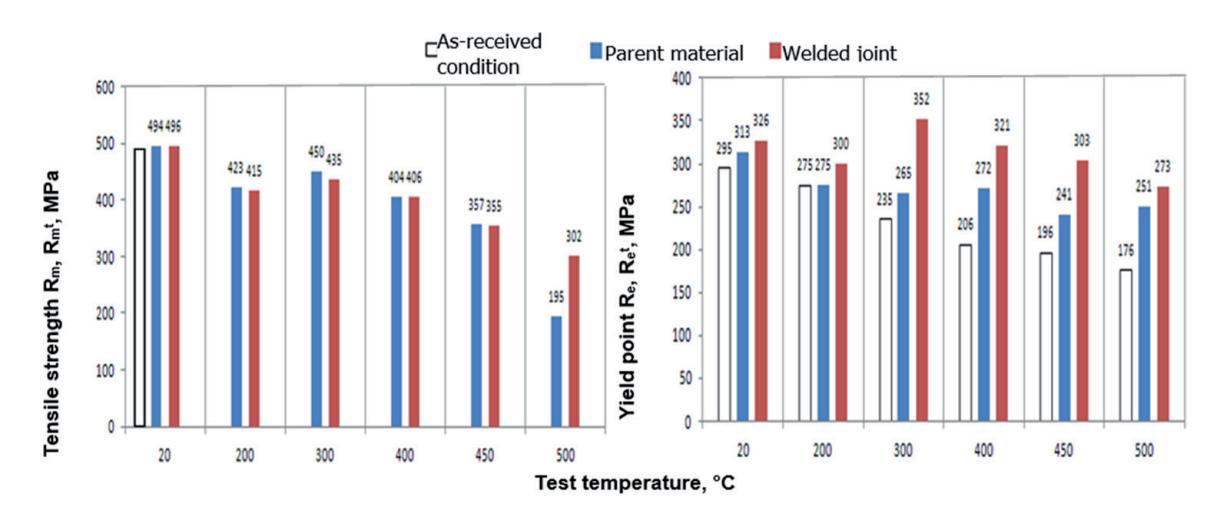
Figure 4.

The comparison of test results for yield point at room (R_e) and elevated (R_e^t) temperature of the parent material and butt-welded joint of the primary steam pipeline made of 14MoV6-3 steel after 240,000 h service under creep conditions in relation to the as-received condition of the material.

Table 2 presents an analysis of the chemical composition of the tested sections. The mechanical properties of the material obtained from pipeline sections were shown in graphical form in **Figures 4–8**. In order to assess the properties of the tested steels and their welded joints, reference was made to the requirements contained in PN-75/H-84024.

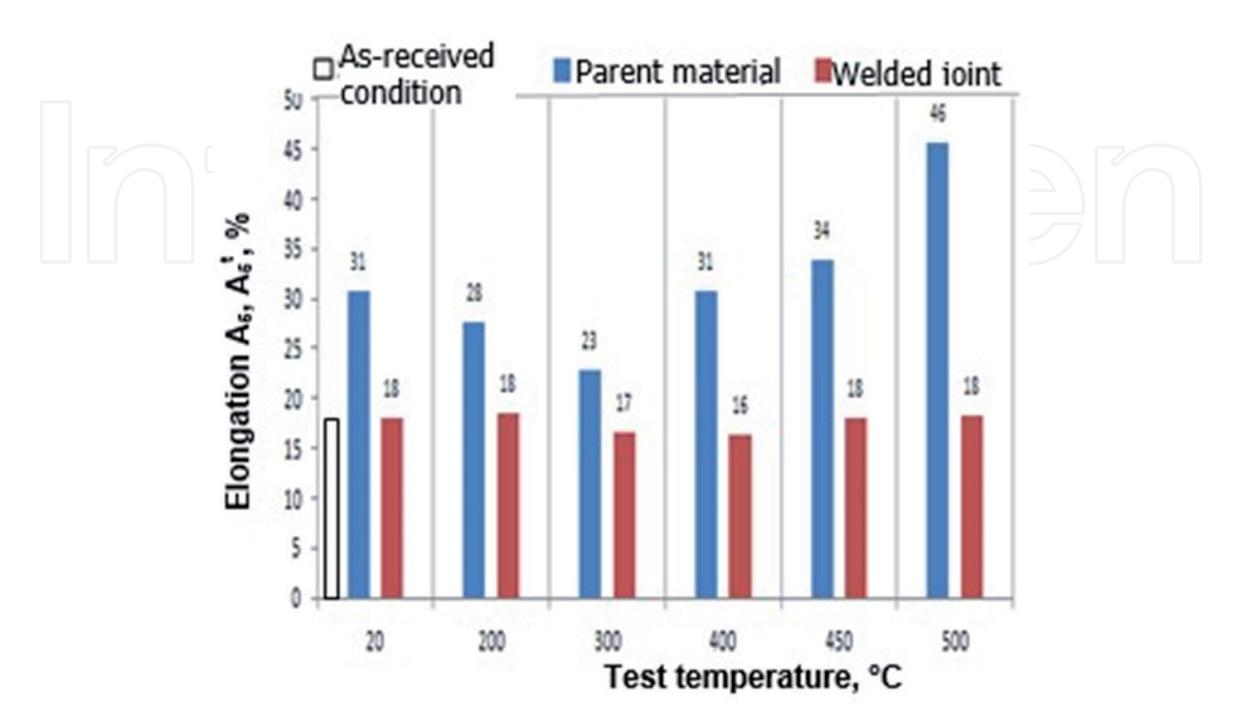
Figure 5.

The comparison of test results for A_{5t} elongation at room and elevated temperature of the shell material and butt-welded joint of the primary steam pipeline made of 14MoV6-3 steel after 240,000 h service.

elongation in tensile test, its impact energy and brittle fracture appearance transition temperature both in the weld and the heat-affected zones. The example of elongation test results depending on the test temperature of welded joints compared to the parent material after long-term service far beyond the design service time is shown in **Figure 5**, whereas **Figure 8** presents the comparison of mechanical properties of the parent material and butt-welded joint with regard to the requirements for the parent material in the as-received condition.

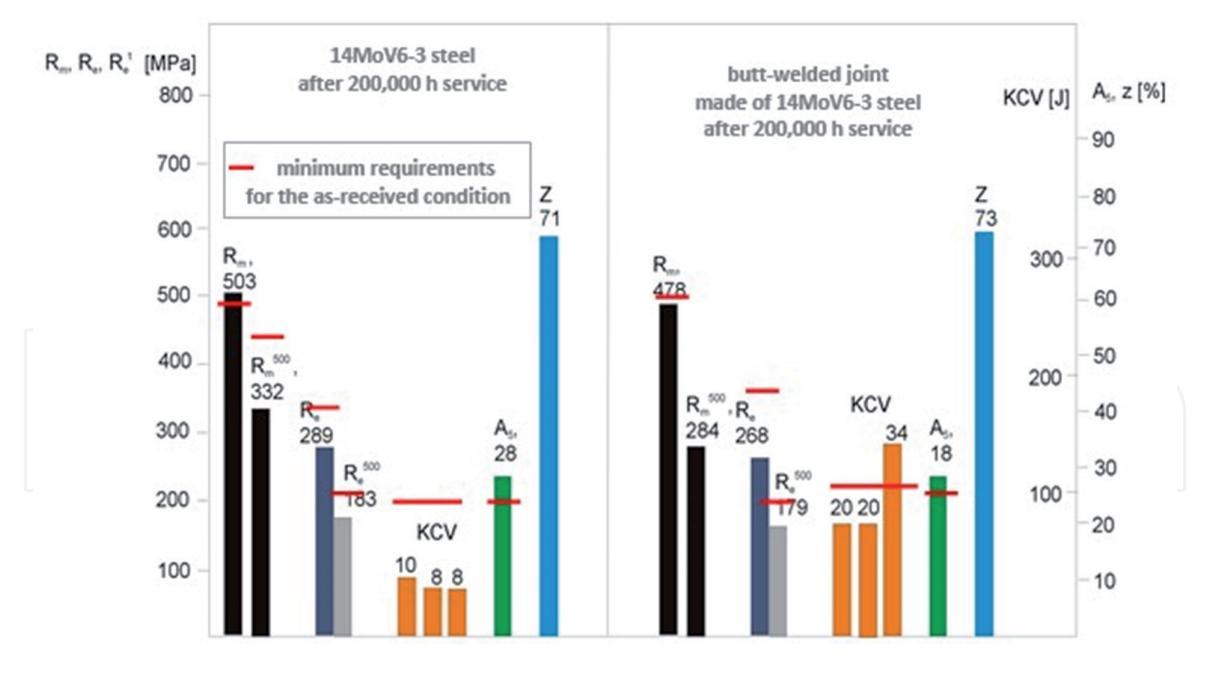
Figure 6.

The comparison of test results for mechanical properties of the parent material and homogeneous butt-welded joint of pipeline components made of 14MoV6-3 after long-term service under creep conditions for 200,000 h.

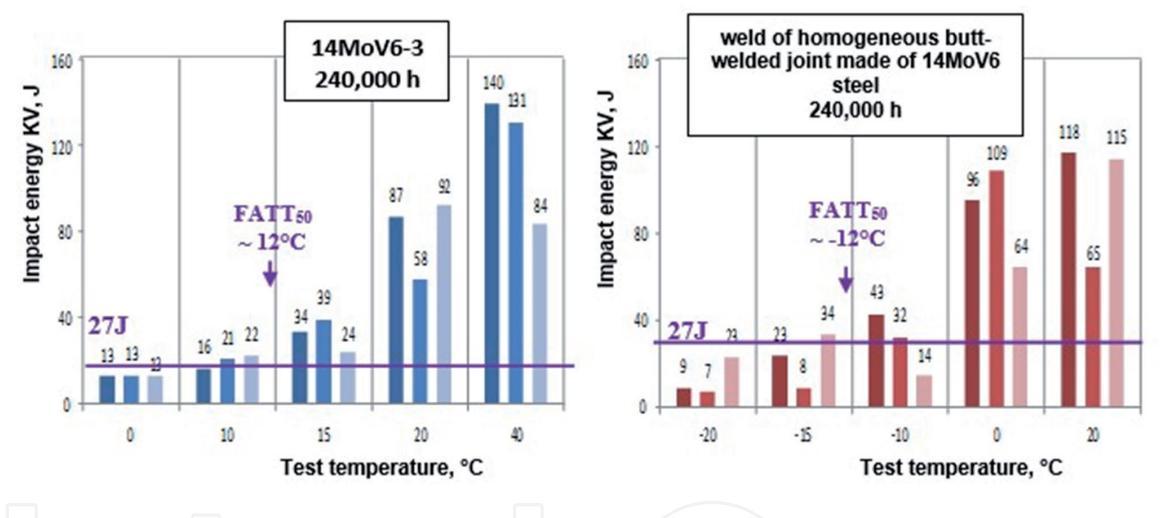
Figure 7.

The comparison of test results for impact energy measured on V-notch test specimens depending on test temperature of parent material and weld of homogeneous butt-welded joint of pipeline components after long-term service under creep conditions: (a) made of 14MoV6-3 steel, (b) made of 10CrM09-10 steel.

The test results for impact energy measured on V-notch test specimens depending on the test temperature of parent material and weld of homogeneous butt-welded joint of the pipeline components after long-term service under creep conditions are compared in **Figure 7**, whereas **Figure 8** shows the relationship between the impact energy measured on V-notch test specimens and the test temperature of the parent material, heat-affected zone and weld of the butt-welded joint of the main steam pipeline made of 14MoV6-3 steel after 20,000 h service as well as brittle fracture appearance transition temperatures determined for the materials of these areas. This example illustrates how diversified the level of brittle fracture appearance transition temperature of the material of individual welded joint components after long-term service under creep conditions can be. In accordance with the results of long-term own research, for the materials that most often exist in the components operated under creep conditions far beyond the design service time, such as 13CrMo4-5, 14MoV6-3, 10CrMo9-10 low-alloy steels and X20CrMoV121 high-chromium steel, the highest trend towards the loss of plastic properties is shown by the components made of 14MoV6-3 steel and then those made of X20CrMoV121 steel. The knowledge of these material features is necessary for the selection of water-pressure test parameters and the method for overhaul works and repairs.

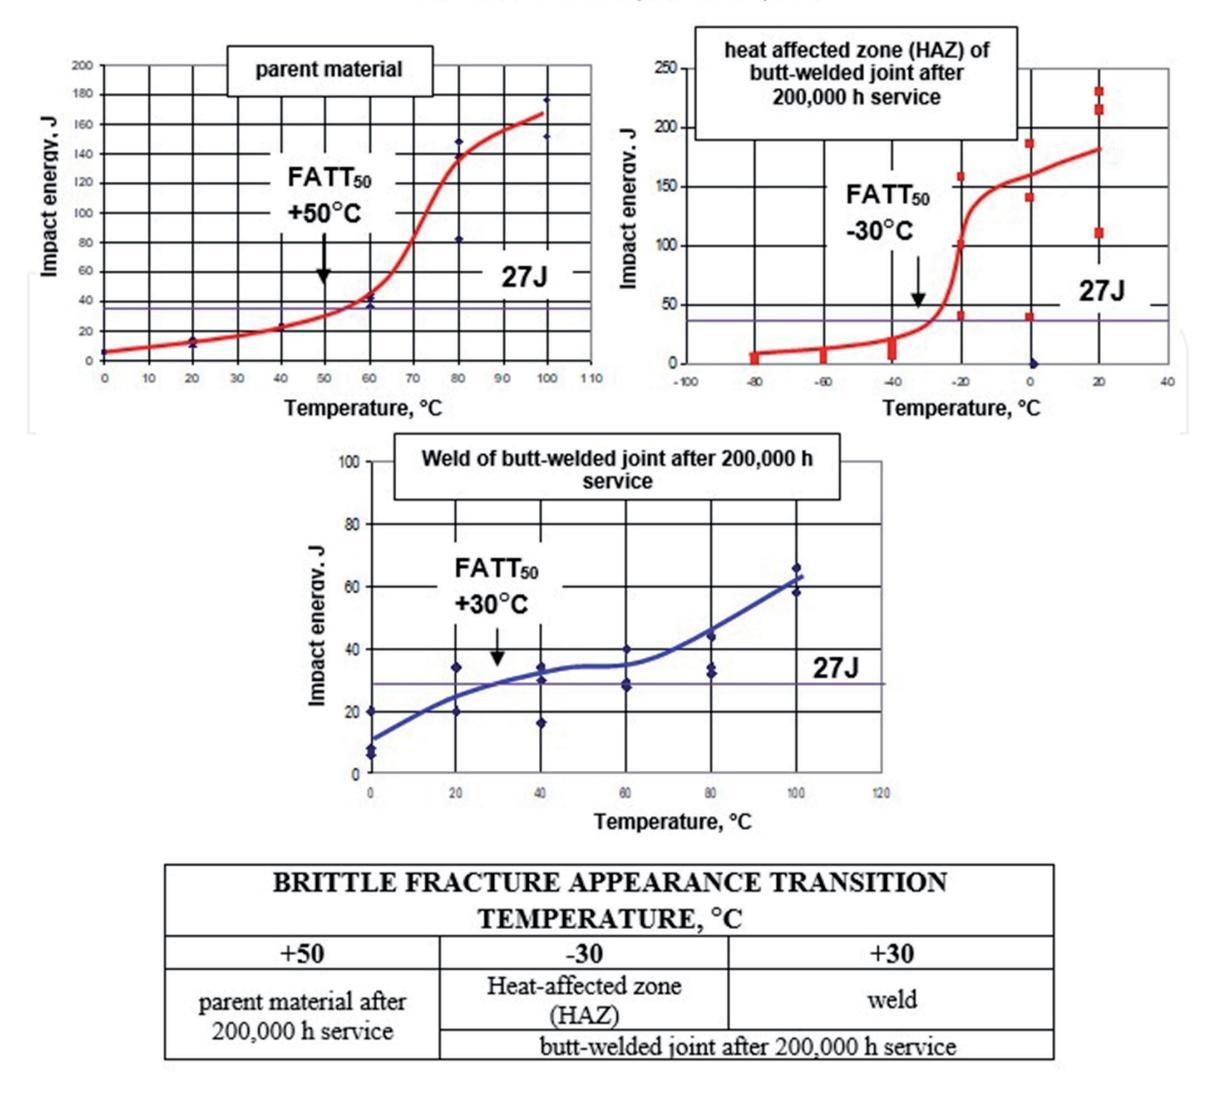
Figure 8.

The relationship between the impact energy measured on V-notch test specimens and the test temperature of butt-welded joint components of steam pipeline made of 14MoV6-3 steel after 200,000 h service and the brittle fracture appearance transition temperature determined for (a) parent material, (b) heat-affected zone and (c) weld.

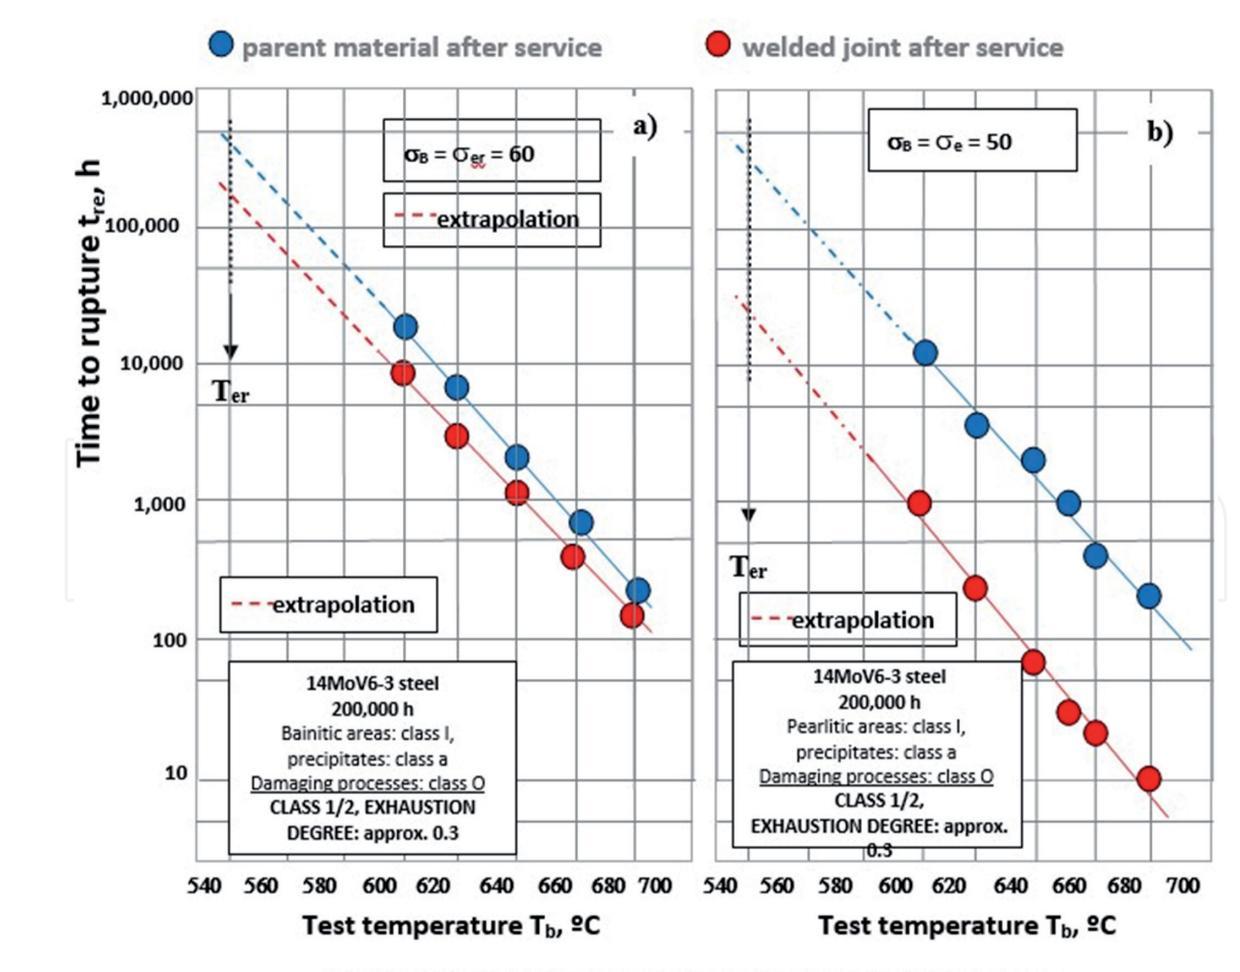
Figure 9.

Residual life of parent material and butt-welded joints of components working far beyond the design service time based on results of short-term creep tests in the form of log $t_{re} = f(t_b)$ at σ_b = const for two different main primary steam pipelines made of 14MoV6-3 steel after 200,000 h service. σ_B - test stress.

The examples of residual life, which is the time to rupture under the temperature and stress conditions equal to operating ones, determined in short-term creep tests and compared to the residual life of the parent material after service are shown in **Figure 9**.
