Fatigue Characteristic of Automotive Jounce Bumper

Aidy Ali, R.S. Sidhu and M.S.A. Samad

*Department of Mechanical and Manufacturing Engineering
Faculty of Engineering, Universiti Putra Malaysia
43400 Serdang, Selangor,
Malaysia*

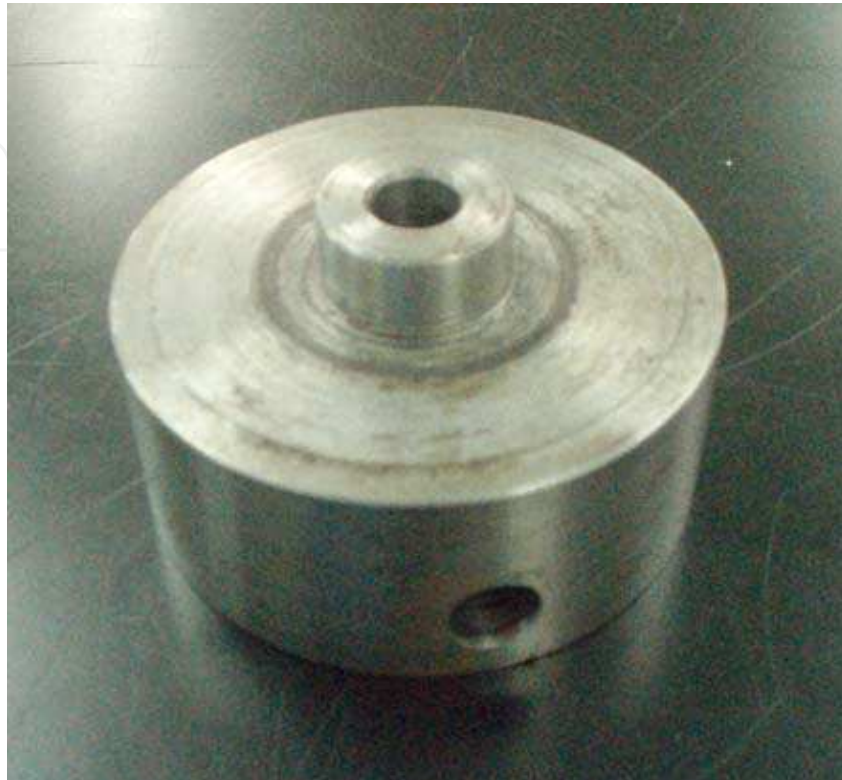
Fig. 2. Jig

A jig made out of mild steel is design to accommodate the loading condition by allowing the air to flow out while the jounce bumper is compressed. It also mimics the shock rod where it keeps the jounce bumper in line and prevents slips. The jig is shown in Figure 2.

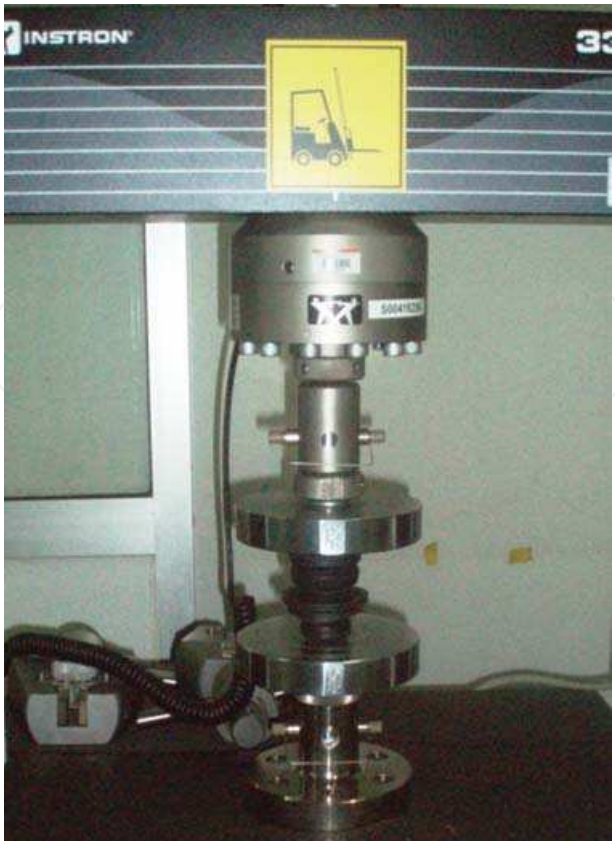
Fig. 3. Instron 3382 Floor Model Universal Testing System

The monotonic compression test was conducted using the Instron 3382 Floor Model Universal Testing System as shown in Figure 3. The test was done at a rate of 10mm/min to determine the maximum force of the jounce bumper and to obtain the Load versus Deflection response (L-D). For the fatigue compression test, twelve samples with different displacements were tested in an ambient temperature of 20 °C. The tests were carried out using the Instron 8871 table top model fatigue systems (Figure 4) with a sine waveform at frequency of 2 Hz at a load ratio of 0.

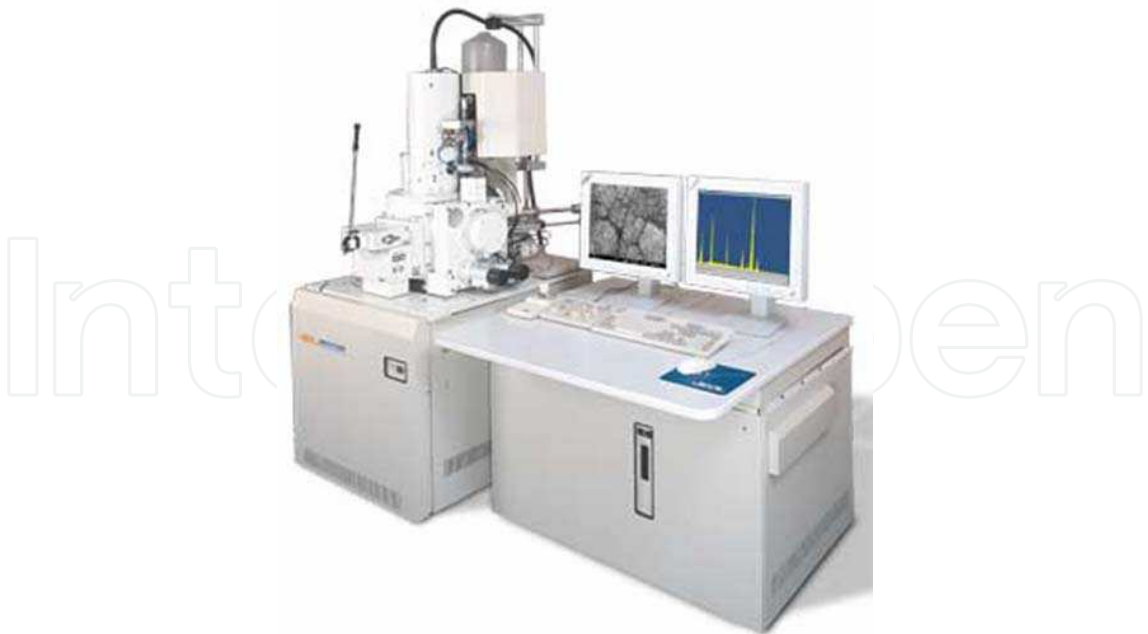
Fig. 5. JEOL FE-SEM JSM-6701F

The jounce bumpers were cycled for 30 rounds to eliminate the Mullins effect before the number of cycles to failure is taken into consideration. Mullins Effects can be described as an initial softening that occurs at the start of the fatigue test (Diani et al., 2009). The determination of fatigue failure is based on the 15 % load drop. For the SEM and EDS testing, the samples were cut from the failure surface (after fatigue) and also a controlled surface (before fatigue) and placed onto specimen stub with carbon double-sided tape. Then the specimens were coated by evaporative coating with ultra-thin layers of Platinum under high vacuum. This process creates a conducting layer that permits SEM examination to take place. The JEOL FE-SEM JSM-6701F as shown in Figure 5, was operated at 20 kV with 15 mm working distance. For elemental analysis, Energy dispersive x-ray (EDS) was used.

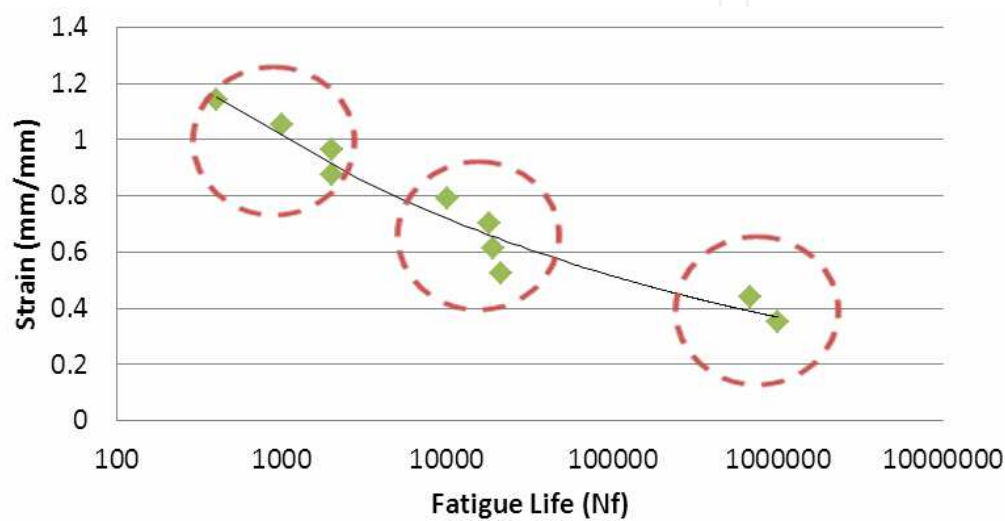
Fig. 7. Strain - Life (ϵ -N)

Figure 7 shows the strain versus fatigue life curve. The fatigue curve can be categorized into three zones. Zone one has the highest strain range between 0.88 - 1.14 mm/mm. Strains in this zone should be avoided at all cost as it yields very low fatigue life. Jounce bumper undergoing strains in zone two (0.53 - 0.79 mm/mm) will have a much longer fatigue life. However a regular replacement is necessary since it would not last for more than a 100000 cycles. Zone three is the safest zone with strains below 0.43 mm/mm. Strain values in this zone have fatigue life ranging from 675000 cycles and goes above 1.5 million cycles. Tests conducted on strains above 0.8 reveals significant fracture in the jounce bumper. The cracks originate from the lower part of the jounce bumper as highlighted in Figure 8.

The fatigue characterization of the automotive jounce bumper was successfully determined. The compression test reveals that the jounce bumper is able to withstand a maximum force of 7 KN. From the fatigue test conducted, we were able to characterize the jounce bumper depending on the strain acted upon it. Three zones were established to separate the safe zone from the potential danger zone. FEA simulation using Abaqus successfully predicted the point of failure which matches the experimental results. Pre-existing flaws accelerates the initiation of cracks under fatigue loading. The SEM result proves that the virgin jounce bumper have decohesions. Type of material used to fabricate rubber components as well as the process of producing the component plays an important role in determining the quality of a product. In this case, the use of CaCO_3 and the mysterious existence of Aluminium compound reflect the poor quality of the rubber jounce bumper.
