Common Pacemaker Problems: Lead and Pocket Complications

Enes Elvin Gul and Mehmet Kayrak
*Selcuk University,
 Meram School of Medicine,
 Cardiology Department Konya,
 Turkey*

Modern Pacemakers - Present and Future

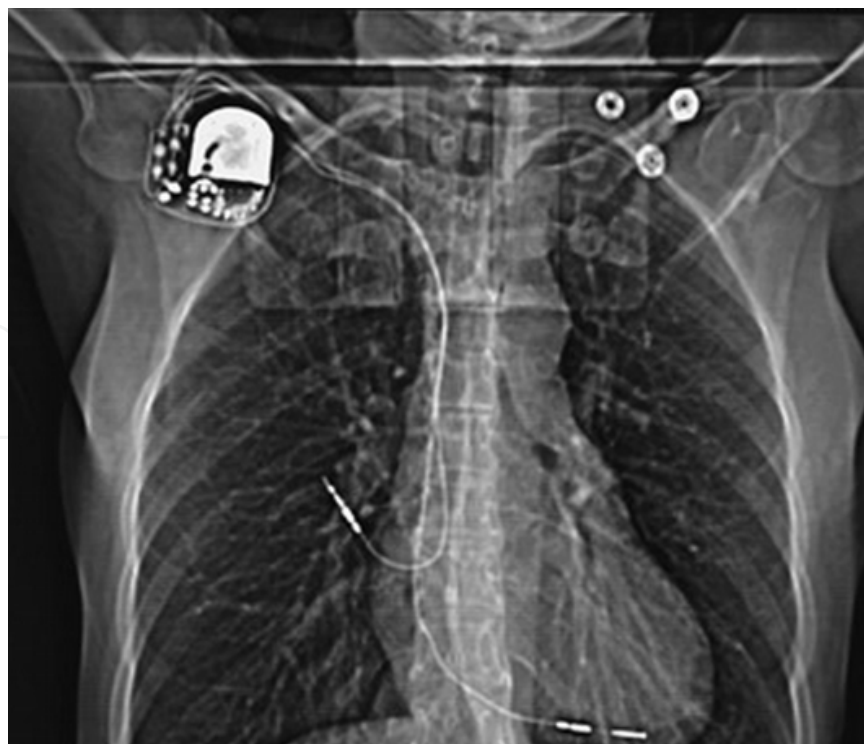
Fig. 5. Chest X-ray demonstrating severe lead perforation due to implantable cardioverter-defibrillator implantation.

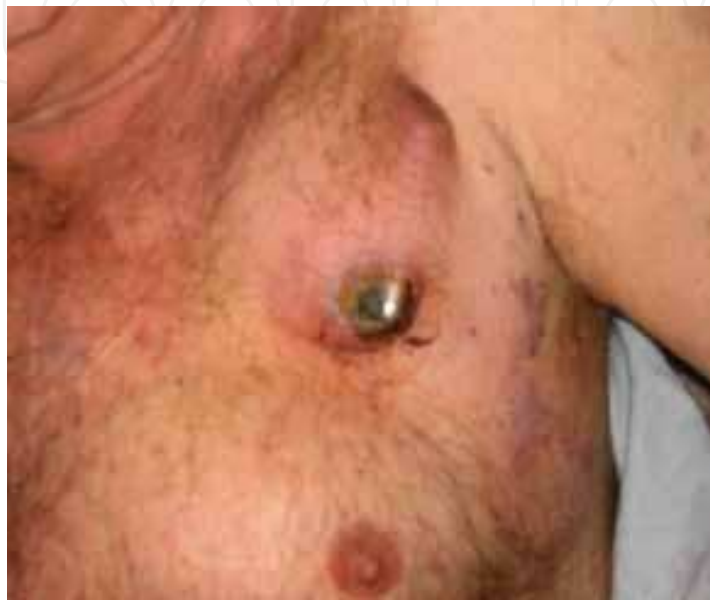
Fig. 9. Erosion of the automated implantable cardioverter-defibrillator (AICD).
