A Novel Approach to Spent Fuel Pool Decommissioning

R. L. Demmer

*Idaho National Laboratory, Idaho Falls, Idaho
USA*

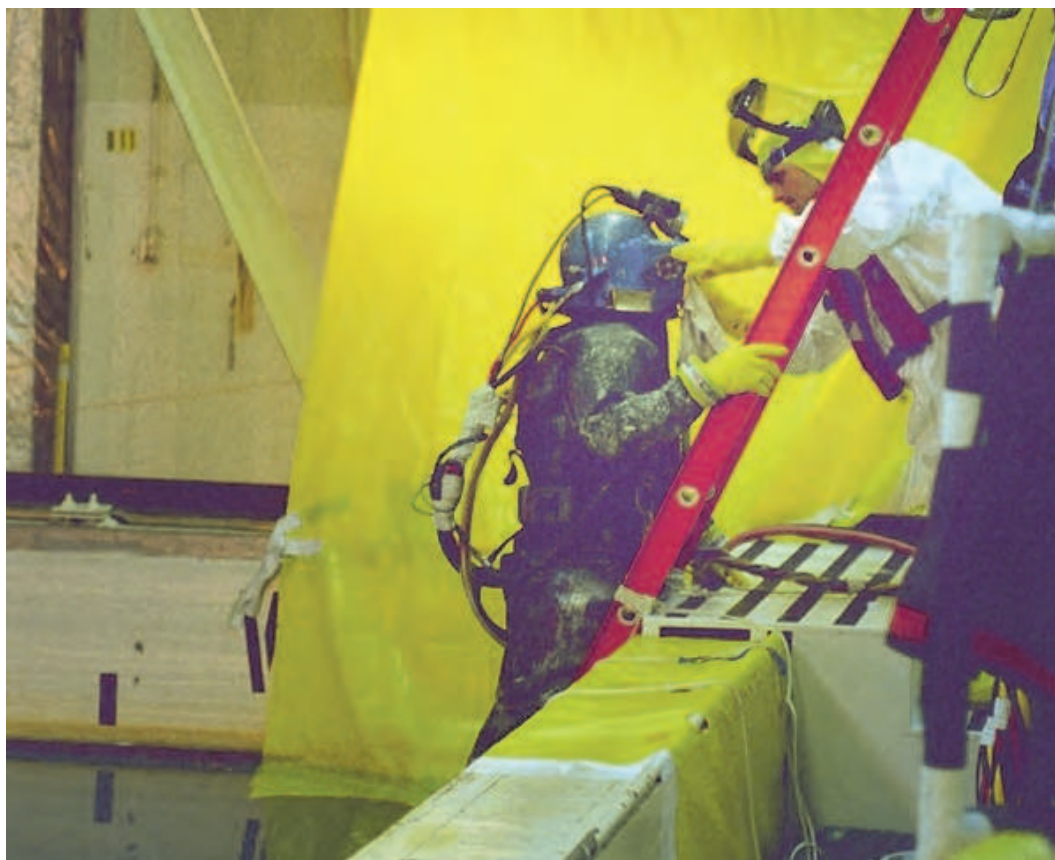
Fig. 1. Diver at INL completing entry into basin for underwater cleaning and coating.

The first half-hour dive provided several important indications that a successful project was underway. A splash curtain was installed along the area where the diver entered and exited the water, and the wipe down and doffing took place within this area. The diver was rinsed

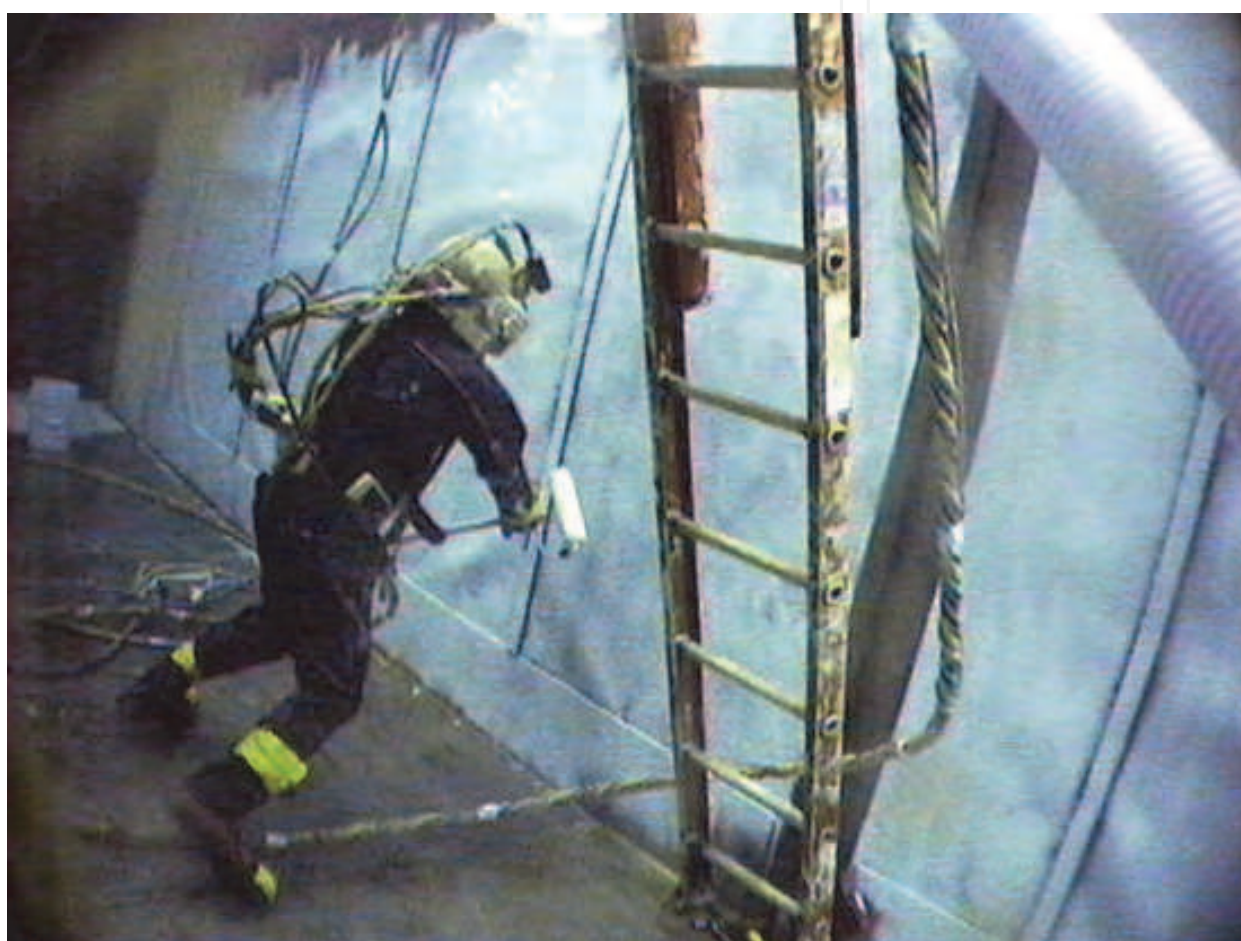
A special type of paint roller system was used for underwater application of the epoxy coating, which is shown being applied underwater in Figure 2. The system had two separate pumps for the epoxy resin and hardener, which were pumped through separate hoses to a mixing manifold about 1.5 m from the roller. The roller/extruder system was flexible up to that point, and like a solid wand from there to the roller head.

Fig. 2. Special two hose roller system used for wall coating at the MTR pool.

- Epoxy coatings may have complicated application requirements. Ensure that the manufacturer has optimized viscosity for roller application and that temperature requirements are met. Use a two-hose application system if possible.

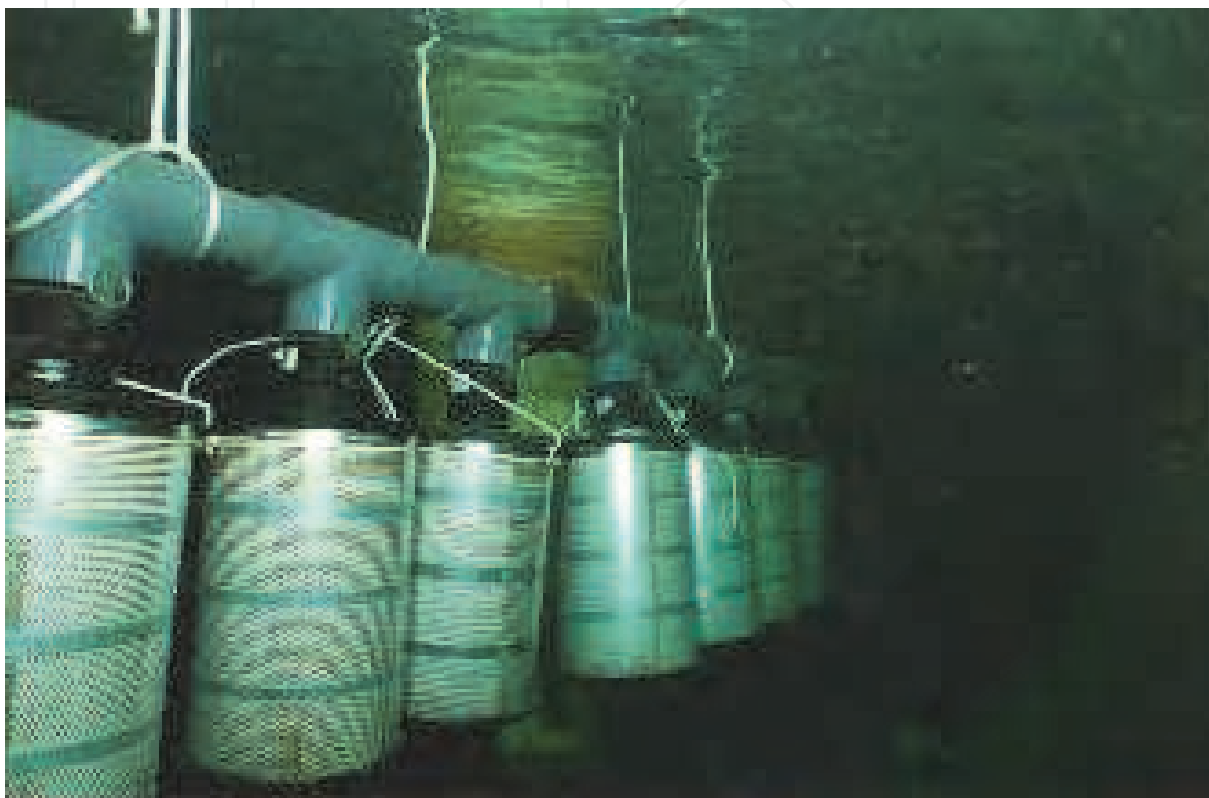
Fig. 4. UCC vacuuming filtration system underwater manifold.
