Intraoperative Imaging in Aortic Valve Surgery as a Safety Net

Kazumasa Orihashi
Kochi Medical School
Japan

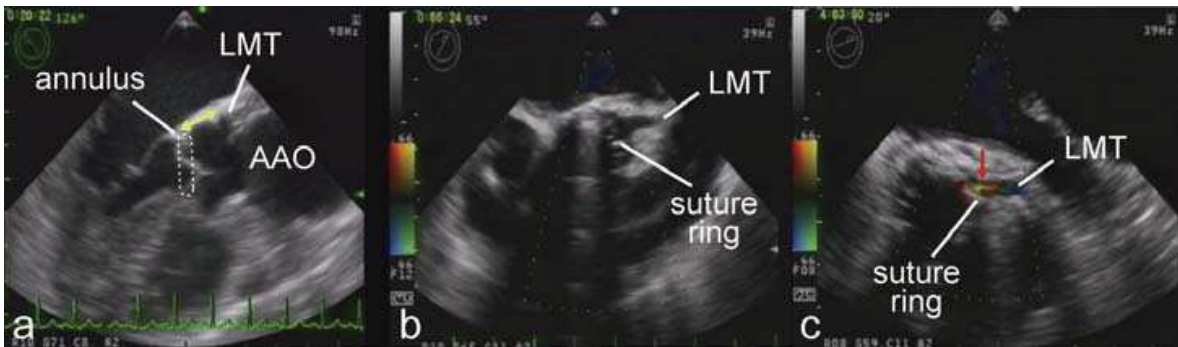
Fig. 9. Aortic valve replacement and coronary artery. a: Distance between the annulus and left coronary orifice is measured. b: no obstruction of left coronary orifice. c: accelerated flow in front of the left coronary orifice, suggesting the presence of narrowed space. AAO: ascending aorta, LMT: left main truncus

In midesophageal aortic valve long-axis view, the ostium is located and placement of prosthetic valve is simulated (Fig. 9a). During weaning from cardiopulmonary bypass, the coronary ostium is checked for obstruction. While there is no obstruction in Fig. 9b, acceleration of flow is noted in Fig. 9c. In the latter case, even a small pannus formation can

occlude the left coronary artery ostium. This intraoperative TEE assessment would be the last chance for confirming the exact spatial relationship between the coronary ostium and valve prosthesis.
