Fouling in Plate Heat Exchangers: Some Practical Experience

Ali Bani Kananeh and Julian Peschel
*GEA PHE Systems
Germany*

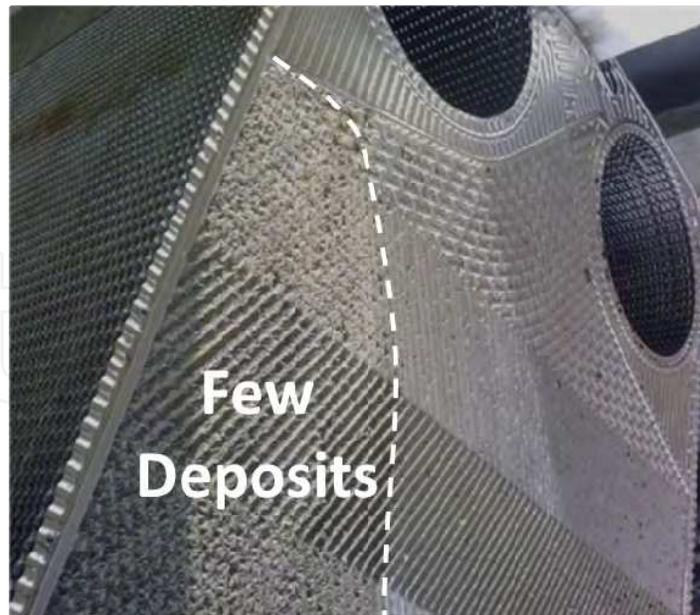
Fig. 8. Deposits formed on the surface of NT-plate.

Fewer deposits were accumulated on the NT-plates due to the asymmetric flow distribution over the channels as can be seen in Figure 8. These deposits were formed because the unit was taken into operation in parallel with the old two VT-plates units and hence most of the cooling water was flowing inside them. The NT-plates unit was designed in principle to replace one of the VT-plates units so that the gap velocity could be increased.

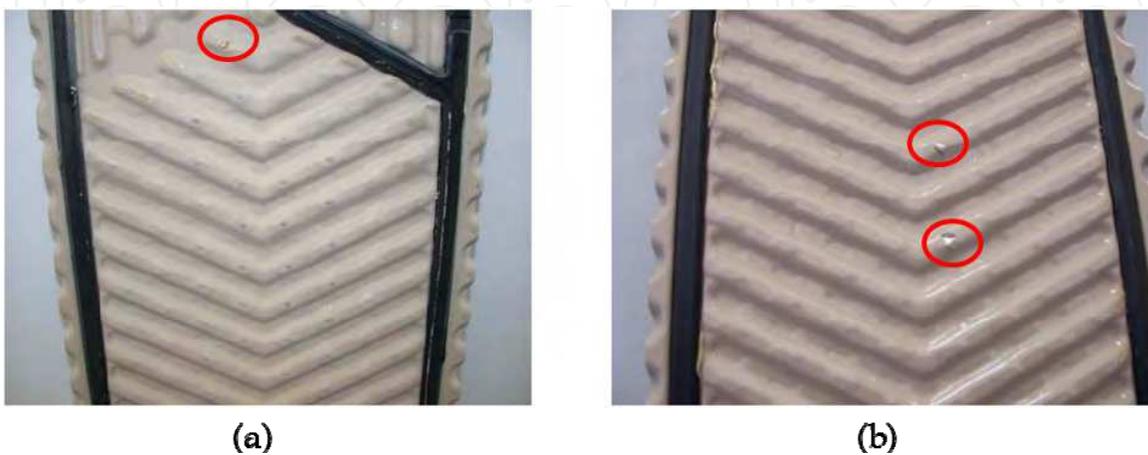
Fig. 14. Coated heat exchanger plates from heating section: (a) A2 coating, (b) A10 coating.

Figure 14 shows photographs for two different coated plates from the heating section in the heat exchanger after different experimental runs (A2 on left and A10 on right).

It is evident that the coatings have been locally destroyed at the contact points, as pointed by the red circles in the figure. The flow in the plate gap causes relatively high vibrations with particularly strong stresses to the contact points, which is added to the high thermal stresses. The coatings at the present stage of development could not withstand these stresses and need further development.
