# Nondestructive Evaluation of FRP Strengthening Systems Bonded on RC Structures Using Pulsed Stimulated Infrared Thermography

Frédéric Taillade, Marc Quiertant, Karim Benzarti,  
Jean Dumoulin and Christophe Aubagnac  
*Université Paris-Est, IFSTTAR, F-75015 Paris  
France*

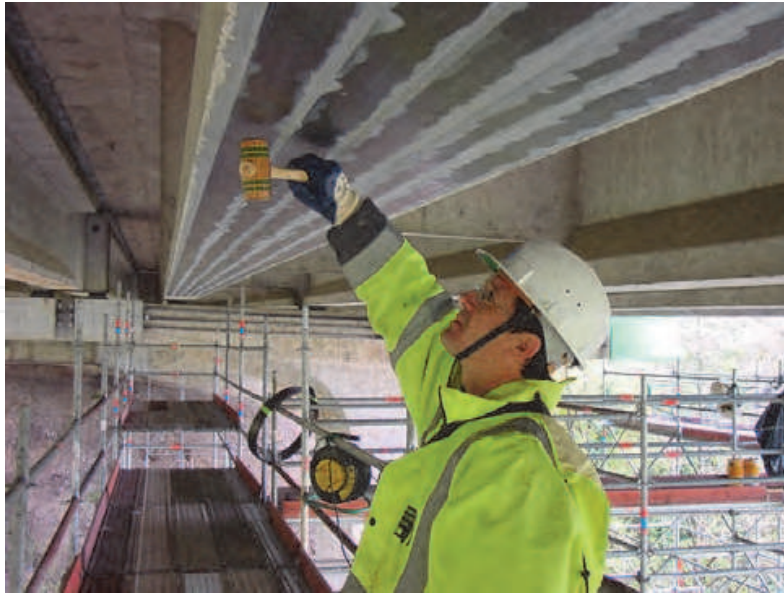
Fig. 1. Inspection with acoustic sounding (hammer tapping).

Visual inspection and acoustic sounding (hammer tapping) are commonly used to detect delaminations (disbonds) (Fig.1). However, these current practices are unable to provide relevant information about the depth (in the case of multilayered FRP systems) and width of debonded areas and they are not capable of evaluating the level of adhesion between the FRP and the substrate (partial delamination, damage or poor mechanical properties of the polymer adhesive). Adherence properties of FRP systems installed on concrete substrates can be evaluated by conducting on site pull-off adhesion tests on witness panels specifically bonded on test zones (Fig.2).

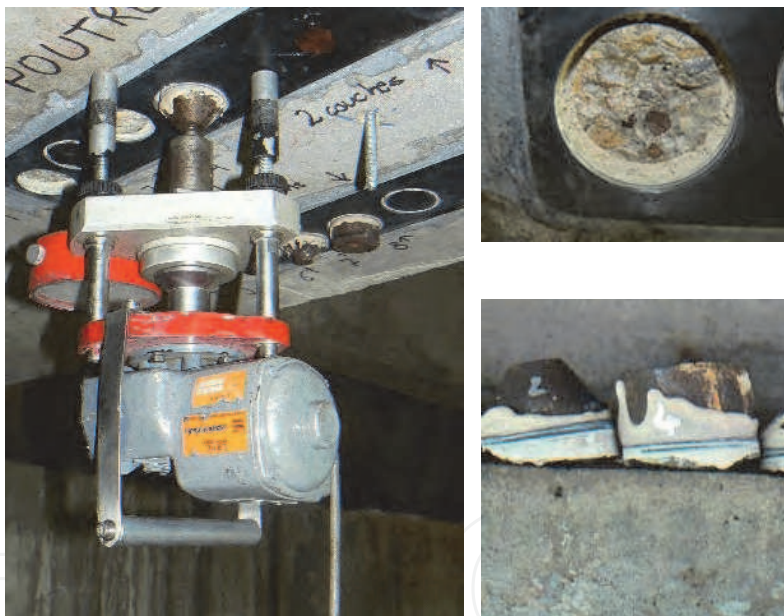
Fig. 2. Pull-off method.

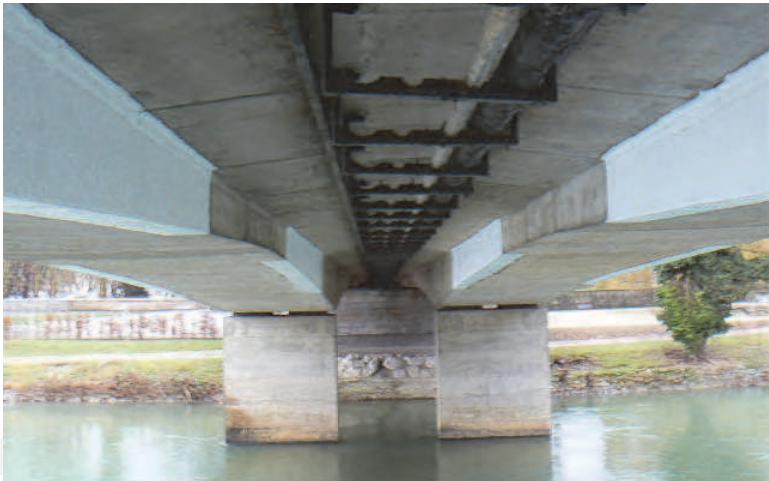
Fig. 17. View of the bridge under consideration; FRP repaired zones correspond to the white parts on the girders.

In order to prevent brittle failure at mid-span, it was decided to repair the cracked box-girders by bonding carbon fibre sheets according to the wet lay-up process (onsite impregnation). A recalculation of the structure was performed in order to optimize the repair design with respect to the shear stress distribution. Finally, composite reinforcements were installed at the outer side of the web of girders as shown in figure 17.

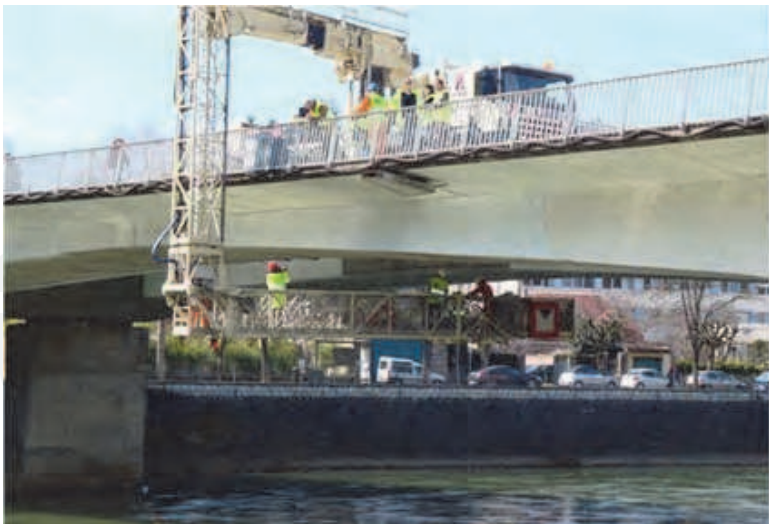
Fig. 18. Inspection operations.

Such a simple set-up offers a fully portable real-time assessment system. The main difficulty of the inspection was the accessibility to the FRP bonded areas, which was resolved by using a truck mounted lift-platform (Fig. 18).
