# **Economic Feasibility Study of Canal Plastic Lining in the Aral Sea Basin**

Inna Rudenko, Sanaatbek Salaev,  
Sanjar Davletov and Ruzumboy Eshchanov

<http://dx.doi.org/10.5772/59101>

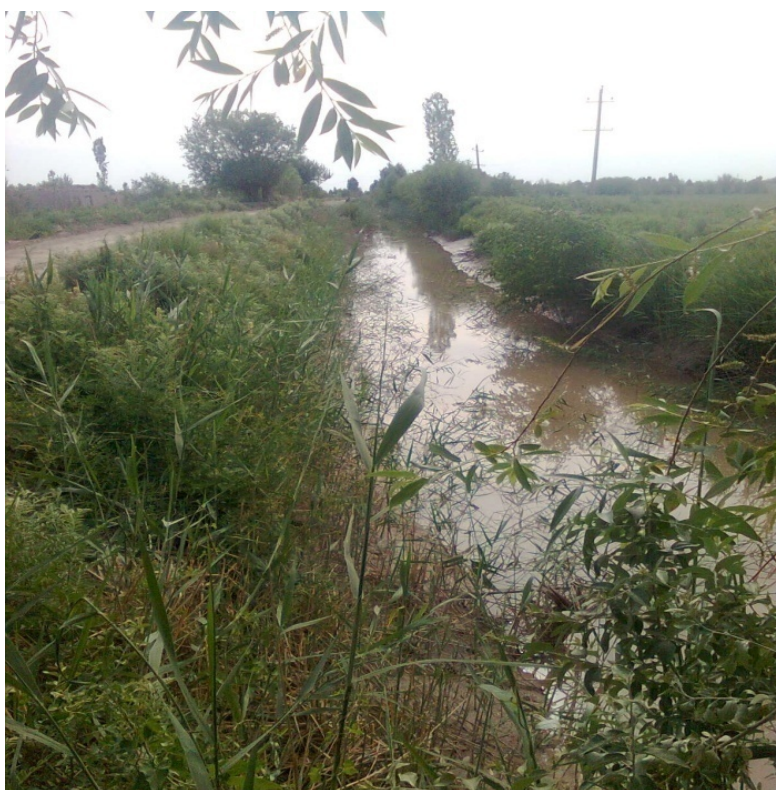
**Figure 1.** Appearance of the channel prior to plastic lining

The selected channel, 2.6 km long, provided irrigation water to 400 ha of farm land and had the discharge capacity of 1.5-2 m<sup>3</sup> per second. The average performance ratio hardly reached 0.49, meaning that 51% of water in the channel was lost due to seepage and infiltration.

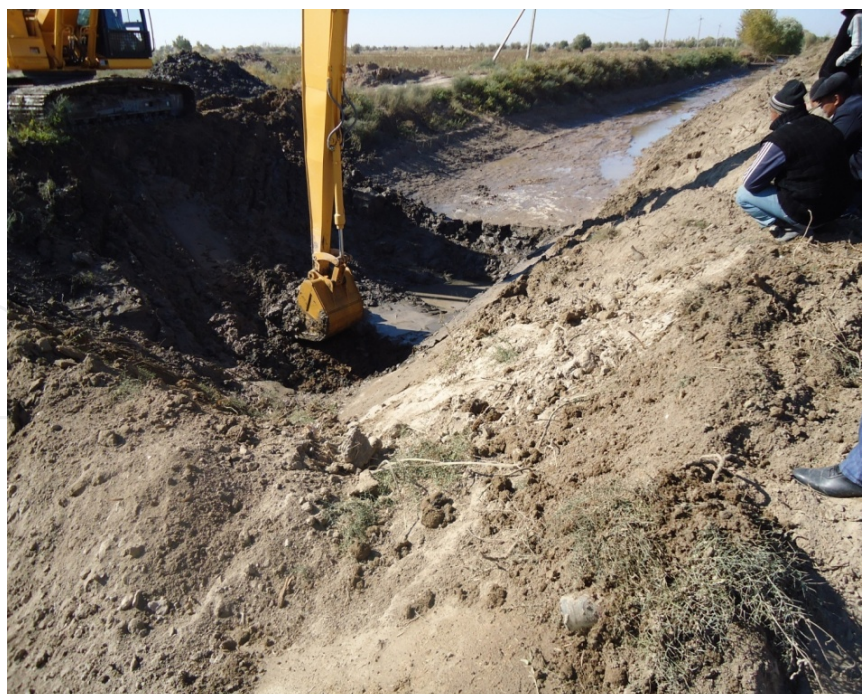
**Figure 2.** Cleaning the bottom and the banks of the channel

When applying the technology an area slightly larger than the banks and bottom of the canal was cleaned and excavated of soil. Prior to excavation works the channel was checked for elevation with the use of special leveling laser tools as to ensure gravity flow of water after plastic lining. Approximately 10 to 15 cm of sand was placed as a base on the cleaned bottom of the channel (refer to the photos). The plastic was laid on top of the sand. The plastic was then covered by up to 0.5 m layer of compacted soil to keep the plastic in place, and prevent exposure to the sun.

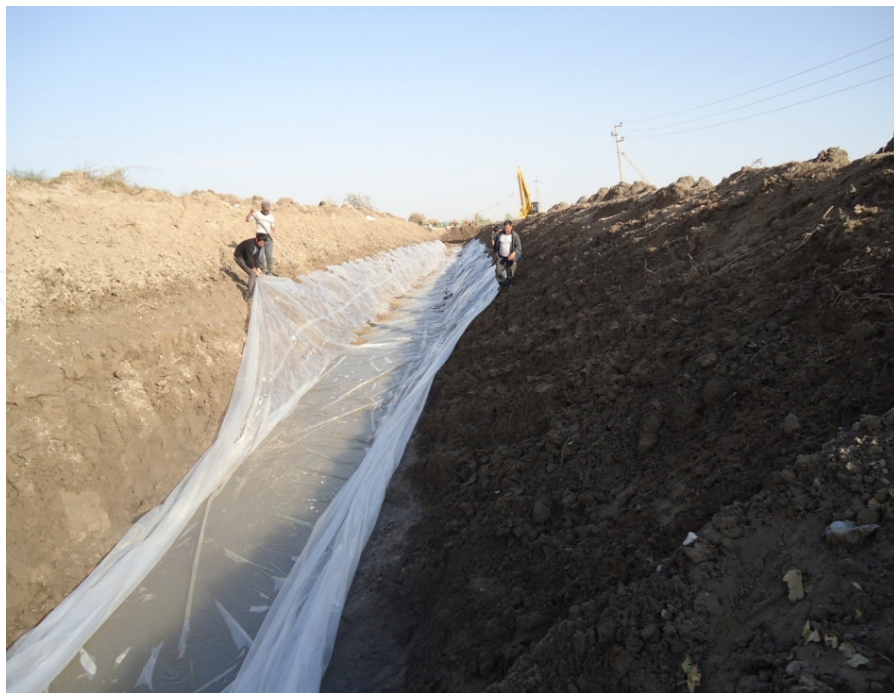
**Figure 3.** Lining of plastic

Specifications of the plastic liner included 100  $\mu\text{m}$  thickness, 7 m wide, and elasticity of 250%. Such plastic is locally available and is usually and widely used by the rural population to cover the temporary greenhouses for year round production of vegetables and green vegetables. The

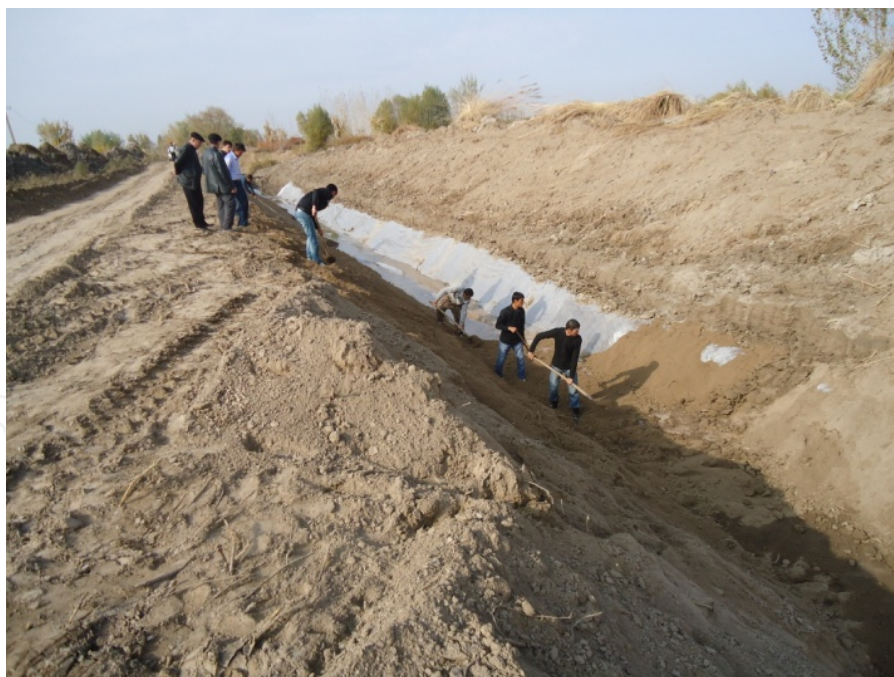
**Figure 4.** Covering of plastic with compacted soil

plastic laid at the bottom of the channel can last up to 50 years given the proper coverage by compacted soil and non-exposure to the UV sun rays.

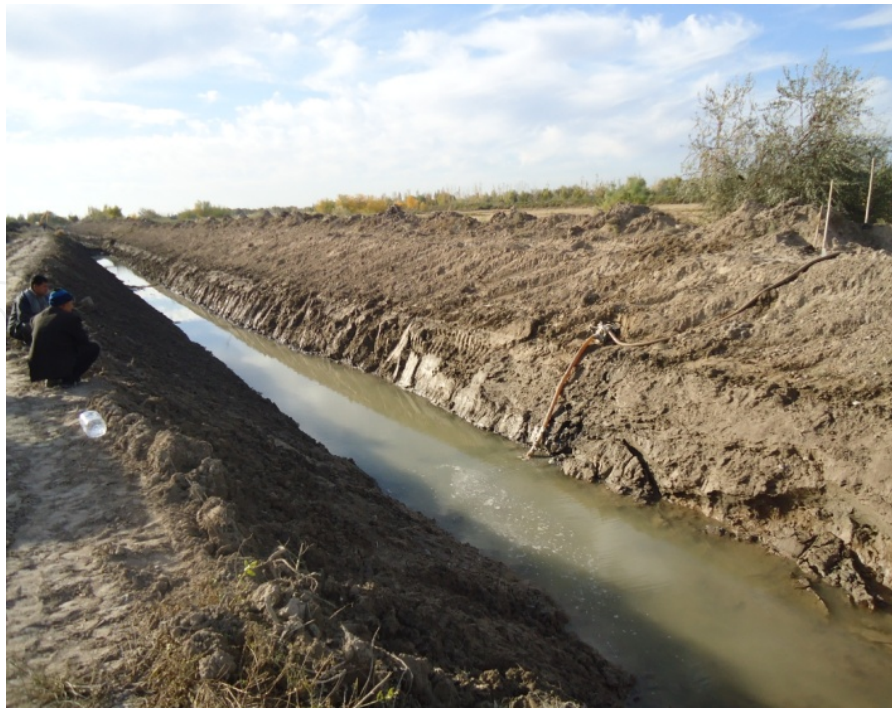
**Figure 5.** Gravity flow of water in the plastic lined channel

Concurrent with application of plastic liner, fields irrigated from the selected channel were lazer leveled to improve gravity flow. The combination of enhanced gravity flow and water saved resulted in less use of mechanized pumps.

Another major achievement was the gravity flow of water in the lined channel due to leveling measures. Gravity flow allowed the farmers to stop using pumps for delivering water both to the tail end of the channel and to the fields with higher elevation levels compared to the channel. Thus, the farmers could save enormous financial resources for electricity or diesel, not talking about the benefits to the environment.
