The Structural Performance of Stone-Masonry Bridges

George C. Manos, Nick Simos and
Evaggelos Kozikopoulos

Abstract

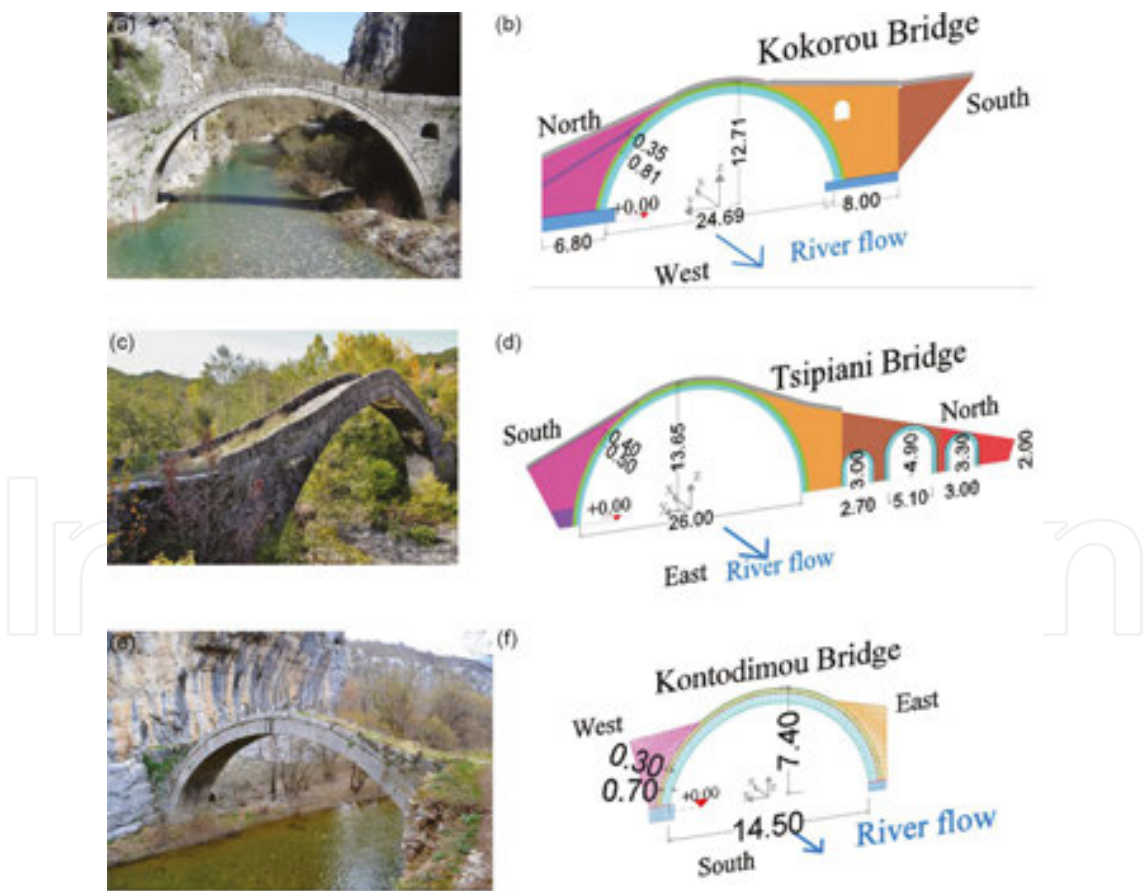
Figure 8. (a) and (b) Kokorou stone bridge, Kipoi Village, East Zagori, Ipiros (width 2.85 m); (c) and (d) Tsipianis stone bridge, Milotades Village, East Zagori, Ipiros (width 2.80 m); (e) and (f) Kontodimou stone bridge, Kipoi Village, East Zagori, Ipiros (width 2.77 m).

Apart from the Plaka and Konitsa stone bridges, three more bridges will be examined in the present study. These stone bridges are depicted in **Figure 8a–f** and are namely the Kokorou Bridge, the Tsipianis Bridge and the Kontodimou Bridge. As can be seen in **Figure 8b and d**, the main central arch of the Kokorou Bridge has a clear span of 24.69 m and a rise of 12.71 m, whereas the Tsipianis Bridge has a clear span of 26.00 m and the rise 13.65 m. As can be seen, the central main arch of these two bridges has similar dimensions. Finally, the clear span of the Kontodimou Bridge is 14.50 m and the rise 7.40 m.

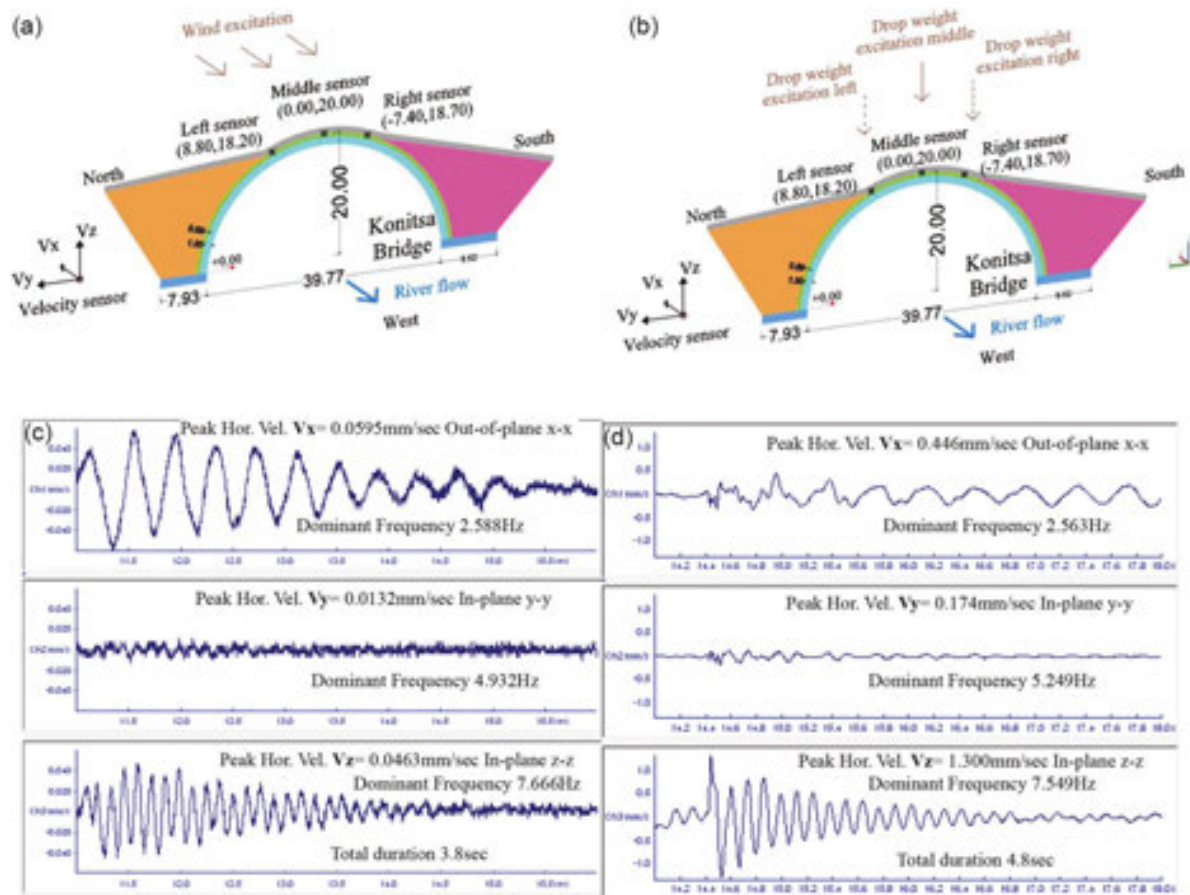
Figure 15. (a) Konitsa Bridge: wind excitation; (b) drop weight excitation; (c) vibration measurements from wind excitation recorded by the triaxial velocity sensor located at the crown of the Konitsa Bridge; and (d) vibration measurements from drop weight excitation at the crown of the bridge recorded by the triaxial velocity sensor located at the middle of the Konitsa Bridge.

vertical vibrations and exciting the in-plane eigen-modes of each structure that could be captured by the employed SysCom triaxial velocity sensors with a sensitivity of 0.001 mm/s and a SysCom data acquisition system with a sampling frequency of 400 Hz. All the obtained data were subsequently studied in the frequency domain through available FFT software. In **Figure 15c**, the velocity measurements are depicted along the three axes (x - x horizontal out-of-plane, y - y horizontal in-plane and z - z vertical) as they were recorded during a typical sampling with the wind excitation. In **Figure 15d**, the velocity measurements are again depicted along the three axes (x - x horizontal out-of-plane, y - y horizontal in-plane and z - z vertical) as they were recorded during a typical sampling with the drop weight excitation. As can be seen, the drop weight excitation could produce at the dominant frequencies vibrations at least one order of magnitude larger than the wind excitation. From these measurements, an attempt was also made to obtain an estimate of the damping ratio for the dominant in-plane and out-of-plane frequencies. As is depicted in **Figure 16a** for the wind excitation, the main symmetric out-of-plane vibration that is excited by the wind has a dominant period of 2.539 Hz and a corresponding damping ratio approximately 1.7%. Similarly, as is depicted in **Figure**

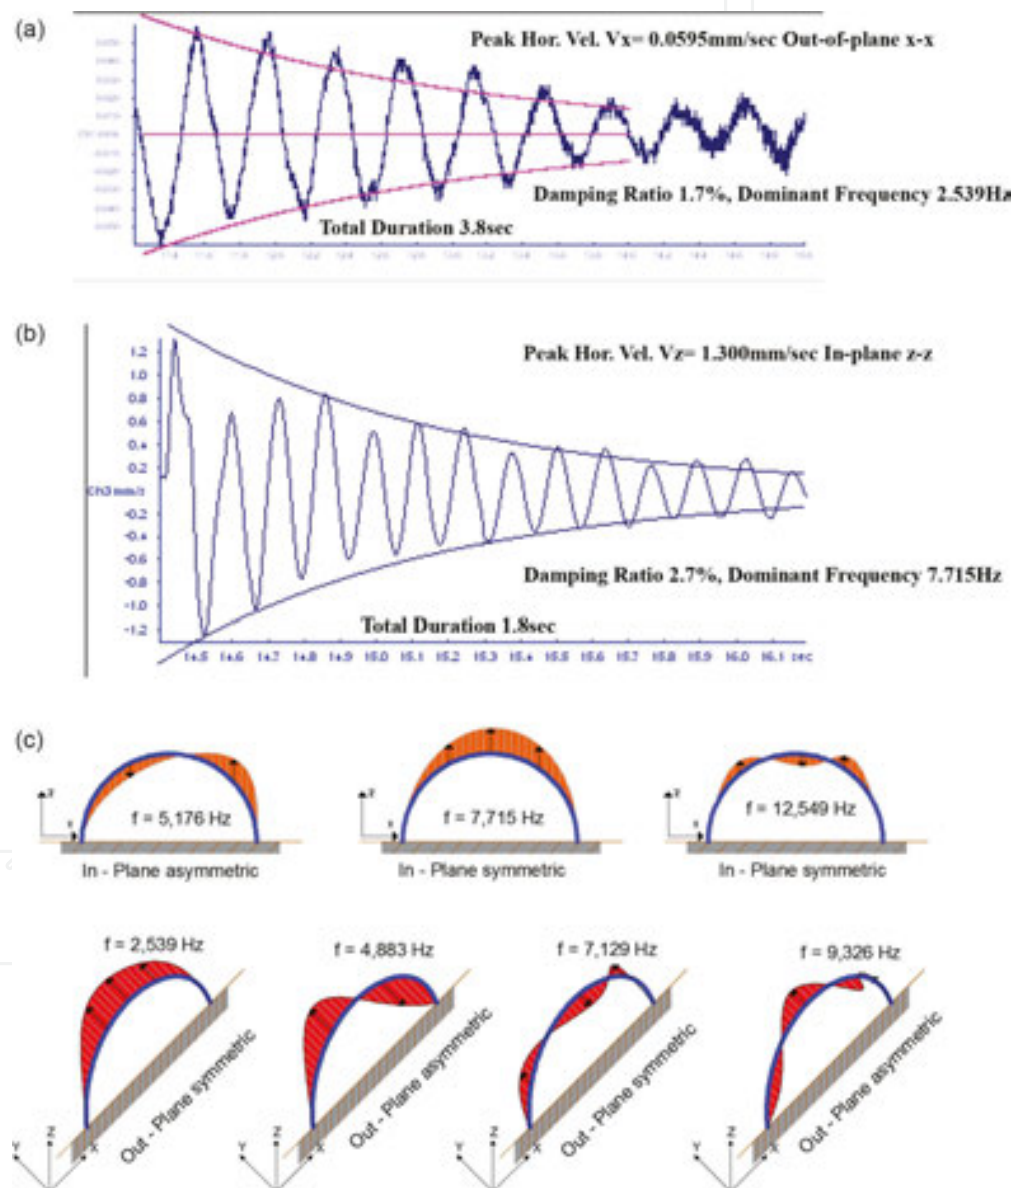
Figure 16. (a) Vibration measurements from wind excitation obtained from the triaxial velocity sensor located at the middle of the Konitsa Bridge; (b) vibration measurements from drop weight excitation at the middle of the bridge obtained from the triaxial velocity sensor also located at the middle of the Konitsa Bridge; and (c) measured eigen-frequencies and corresponding eigen-modes for the Konitsa Bridge.

16b for the drop weight excitation, the main symmetric in-plane vibration that is excited by the drop weight has a dominant period of 7.715 Hz and a corresponding damping ratio approximately 2.7%. This increase in the damping ratio value for this latter dominant frequency must be attributed to the relatively larger amplitudes of vibration that are produced from the drop weight excitation than from the wind excitation, as already underlined. All vibration measurements of the dynamic response of the Konitsa Bridge for either type of excitation were utilized to extract the eigen-frequencies depicted in **Figure 16c** together with the approximate shape of the corresponding eigen-modes.

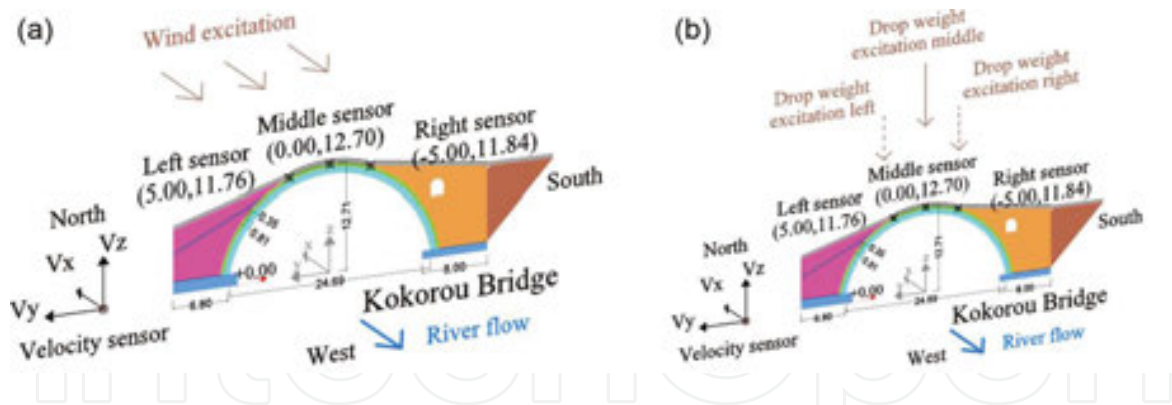
Figure 17. Kokorou Bridge: (a) wind excitation and (b) drop weight excitation.

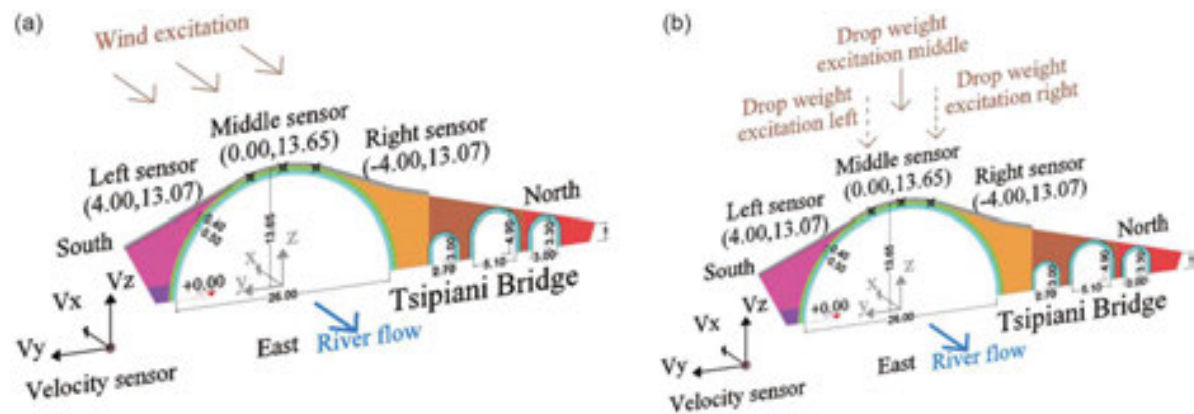
Figure 18. Tsipianis Bridge: (a) wind excitation and (b) drop weight excitation.

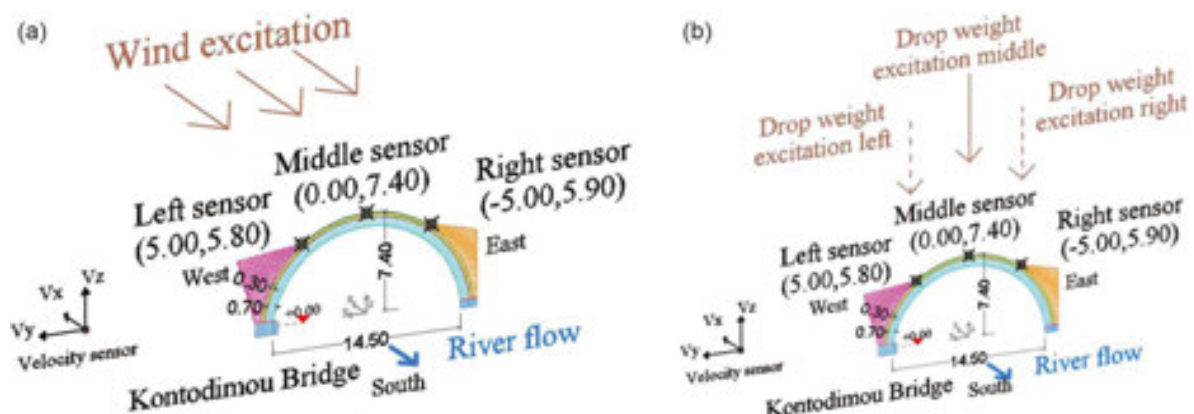
Figure 19. Kontodimou Bridge: (a) wind excitation and (b) drop weight excitation.

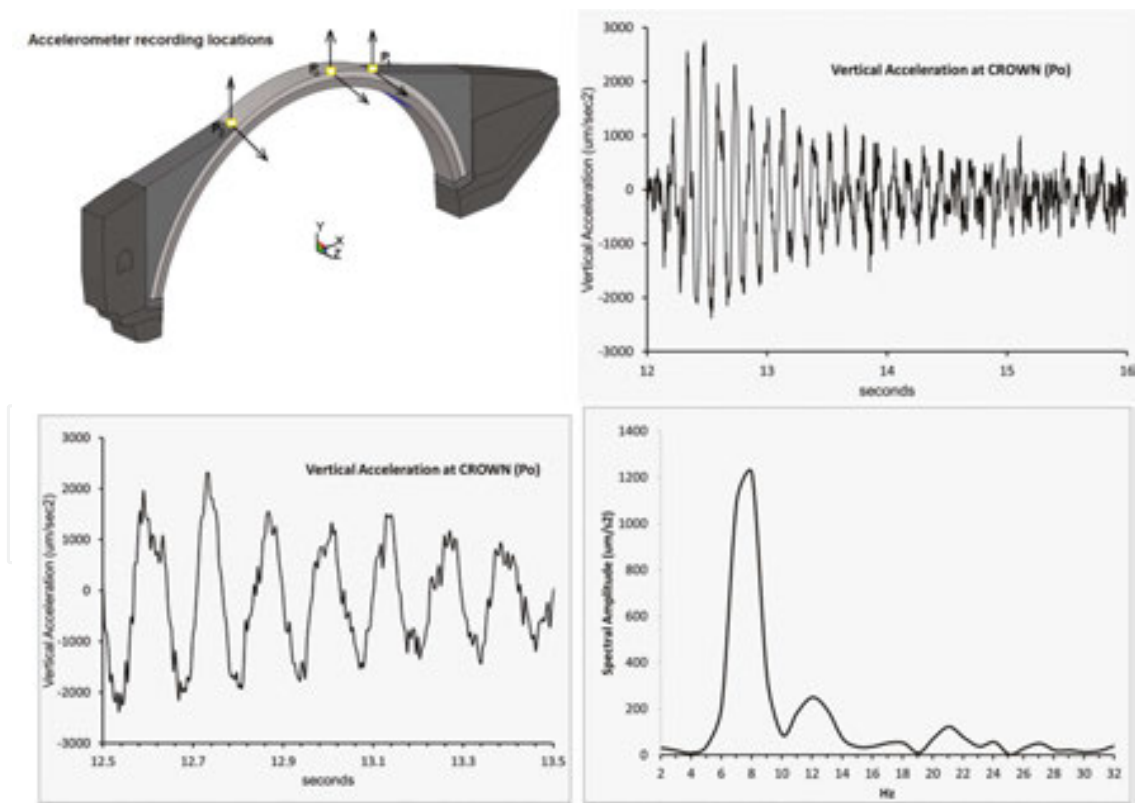
Figure 21. Decay segment of acceleration trace (vertical) and the corresponding power spectrum (7.75 Hz, damping ratio estimate of 1.6%).

Shown in **Figure 21** are the post-wind gust bridge response (vertical acceleration) and the corresponding power spectrum associated with the trace segment between 12 and 16 s of the record [4]. The power spectrum associated with the decay segment clearly delineates (a) the symmetric vertical mode (7.75 Hz).

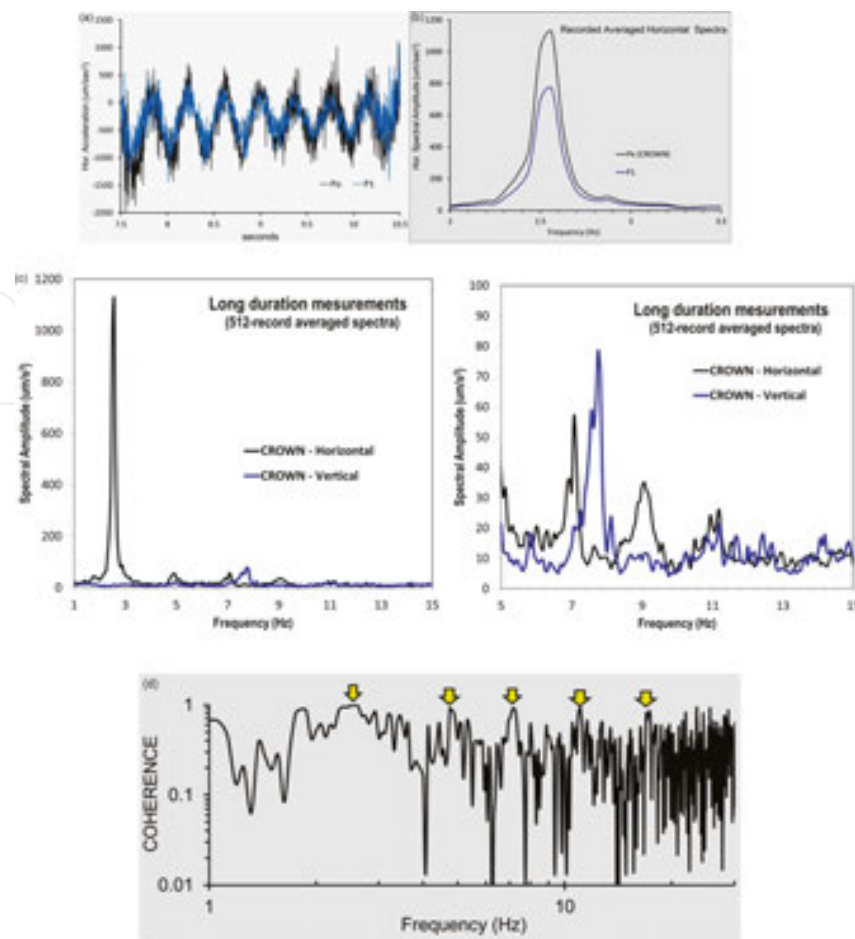
Figure 22. Horizontal (out-of-plane) acceleration time histories recorded simultaneously at two locations on the Konitsa Bridge deck. (a) Entire trace including high wind effects; (b) post-wind free vibration. Dominant frequency of 2.56 Hz; (c) recorded vertical and horizontal spectra at crown averaged over 512 records; (d) coherence measurements between P_0 and P_1 locations aiding mode identification (arrows indicate 100% coherence characteristic of the structure modes).

Figure 22 depicts the horizontal (out-of-plane) acceleration time histories recorded simultaneously at two locations on the Konitsa Bridge deck and their corresponding power spectrum with dominant frequency of 2.56 Hz (first out-of-plane eigen-mode). Comparing the eigen-frequency values obtained for the *in situ* experiments, reported in Section 4.1 (depicted in **Figures 15** and **16**), with the corresponding values obtained from this independent *in situ* experiments (depicted in **Figures 21** and **22**), very good consistency can be observed. **Figure 22c** and **b** depict the FFT-averaged Fourier spectral curves that formed the base together with the coherence plot of **Figure 22d** to identify with confidence the eigen-frequency values [9].

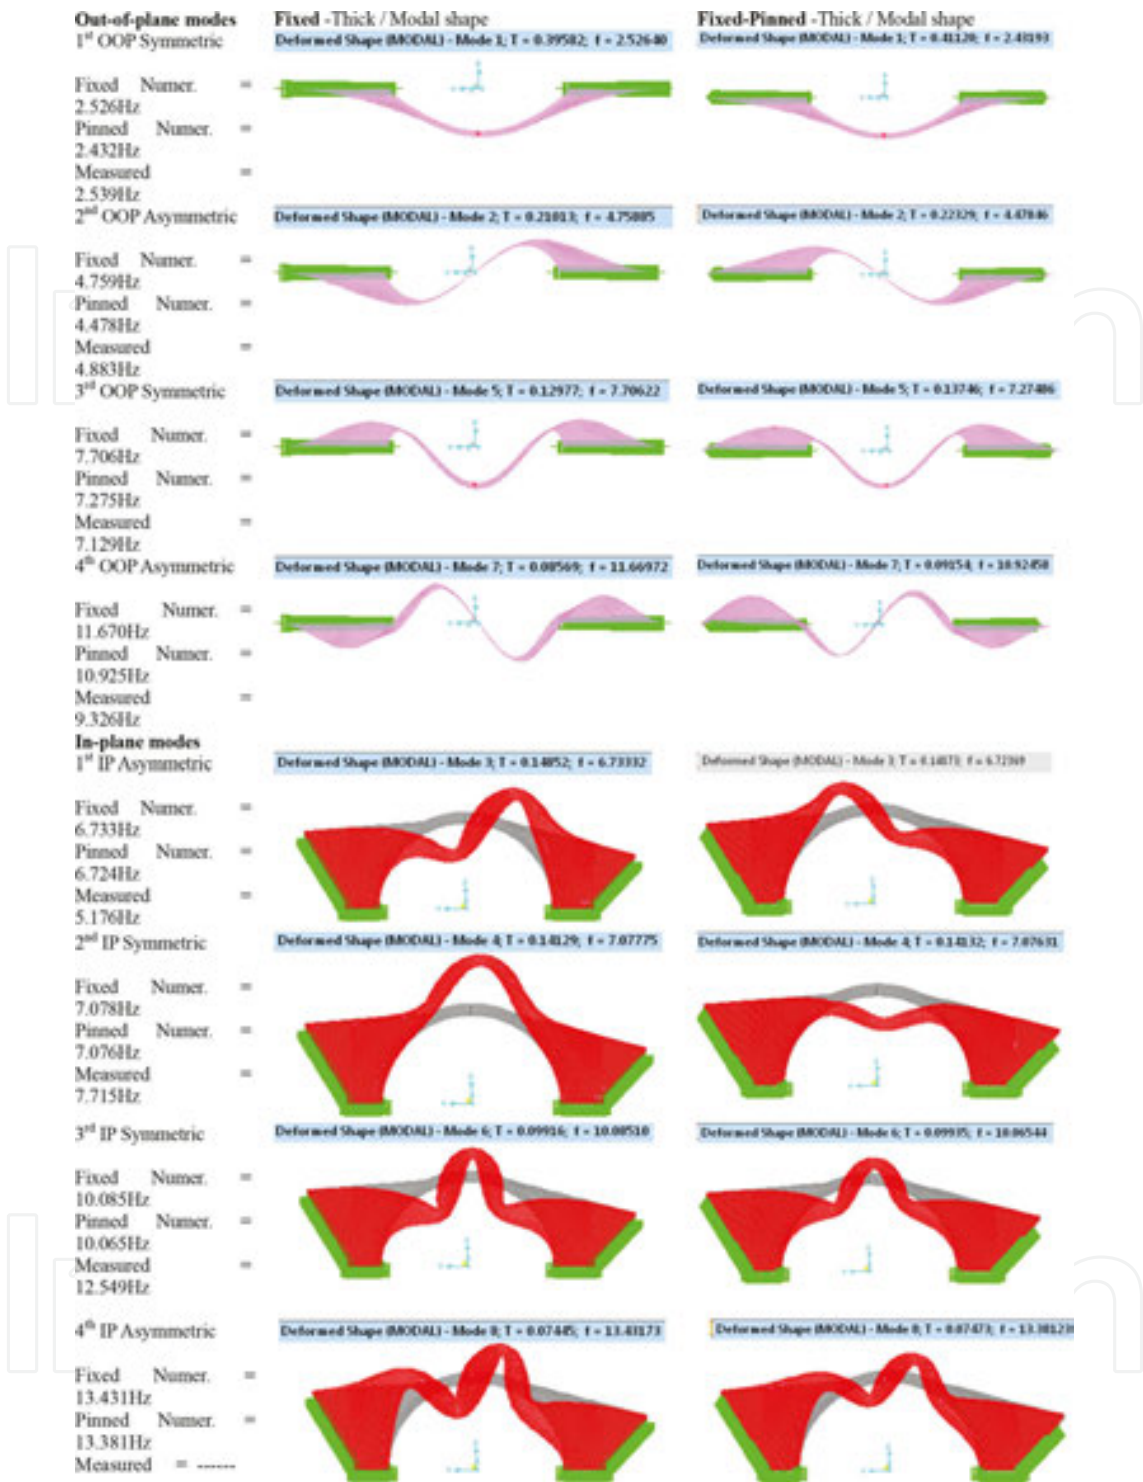
Figure 24. Numerical and observed eigen-values for the *Konitsa Bridge*. $E_{\text{masonry}}=4000\text{MPa}$, $E_{\text{contact}}=2000\text{MPa}$. Bending Stiffness Modifiers = 3.0.

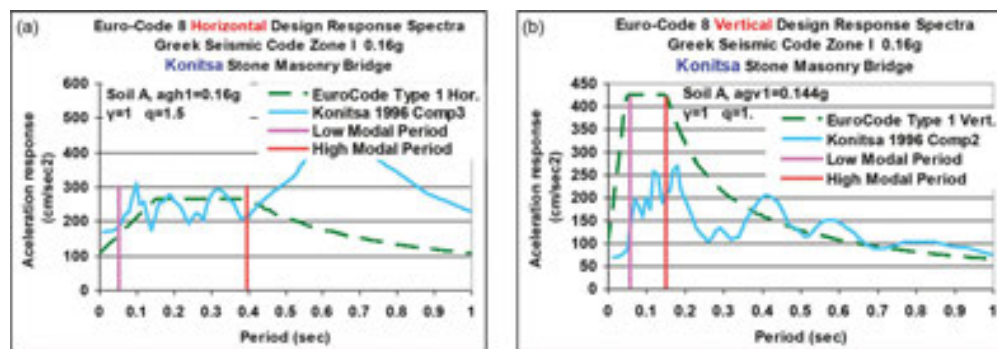
Figure 26. (a) Horizontal spectral curves for the 1996-Konitsa earthquake and the type-1 Euro-Code and (b) vertical spectral curves for the 1996-Konitsa earthquake and the type-1 Euro-Code.

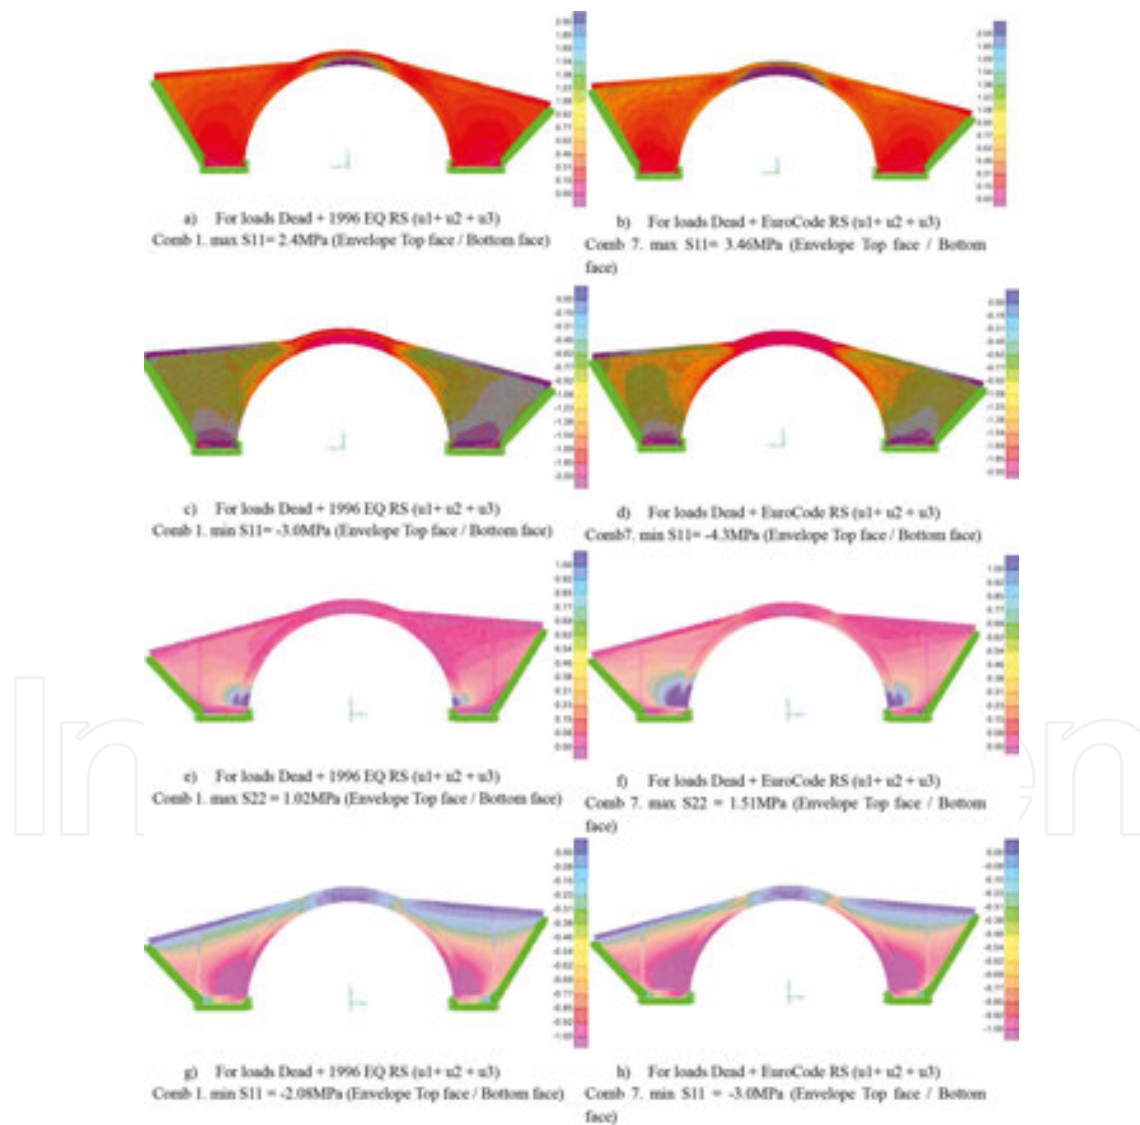
Figure 28. State of stress through the distribution of stresses S_{11} and S_{22} for Konitsa Bridge.

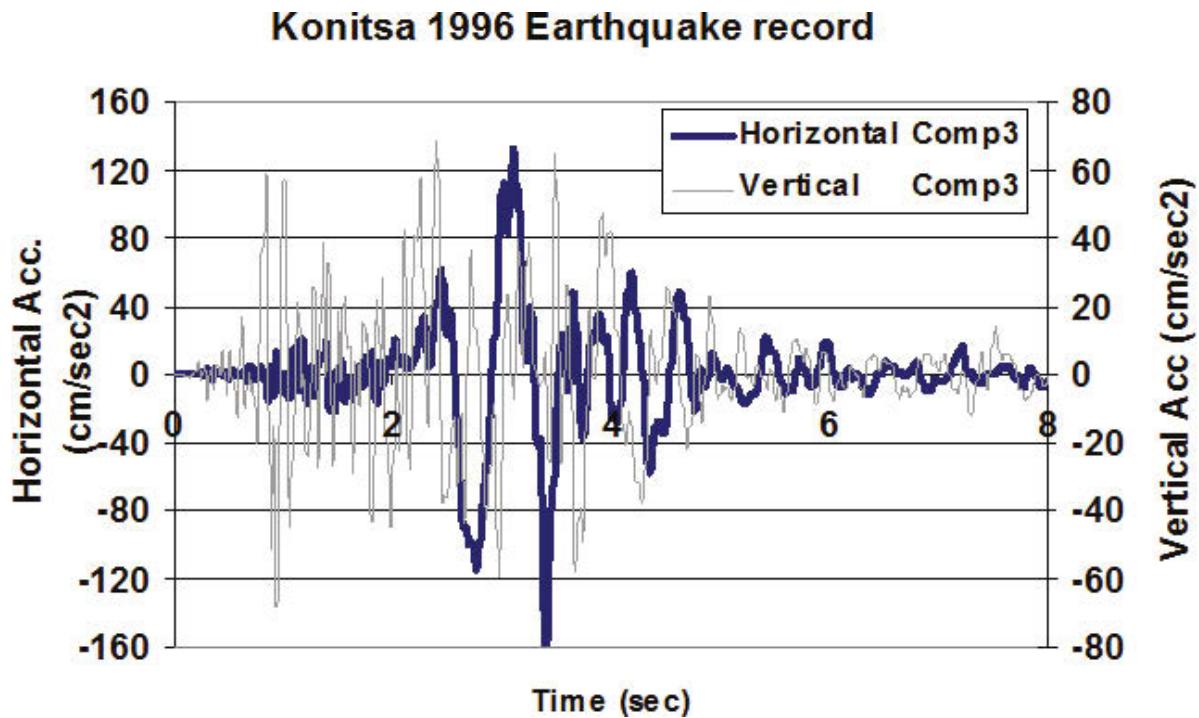
Figure 29. The first eight (8) most intense seconds of the 1996 earthquake record (ITSAK).

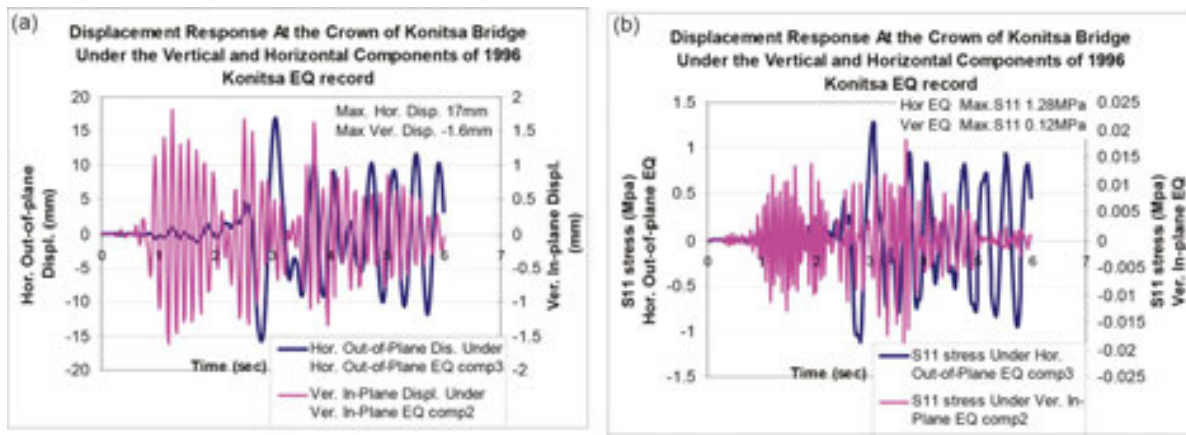
Figure 30. (a) Displacement (Hor. or Ver.) response at the crown of the Konitsa Bridge when subjected to either the horizontal or the vertical component of the Konitsa 1996 earthquake. (b) S11 stress response at the bottom of crown of the Konitsa Bridge when subjected to either the horizontal or the vertical component of the Konitsa 1996 earthquake.

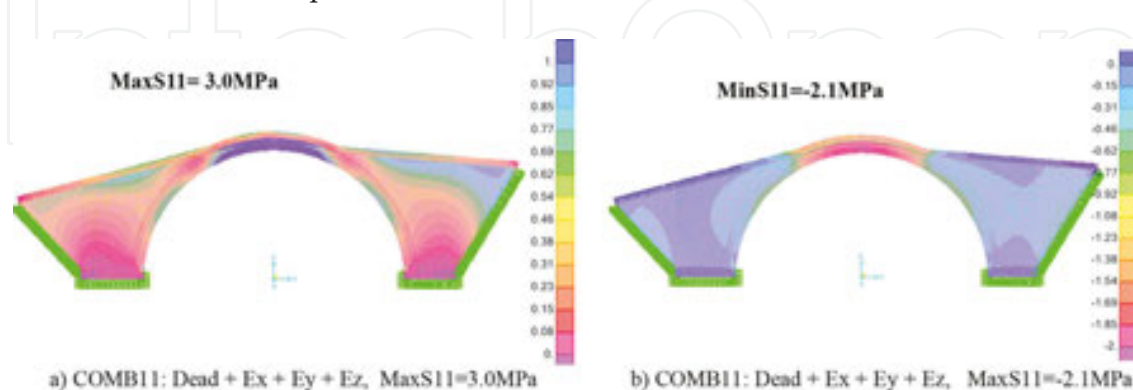
Figure 31. State of stress through the distribution of stresses S11 (envelope) at the bottom fibre of the crown for Konitsa Bridge.

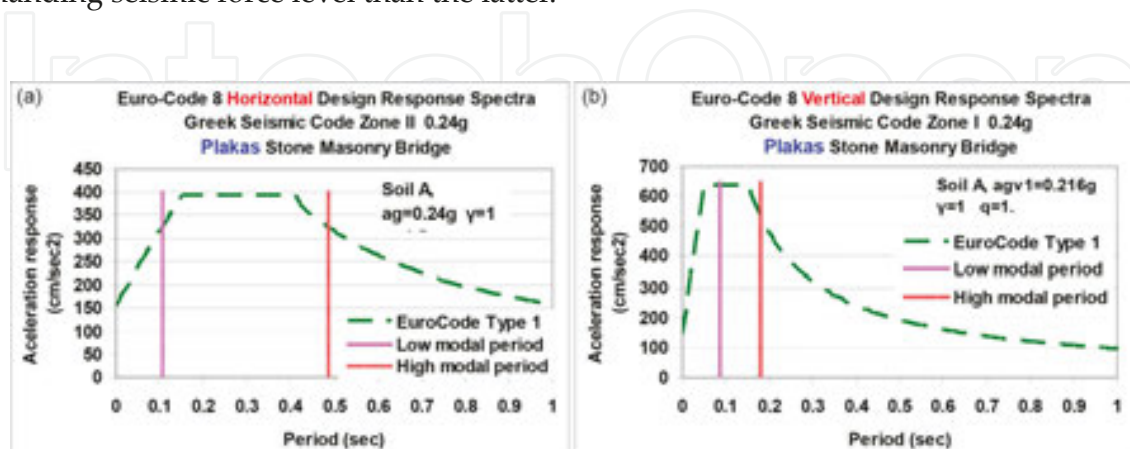
Figure 32. (a) Horizontal spectral curves for type-1 Euro-Code to be applied in Plaka bridge and (b) vertical spectral curves for type-1 Euro-Code to be applied in Plaka bridge.

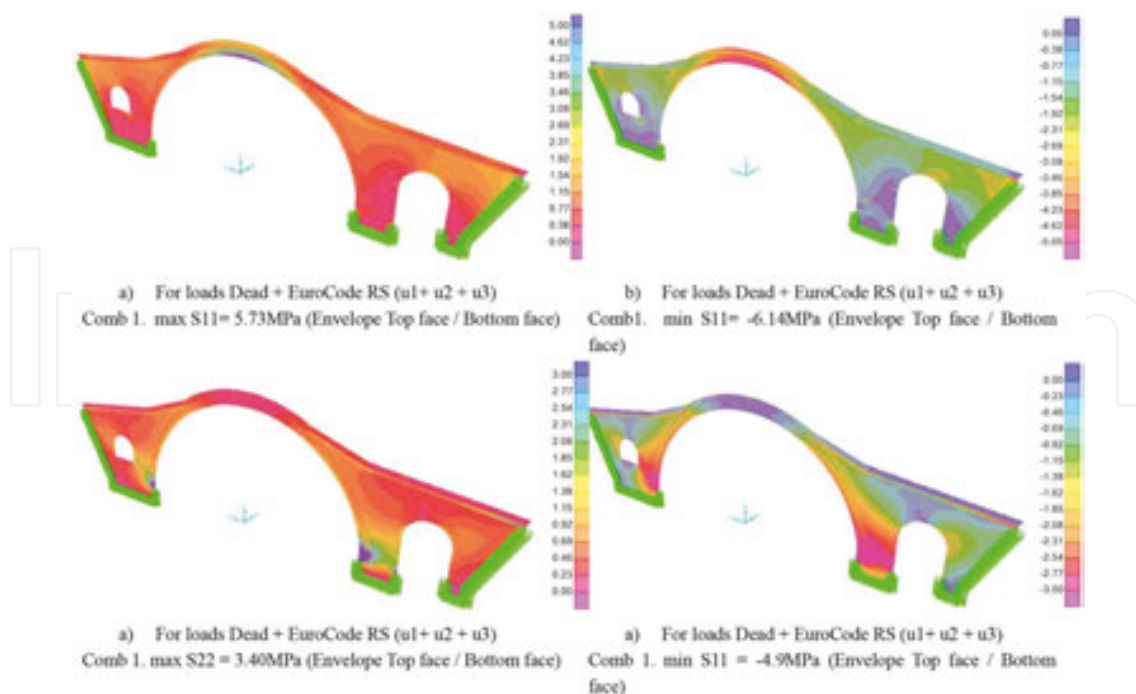
Figure 34. State of stress through the distribution of stresses S_{11} and S_{22} for Plaka Bridge.

provided by Euro-Code. The largest value of tensile stress S_{11} (5.73 MPa, **Figure 34a**) develops at the bottom fibre of the crown of the arch. This relatively large tensile stress value [11, 16] is exceeding by far the tensile capacity of traditionally built stone masonry. The largest value of tensile stress S_{22} (3.40 MPa, **Figure 34c**) develops at the area where the toes of the primary arch join the foundation block. Again, this is a relatively large tensile stress value and is exceeding by far the tensile capacity of traditionally built stone masonry. Both these remarks indicate locations of distress for the Plaka stone-masonry bridge, as was done for the Konitsa Bridge predicting in this way the appearance of structural damage. On the contrary, the largest value of compressive stress equal to $S_{11} = -6.14$ MPa (**Figure 34d**, for combination 1) could be met by the compression capacity of the stone masonry for this bridge. The maximum tensile stress values that were numerically predicted for Plaka Bridge are approximately twice as large as the corresponding values obtained for Konitsa Bridge. This is due to the seismic forcing levels, which for Plaka Bridge are by 50% higher than those applied for Konitsa ridge. This is because Plaka Bridge is located in seismic zone II (design ground acceleration equal to 0.24 g) whereas Konitsa Bridge is located at seismic zone I (design ground acceleration equal to 0.16 g). Furthermore, although the main central arches of the two bridges are very similar in geometry (with the deck of the Plaka Bridge being somewhat wider than the deck of the Konitsa Bridge), the Plaka Bridge has a much larger total length than the Konitsa Bridge due to the construction of a mid-pier and arches adjacent to the main central arch. Thus, Plaka Bridge is more flexible and has a much larger total mass than the Konitsa Bridge. Based on these remarks, it is reasonable to expect for the Plaka Bridge larger seismic displacement values in the out-of-plane direction and consequently larger tensile stress values, than the corresponding values predicted for the Konitsa Bridge. The final consequence of these remarks is that, according to the

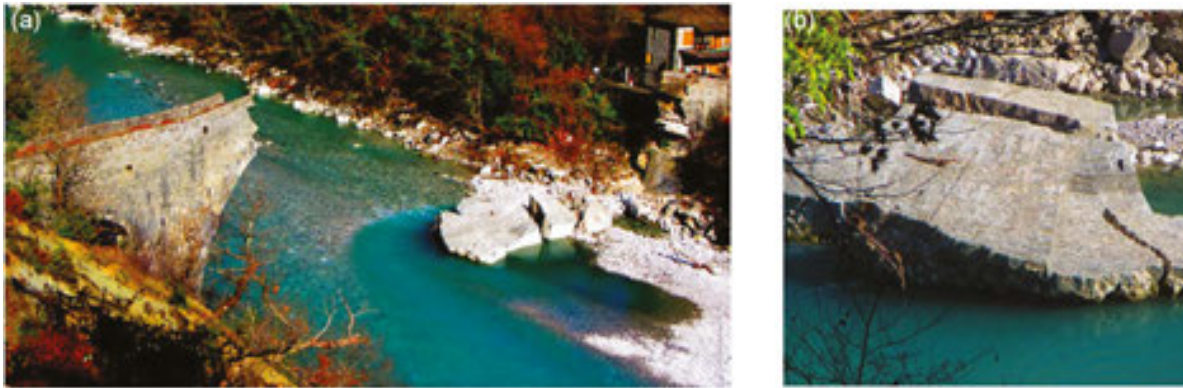
Figure 50. (a) View of the Plaka Bridge after the collapse from the West bank. Note the total destruction of the mid-pier (see also **Figure 7d**). (b) Close-up of the total destruction of the mid-pier of Plaka Bridge (see also **Figure 7d**).

Thus, foundation maintenance seems to be of the utmost importance. The flooding of Arachthos river, which caused the collapse of Plaka Bridge on 31 January 2015, was of considerable proportions. It is of interest to observe the conditions of the mid-pier of Plaka Bridge after the collapse (**Figure 50a** and **b**). As can be seen, the foundation of this pier is almost non-existent being covered by the remains of the East part of central arch and of part of the adjacent arch and mid-pier. Thus, it is evident that this mid-pier was highly distressed leading to this mode of collapse.
