Ductile Behavior of Timber Structures under Strong Dynamic Loads

Maria Cristina Porcu

<http://dx.doi.org/10.5772/65894>

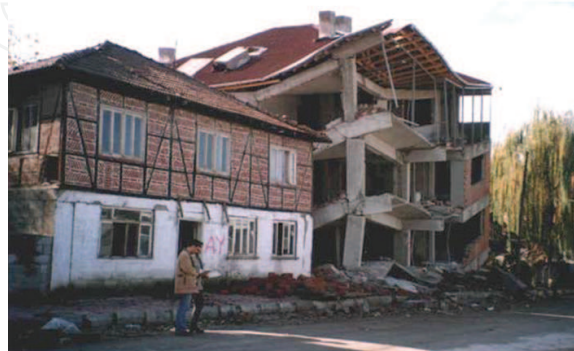
Figure 1. Different damaged conditions of traditional wooden and reinforced concrete buildings after the 1999 Duzce earthquake. Image taken from [6].

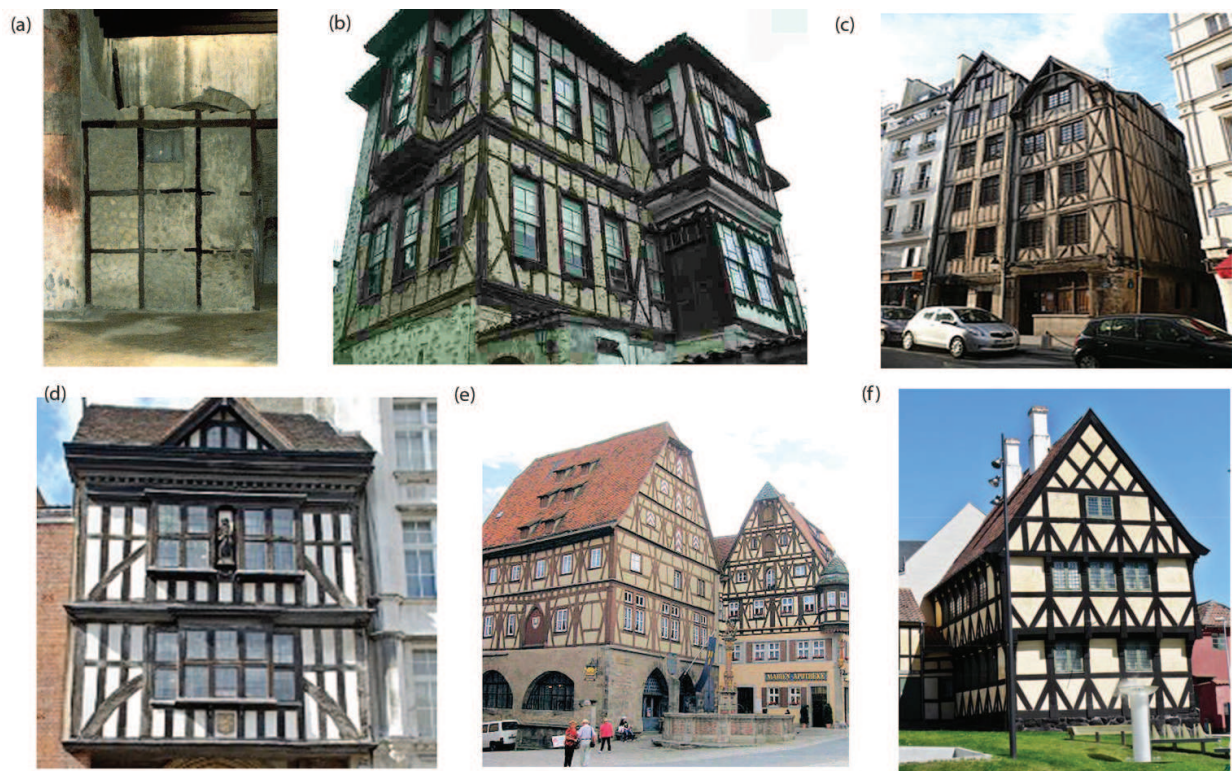
Figure 4. Historical timber-framed masonry buildings: (a) house wall from Herculaneum (opus craticium attested by Vitruvius in the first century BC); (b) nineteenth-century Ottoman house; (c) sixteenth-century timber-frame house in Paris (France); (d) St. Bartholomew's Gatehouse built in London in 1595 and survived to the 1665 great fire; (e) German typical timber-framed houses (Fachwerkhäuser); (f) Anne Hvide's House built in 1560, Denmark.

Constructive systems adopting timber frames with infill masonry (or adobe or stone) may be actually found in different historical periods and geographical areas, starting from one of the most ancient examples still visible: a Roman house of the first century BC in the archeological site of Herculaneum (Italy) (**Figure 4a**). More recent examples are the several well-preserved

Ottoman traditional timber-frame houses (see **Figure 4b**), that may be still found in earthquake-prone areas as Turkey, Balkan countries, Iraq, Siria and Egipt [6, 9, 21]. Likewise the *Pombalino* system, also in the Ottoman houses, the timber frames were introduced from the first floor up (for this reason they are also referred to as half-timbered frames). Further examples of timber-framed buildings (dating back even to the medieval period) may be also found in European countries as Germany, the United Kingdom, Greece, France, Spain, Poland (see e.g. the examples given in **Figure 4c–f**), as well as in India [22, 23], the USA [24], China [25] and Peru [26]. An overview of the history of timber framed buildings may be found for instance in Ref. [32].

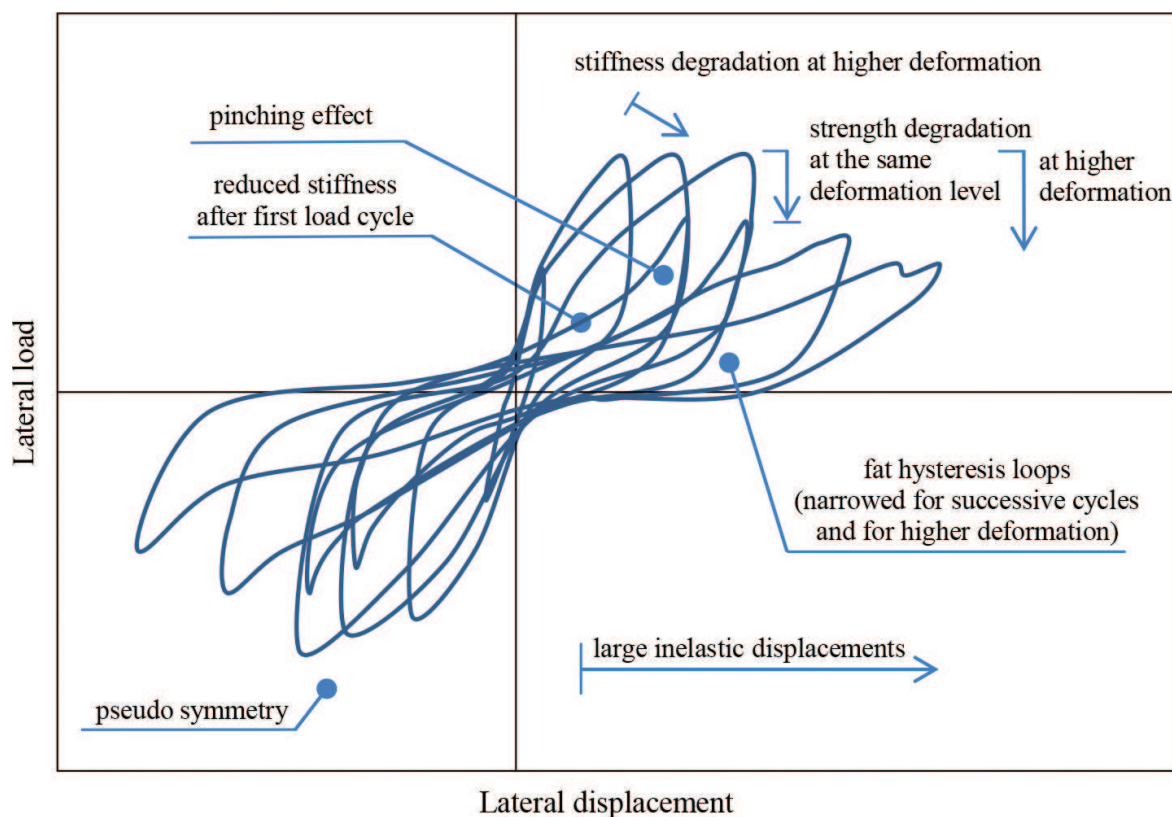
Figure 7. Qualitative hysteresis loops as obtained from experimental tests on timber framed walls.

A qualitative diagram is provided in **Figure 7** showing some of the typical features evidenced by the experimental cyclic tests on timber-framed walls, infilled with masonry and connected with metallic nails. The main features evidenced in Figure 7 are (a) non-linear behavior; (b) almost symmetric curves; (c) indistinct yield point; (d) lateral stiffness degradation for increasing loading cycles; (e) pinching effect after the first load cycle; (f) strength degradation at the same deformation level for increasing loading cycles; (g) strength degradation for higher deformation; (h) fat hysteresis loops which implies large amounts of energy dissipated (narrowed loop areas are generally found, however, for successive load cycles or for higher deformation levels); (i) rather high values of ductility.

The so-called “pinching effect” is due to the formation of a cavity around the fasteners due to irrecoverable crushing of wood (this effect occurs after the first loading cycle) which implies a reduced stiffness at load reversals (the connection stiffness is due, in this phase, to the sole contribution of metallic fasteners). As soon as the contact with the surrounding wood is reestablished, at increased deformation levels, the stiffness rapidly increases which leads to the typical pinched shape of curves in the load-displacement diagram. It can be noted, finally, that features very similar to those illustrated in **Figure 7** and discussed before were

Most of the features evidenced in **Figure 7** and discussed in Section 2.2.1 characterize the behavior of metallic timber connections, as can be inferred from **Figures 9a** and **9b**, which provide qualitative examples of the typical hysteretic behavior of riveted and nailed connections, respectively. In particular, two phenomena were found to be typical of the hysteretic response of steel dowel-type connections, as recalled in Ref. [43]. The first one is the *pinching effect* implying different hysteretic curves from the first to the subsequent load cycles (see **Figure 9**). The second one, referred to as the *memory of material*, is due to a dependence of the load-slip curve from the loading history. Both these phenomena may influence the ductile behavior of a timber structure.
