# Mooring Integrity Management: Novel Approaches Towards *In Situ* Monitoring

Ángela Angulo, Graham Edwards, Slim Soua and Tat-Hean Gan

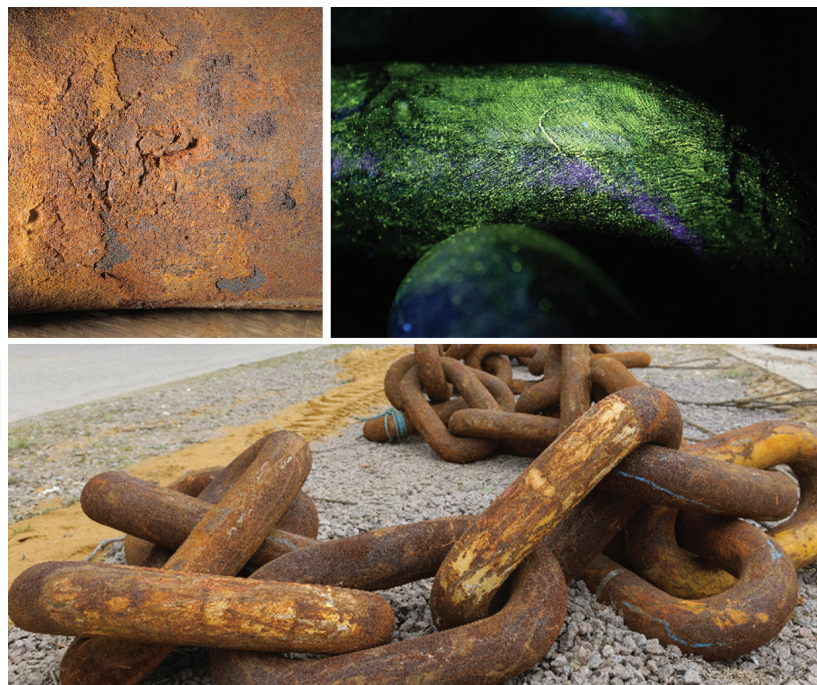
**Figure 1.** From left to right: Example of wear and corrosion on a chain link from the sea-bed touch down zone, in-water inspection showing a studded chain which has lost its stud *in situ*, illustration of marine growth on long-term deployed chain, affecting optical in-water inspection, friction-induced bending.

Consequently, reliance must be placed on in-air inspection, resulting in disruption to the daily operations and substantial economic loss for the operating companies, as the production structures require partial/full de-commissioning during the inspection period (**Figure 1**).

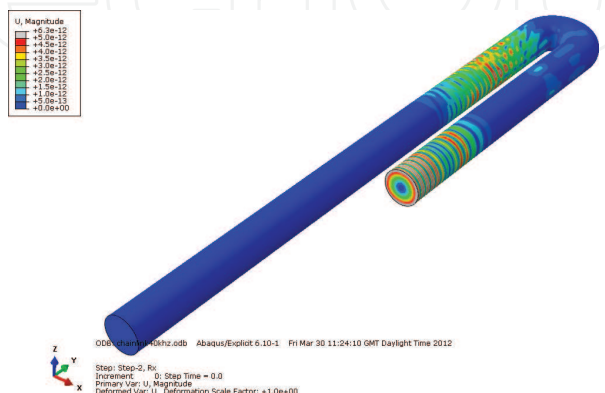
Figure 6. Displacement magnitude after propagation of a 10-cycle 40 kHz pulse around the bend.

The magnitude of the displacement after excitation of a 10-cycle 40 kHz pulse is shown in **Figure 6**. It can be seen that the signal is no longer axisymmetric after propagation around the bend. This indicates that mode conversion has occurred. Some analysis was carried out to quantify the wave modes present in the signal after propagation around the bend. A mode filtering technique was used to separate the wave modes by circumferential order [12]. Since a torsional excitation was applied, it was assumed that wave modes in the torsional family were present. **Figure 6** shows the amplitudes of the individual wave modes plotted against circumferential order. It can be seen that there is a strong F(1,2) wave mode after passing the bend while T(0,1) wave mode propagates in the other direction along the straight section. The amplitude decreases with increasing circumferential order as would be expected.

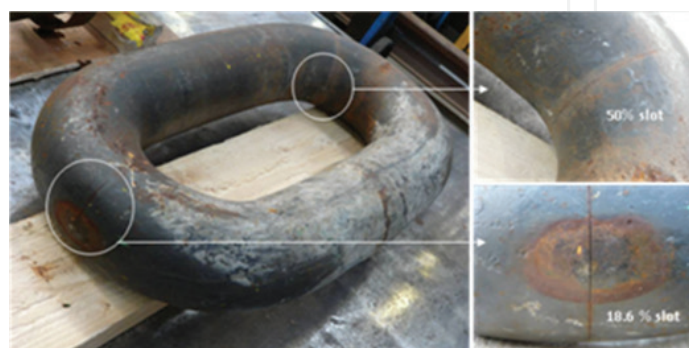
**Figure 11.** Aged chain link with slots.

Two slots were carefully placed on one of the 110-mm chain links; one on the intrados and the other on the extrados. On a second 105 mm chain, a notch on the intrados was ‘grown’ from 5 to 20% through-wall (**Figure 11**).

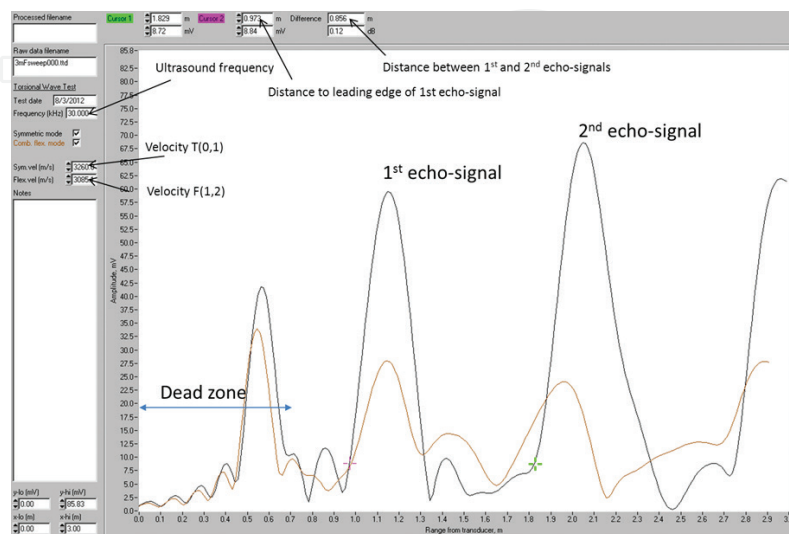
**Figure 12.** 30 kHz T-wave A-scan from 110 mm chain link.
