The Comparison of Cutting Tools for High Speed Machining of Ti-6Al-4V ELI Alloy (Grade 23)

*Chakradhar Bandapalli, Bharatkumar Mohanbhai Sutaria
and Dhananjay Vishnu Prasad Bhatt*

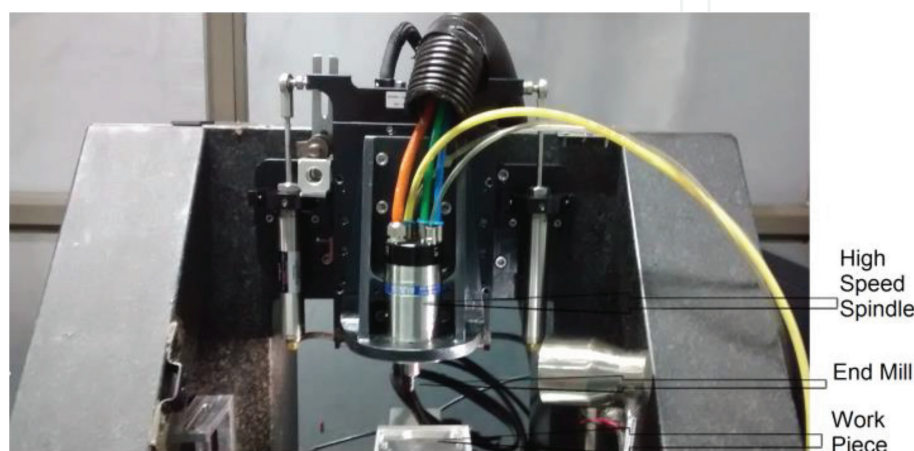
Figure 1.
High speed micromachine.

Standardised experimental tests are carried out on high-speed micromachine setup as shown in **Figure 1**. The work material considered was Ti-6Al-4V ELI titanium alloy (Grade 23) of dimensions $60 \times 40 \times 4$ mm as shown in **Figure 2**. Chemical composition and properties of the work material are shown in **Tables 1** and **2**. Experimental tests conducted are shown in **Table 3**. Two flute uncoated tungsten

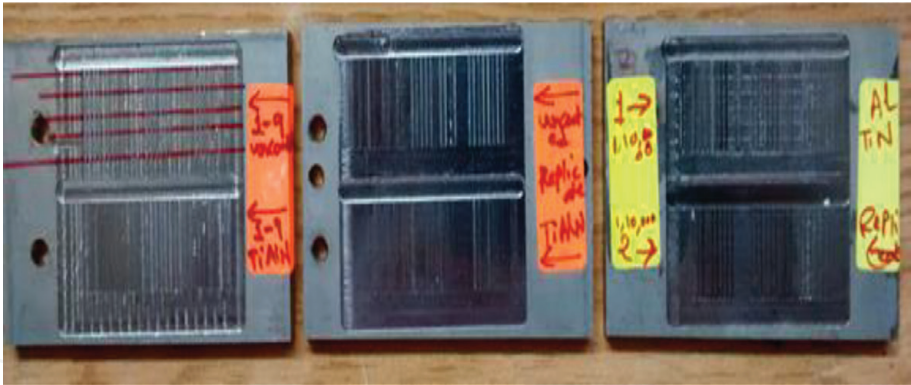
Figure 2.
Ti-6Al-4V ELI titanium alloy (Grade 23).

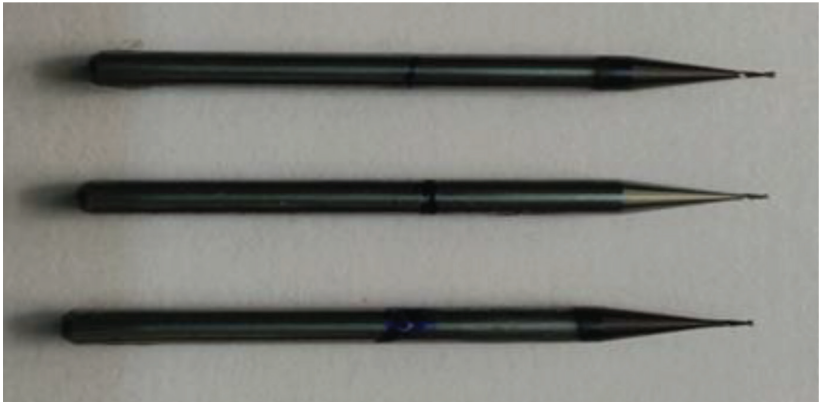
Figure 3.
Micro-end mills.

carbide end mills and physical vapour deposition-coated TiAlN and AlTiN tungsten carbide end mills of diameter 500 µm supplied by IND-SPHINX Axis tools were used in this work as shown in **Figure 3**. The total length of each machined slot was 12 mm. Tool over hang length considered was 18 mm. The width of cut is 500 µm as the process is slot milling operation. Cutting edge radius of tool identified is 2.71 µm through SEM. Coating of the material as specified by the IND-SPHINX Axis tools is

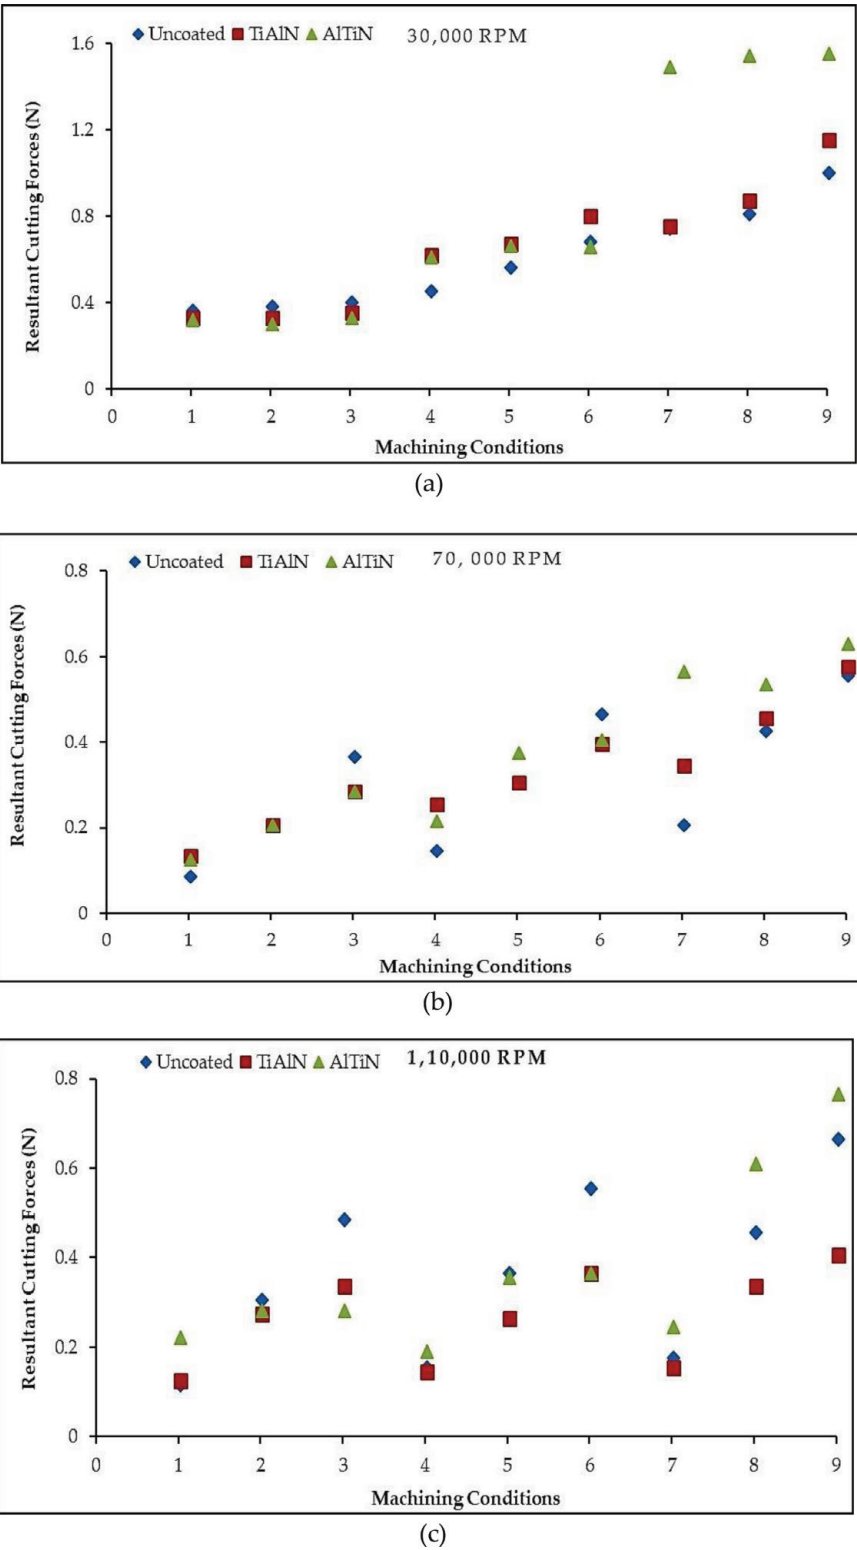
Figure 4. Comparison of (a) uncoated, (b) coated TiAlN and (c) AlTiN WC tools for resultant cutting force (N) at independent spindle speed (rpm), feed ($\mu\text{m}/\text{tooth}$), depth of cut (mm).

At 30,000 rpm, if depth of cut and feed is varied, then resultant cutting force increased by 63% as shown in **Figure 4(a)**. At 70,000 rpm, if depth of cut and feed is varied, then resultant cutting force increased by 87% as shown in **Figure 4(b)**. At 110,000 rpm, if depth of cut and feed is varied, then resultant cutting force increases by 83% as shown in **Figure 4(c)**.

At 30,000 rpm, if depth of cut and feed is varied, then resultant cutting force increases by 81.7% as shown in **Figure 4(a)**. At 70,000 rpm, if depth of cut and feed is varied, then resultant cutting force increases by 85.14% as shown in **Figure 4(b)**. At 110,000 rpm, if depth of cut and feed is varied, then resultant cutting force increases by 78% as shown in **Figure 4(c)**.

At 30,000 rpm, if depth of cut and feed is varied, then resultant cutting force increases by 82.6% as shown in **Figure 4(a)**. At 70,000 rpm, if depth of cut and feed is varied, then resultant cutting force increases by 87% as shown in **Figure 4(b)**. At 110,000 rpm, if depth of cut and feed is varied, then resultant cutting force increases by 85% as shown in **Figure 4(c)**.

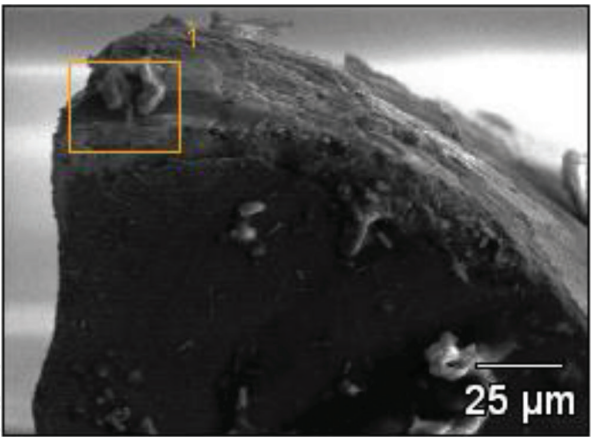
Figure 5.
SEM image of tool edge for uncoated, coated TiAlN and AlTiN WC tools with marked microzone for EDS analysis.

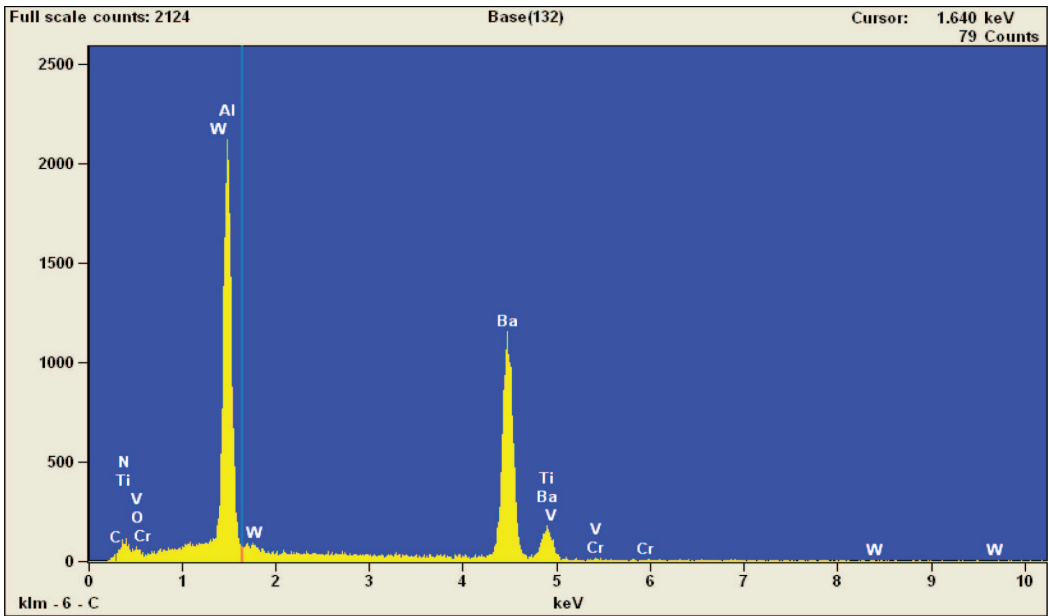
Figure 6.
EDS spectrogram.

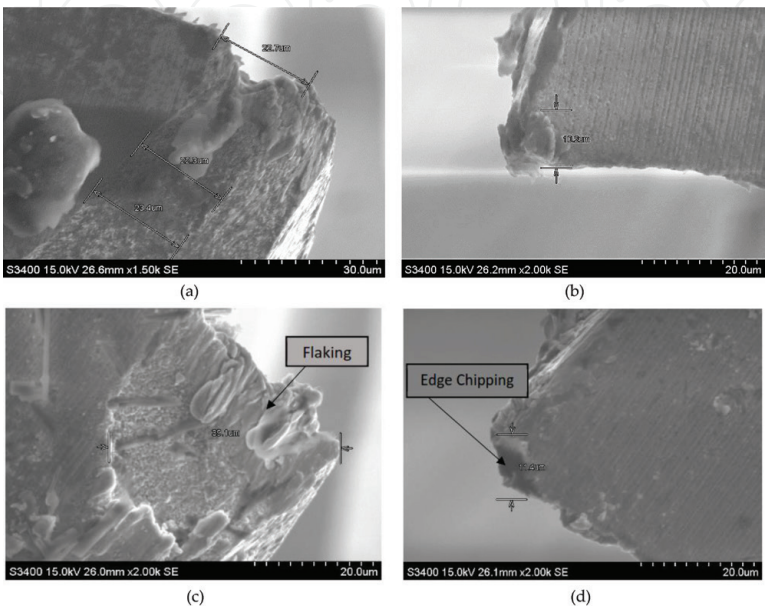
Figure 7.
(a–d) Tool wear observation for uncoated tools.

SEM examination of the leading cutting edge for coated and uncoated tools indicates plastic deformation, adhesion wear, chipping and flaking as shown in **Figures 7–12**. In addition, coating delamination at the tool cutting edge and significant changes in the tool shape was observed under the SEM. Tool material reacts with titanium alloy by means of high chemical reaction, forming adhesive wear. During the tool-workpiece interaction, adhesive layers of tool material will break down that progresses to adhesion wear. The intimate contact between the tool and

subjected to thermal and mechanical loads and could not be able to resist the wear during the interrupted cutting in the end milling process. The chip shape, segmented or continuous, decides the cutting temperature formation inciting to thermoplastic shear localization at the contact length, resulting in the diffusion process. The chip constituents and the rate of diffusion are controlled by cutting temperature. In the machining of titanium alloys, the machining parameters, particularly, cutting speed, influence the cutting temperature origination at the tool edge for initiating the diffusion process. The earlier researchers verified that cutting speeds generate high cutting temperature, a short contact length, a low shear angle and a high cutting pressure. Chip segmentation and tribological parameters—the physical medium—may be causing the coating delamination for both the coated tools while machining the titanium alloy. Since the thermal conductivities of the coating constituents are different, the heat flux q flows through the coating layer and penetrates the tool substrate. The reason behind the diffusion process at the tool substrate surface might be due to chemically instable Co binder elements. Adhesive surface between the coating layer and tool substrate surface was completely eliminated gradually by diffusion process as depicted in **Figures 7–12** and confirmed through EDS analysis.

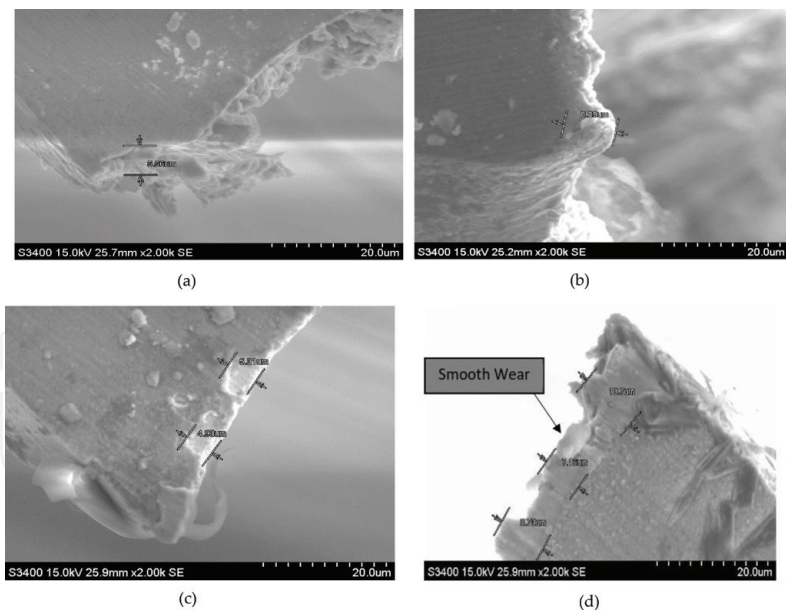
Figure 8.
Coated TiAlN tool wear at (a and b) 30,000 rpm and (c and d) 70,000 rpm.

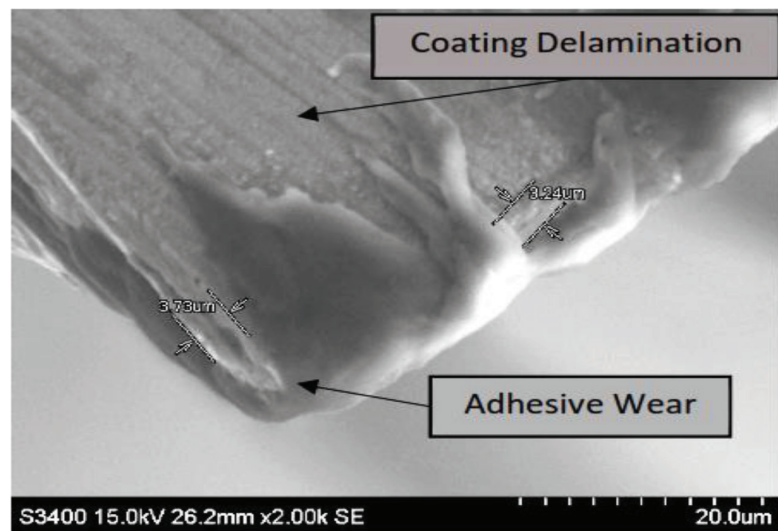
Figure 9.
Coated TiAlN tool wear at 110,000 rpm.

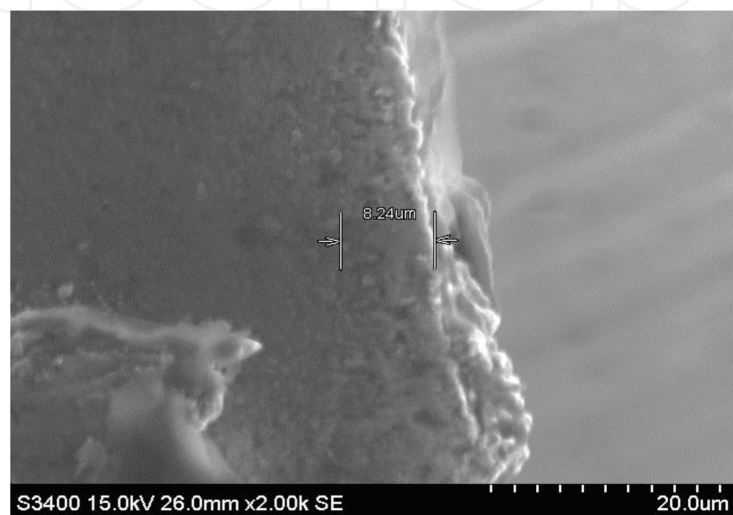
Figure 10.
Coated AlTiN tool wear at 30,000 rpm.

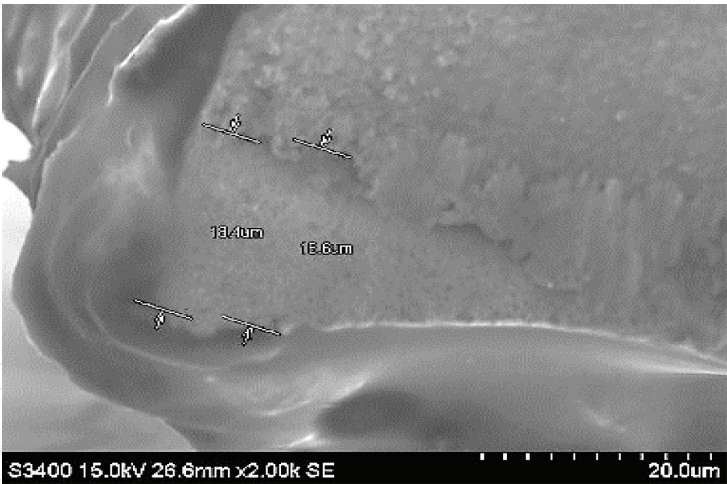
Figure 11.
Coated AlTiN tool wear at 70,000 rpm.

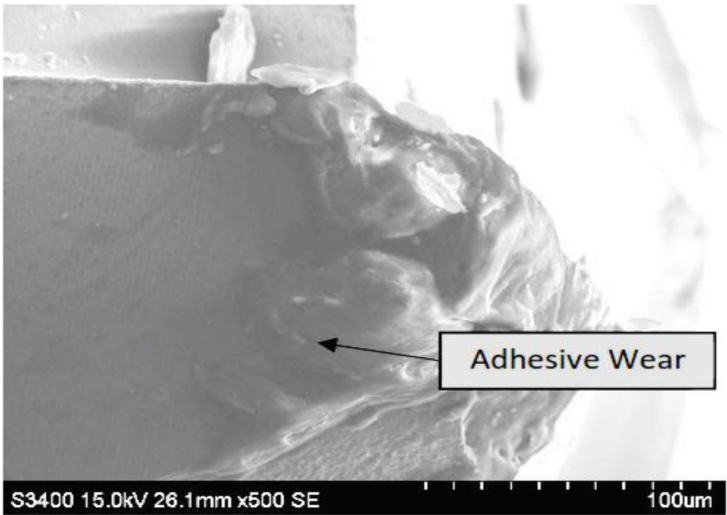
Figure 12.
Coated AlTiN tool wear at 110,000 rpm.

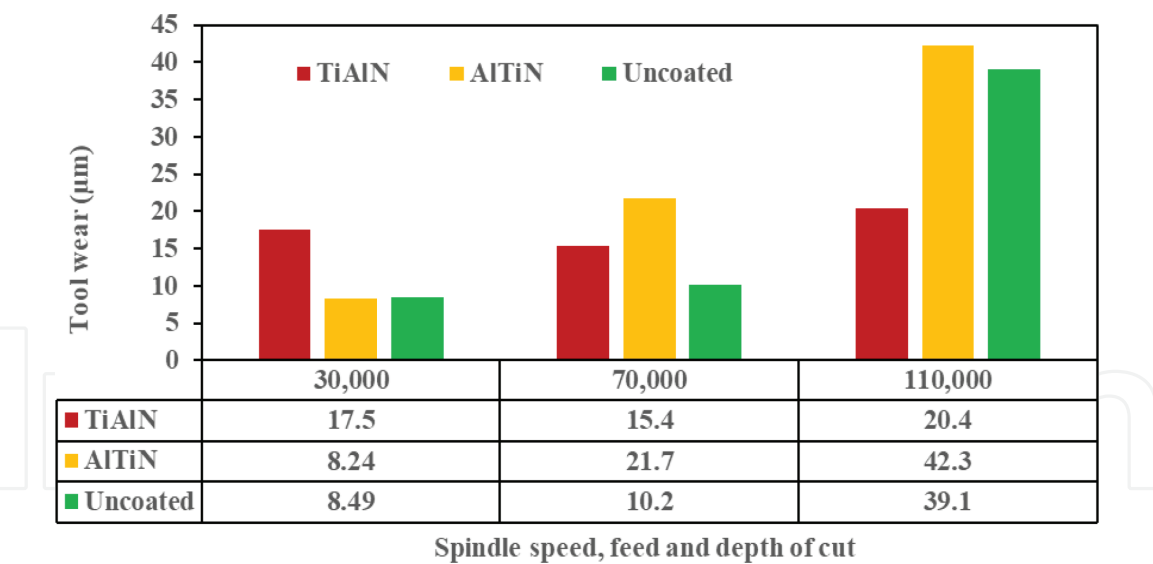
Figure 13.
Tool wear versus different machining conditions.

From the experimentation, it is observed that the resultant cutting force increase might be due to the increment in feed rate and depth of cut, leading to more chip formation, high contact between tool and chip, high-temperature formation by shearing and ploughing action reducing the yield strength of work material. It was observed that when spindle speed is increased, while the depth of cut and feed rate is kept at low, then cutting force generated was less. When depth of cut and feed rates are reduced, the chip load encountered in the process becomes the same order of magnitude as the grain size of many alloys. The cutting-edge radius of the end mill is comparable in size to the chip thickness. As a result, no chip is formed when the chip thickness is below the minimum chip thickness and instead part of the work material plastically deforms under the edge of the tool and the rest elastically recovers. This change in the chip formation process, known as minimum chip thickness effect and the associated material elastic recovery cases, increased cutting forces and surface roughness. Observed irregularity on the machined surface due to the plastic side flow and burr formation seem to suggest that the tool workpiece interaction is more likely to be elastic-plastic in nature. Due to the increment in feed rate, depth of cut and cutting speed, the tool wear and cutting-edge distortion took place that leads to more cutting force requirement to remove the material. At 30,000 rpm, uncoated tools performed better than both the coated tools. Uncoated tools produced less cutting force compared to coated tools because of tools stability and resistance to wear. At 70,000 rpm, 0.02 and 0.06 mm depth of cut with feed 2–8 $\mu\text{m}/\text{tooth}$, the uncoated tool required more cutting force to remove the material rather than both the coated tools. At 70,000 rpm, 0.1 mm depth of cut with feed 2–8 $\mu\text{m}/\text{tooth}$, the uncoated tool is found to generate less cutting force than both the coated tools. At 110,000 rpm, coated TiAlN tools are better performed than coated AlTiN and uncoated tools, which is due to increase in cutting temperature in the shear zone, thus reducing the yield strength of the workpiece material, chip thickness and tool-chip contact length. If coated TiAlN and coated AlTiN tools are compared, then performance of TiAlN tools is better. Depending on the particular parameters during machining processes, uneven phenomenon (sudden tool or spindle vibration, sudden workpiece movement) occurs, leading to increase of cutting forces. SEM and EDS analyses are performed to identify the wear and its formation mechanism on two flutes of each tool, that is, uncoated and PVD-coated AlTiN, TiAlN tungsten carbide end mills as shown in **Figures 5 and 6**. Tool wear on particular end mill is observed using SEM after machining nine slots for each set of spindle speed as shown in **Figures 7–12**. Tool wears measured on each cutting flute in two series of experiments have been considered and average values are reported as shown in **Figure 13**. Coated TiAlN tool wear was high at spindle speed

30,000 rpm machining conditions than uncoated and coated AlTiN tools. Uncoated tools produced less wear than both the coated tools at spindle speed 70,000 rpm machining conditions. Coated TiAlN tools produced less wear than AlTiN-coated and uncoated tools at spindle speed 110,000 rpm machining conditions. Tool wear is increased for all the tools when the feed rate and depth of cut for the considered spindle speed is increased. Adhesive wear, edge chipping, flaking, coating delamination and measured tool wear that were observed under SEM at different machining conditions are shown in **Figures 7–12**.
