# Contemporary Inspection and Monitoring for High-Speed Rail System

*Lu Zhou, Xiao-Zhou Liu and Yi-Qing Ni*

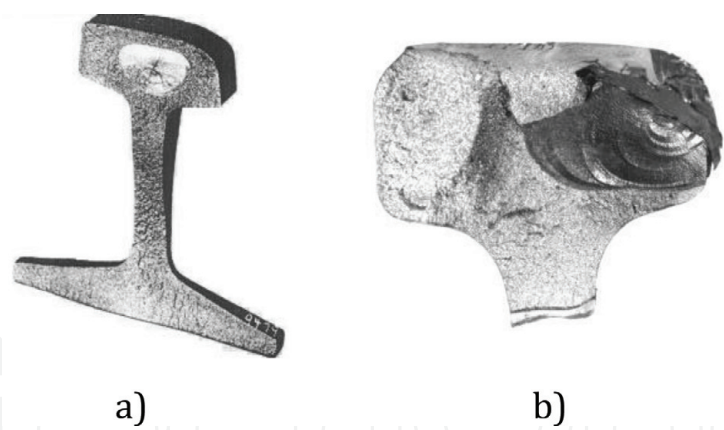
**Figure 1.** Transverse defect and detail fracture [15]. (a) Transverse defect. (b) Detail fracture.

As per increasing of demand for HSR, rail defects have become a critical challenge in operation because an incident could cause more losses when trains run at higher speed. Many researchers have proposed classification methods for typical types of rail cracks derived from different propagation orientations of rail defects [15, 16]. The most common rail defects are caused by inappropriate manufacturing and inappropriate use of rails, and they mainly include transverse defects (TD), detail fractures (DF) and split heads. TD (**Figure 1a**) is one of the most critical type

of cracks that appear in railheads propagating along lateral direction. DF (**Figure 1b**) has an origination point and grows radially from the origination point. These types of defects are caused by inappropriate use such as excessive stress concentrations. The vertical split heads (VSH) (**Figure 2a**), which usually originate from manufacturing anomalies, cause the second most train derailments (after TD).

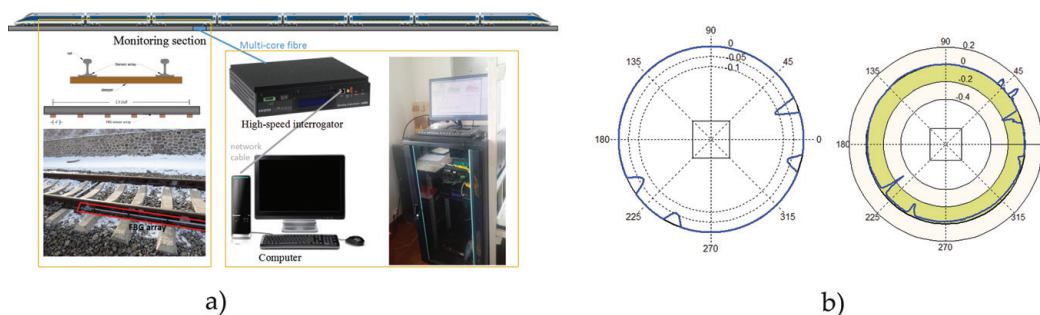
**Figure 3.** High-speed train wheel defect detection using online FBG-based system [36]. (a) System configuration. (b) Detection results (left—online detection; right—offline inspection).

Johansson and Nielsen [1] made use of this set-up to build a detector on the rail web in nine consecutive sleeper bays. Nielsen and Oscarsson [32] used both rail web and rail foot strain gauges to measure the wheel impact load and rail bending moment. Stratman et al. [33] proposes new criteria for removal of wheels with high likelihood of failure, based on two real-time SHM trends that were developed using data collected from in-service trains. Filograno et al. [34] developed an FBG-based sensing system comprising FBG strain gauges mounted at both rail web and rail foot enables train identification, axle counting, speed and acceleration detection, wheel imperfections monitoring and dynamic load calculation. They have expanded the application of this system in the Madrid-Barcelona HSR line [34]. An FBG-based wheel imperfection detection system that can provide in-service measurement of wheel condition was developed by The Hong Kong Polytechnic. It offers a comprehensive health monitoring scheme for vehicle and track in the entire railway network of Hong Kong [35]. A monitoring system has been proposed with FBG sensors implemented on rail tracks to detect wheel local defects such as wheel flats and polygonisation [36]. The impacts of wheel/rail interactions caused by wheel local defects are reflected as subtle anomalies in response to signals collected by FBG sensors, and the deployed system is shown in **Figure 3a**. The detecting results match well with those from offline inspection (**Figure 3b**).

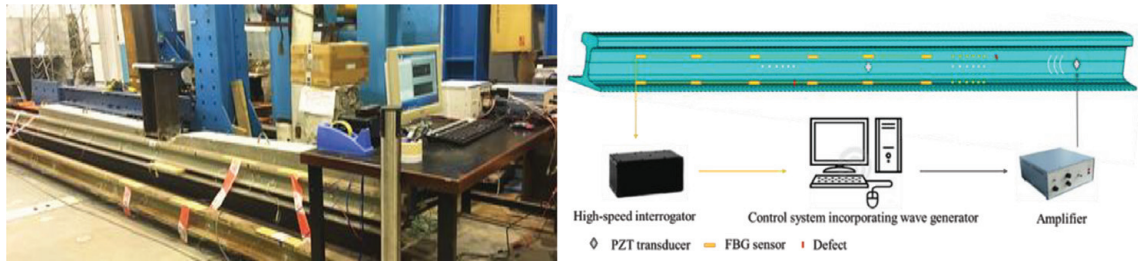
**Figure 8.**  
 Schematic set-up of the FBG-PZT monitoring system [79].

FBG sensors for detecting acousto-ultrasonic signals have been studied since the mid-1990s [77]. The conventional interrogation technique for FBGs as sensing elements utilises their spectral encoding and decoding capabilities for the measurand; however, the spectral decoding capability cannot be used to detect high-frequency signals (e.g., acoustic and ultrasonic waves) due to the low wavelength scanning speed. Appropriate demodulation techniques capable of high-sensitivity detection of high-frequency waves are necessary to develop acousto-ultrasonic FBG sensors. There are two main approaches to detecting acoustic and ultrasonic waves with FBGs: the first one uses a narrowband light source to

illuminate the FBGs and demodulate the power intensity variation when the waves impinge on the FBGs, while the second one uses a broadband light source and an optic filter. Minardo et al. [78] conducted a numerical investigation on the response of FBGs subjected to longitudinal ultrasonic waves. Ni et al. [79] have developed a hybrid monitoring system using FBG sensors to interrogate ultrasound signals emitted by PZT sensors (**Figure 8**). The hybrid system has been verified in lab and a test line in mainland China.
