NDT Methods for Evaluating FRP-Concrete Bond Performance

Kenneth C. Crawford

Abstract

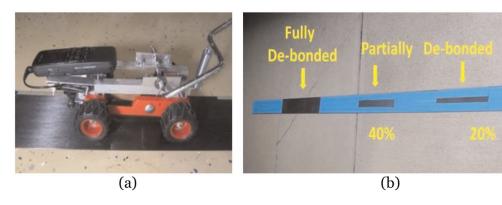
The latest impact machine, **Figure 3**, is a 5×17 cm single 3D-printed frame made with polylactic acid (PLA) plastic by fused filament fabrication, is used for its strength and workability. PLA, or polylactide, is a biodegradable and bioactive thermoplastic aliphatic polyester derived from renewable resources and provides a

Figure 3.
(a) Mobile impact machine and (b) laboratory CFRP test plate.

strong structural frame which attenuates vibrations and sound, ideal for this impact machine application. The machine has a single 10 cm lever (cherry wood) with one 10-24 screw for the impact hammer, driven by a four-pin actuator wheel. The machine produces 25 impacts per meter, with a 0.4 pound impact force. The impact sound wave signals generated are recorded with a microphone and digital data recorder mounted on the machine.

The experimental investigation was conducted in two phases. Phase one involved testing in the laboratory with the impact machine, Figure 3a, on a bonded, de-bonded, and partially de-bonded CFRP plate, **Figure 3b**, and on the concrete to which the CFRP plate was bonded. The purpose of obtaining impact waveforms on the laboratory concrete was to compare them to the waveforms on the bridge concrete. Similarly the impact waveforms obtained from the laboratory bonded and de-bonded CFRP plate are used to compare to the bonded and de-bonded CFRP material on the bridges. A partially de-bonded CFRP plate was simulated in the laboratory with 40 and 20% de-bonding of the test plate, **Figure 2b**. Multiple passes of the impact machine in the laboratory on the concrete, bonded, de-bonded, and partially de-bonded CFRP plate were made with the data recorded on a Sony M2 digital recorder. The recordings were displayed in a Tektronix 475 oscilloscope and video recorded. The video recordings were broken down into still pictures of the waveforms, from which the impact signal frequencies and damping ratios were measured. The frequencies were obtained from the inverse of the time displayed on the oscilloscope screen. The damping ratios were measured with curve fitting of the decayed sinusoid waveforms.

The application of the mobile impact machine, **Figure 3a**, with its data recorder proved successful in detecting bonded and de-bonded CFRP material in the laboratory and in the field on RC highway bridges. The waveforms for bonded and de-bonded CFRP material produced in the laboratory were consistent and similar to the bonded and de-bonded waveforms produced on the two RC bridges. This indicates the concept of using the impact-echo NDT method with the impact machine to test FRP-bonding on RC bridges and producing bond condition data is valid. It was noted the impact data obtained in the field on the two bridges had a relatively high degree of noise in the waveforms. Improvements in the impact system and data recording method, with noise filters, can improve the impact signal to noise ratio, producing a relatively cleaner and more distinguishable and measurable waveform, denoting CFRP-concrete bond condition.

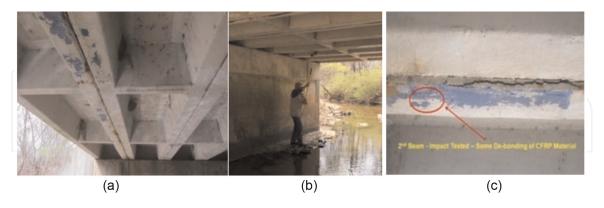
Figure 5.

On the Creasy Springs Road bridge impact testing, **Figure 5**, was done on the second beam in the first channel (west side) and then on the third, fourth and sixth beams as far as the extension pole could reach over the water. It is noted CFRP debonding was found on the second beam, **Figure 5c**.

Creasy Springs Road bridge—impact testing on channel beams. (a) Second and third beams, (b) testing fourth beam, and (c) CFRP de-bonding second beam.
