# Overview of Selected Issues Related to Soldering

*Karel Dušek, David Bušek and Petr Veselý*

## Abstract

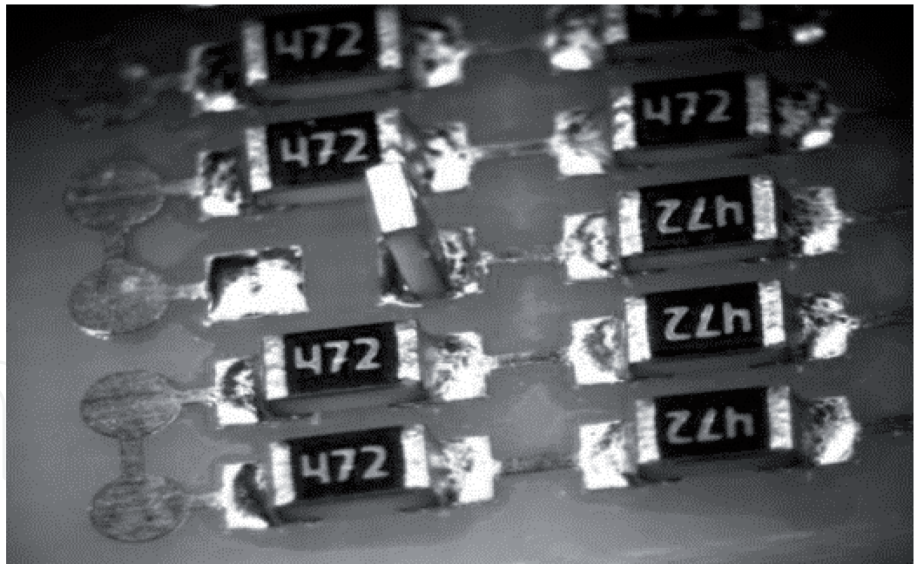
**Figure 14.**  
*Photo of the tombstone effect.*

The tombstone effect (or Manhattan effect, drawbridging or the Grabstein effect) is a phenomenon which is characterised by one of the sides of a small SMD component (typically in a 0805, 0603, 0402 and 0201 package) lifting up during reflow. A photo of the tombstone effect is shown in **Figure 14**.
