Experimental Study of Flow-Induced Vibrations and Scattering of Roof Tiles by Wind Tunnel Testing

Satoru Okamoto
Shimane University
Japan

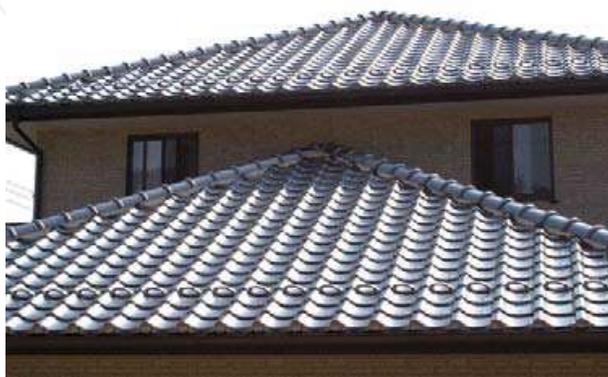
Fig. 1. Japanese residence and roof tiles

Flow-induced vibration of roof tiles usually appears just before they are scattered. The flow-induced vibration (aeroelastic instability) of structures is an important phenomenon for the following two reasons: (1) strong lateral self-excited oscillations can develop at a certain wind velocity (onset velocity) as a result of the lateral aerodynamic force component and (2) these vibrations have a tendency to affect the behavior of the structure prior to the onset velocity because they produce negative aerodynamic damping that can considerably reduce the total damping available to the structure (Naudascher et al., 1993). However, the flow-induced vibration of roof tiles prior to scattering has been given very little attention. This study investigates the nature and source of the vibrating and scattering behavior of the roof tiles in order to provide better insight into this mechanism. This paper presents the first results of studies on the wind-inducing mechanism in roof tiles, which are widely used for roofing Japanese wooden dwellings (Fig. 1).

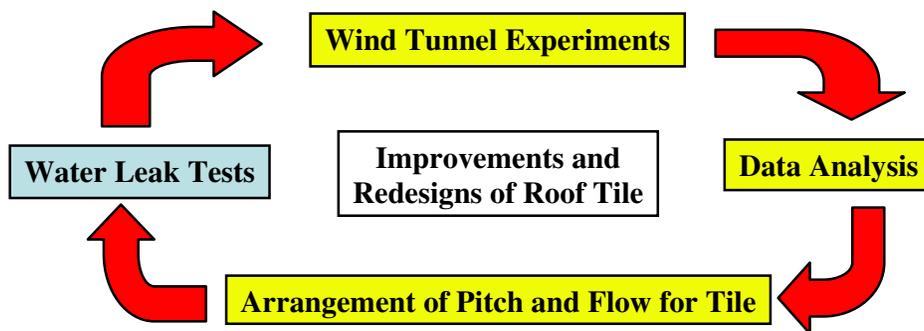
Fig. 2. Outline of the research

Using wind tunnel tests, an experimental study was conducted to explain the behavior of roof tile vibration and the primary factors that affect their scattering. The results indicate that the vibration mechanism behaves in a manner that is consistent with that of a self-excited system, and the surface flow creates reasonable up-lifting moments only when the wind direction is roughly perpendicular to that of the eaves (Fig. 2).

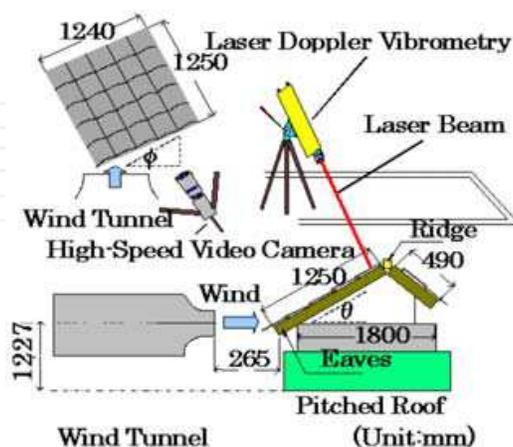
Fig. 3 illustrates the general layout of the apparatus used in this experiment. The experiments were conducted in an open-circuit wind tunnel that was driven by an axial flow fan. The nozzle of the wind tunnel had a 500 mm × 1,300 mm cross section. The maximum velocity of flow from the nozzle was approximately 50.0 m/s. The representative wind velocity was measured by a hot-wire anemometer and a linearizer on the exit nozzle of the wind tunnel. Approximately 10.0% of the flow's streamwise turbulence intensity was

generated by the grids. The spatial characteristics of air jet were checked for uniformity in wind speed and turbulence to ensure that all tiles were exposed to a near uniform air flow. The turbulence intensity of the flow condition is of the same order as the turbulence intensity experienced in practice.

Fig. 3. Experimental apparatus

25 roof tiles were set up in 5 rows \times 5 columns on a pitched roof in the downstream flow of a wind tunnel (Fig. 3). The roof tiles were tested by the air flow, which barely covered the entire exposed area of the tiles. They were made of clay, and each weighed approximately 2.8 kg. The tiled pitched roof was fitted similar to a real roof arrangement with a plenum underneath the tiles, which acts as a roof cavity. This plenum was sealed with a clay pad. The internal pressure in this plenum was monitored and regulated by a pressure transducer placed underneath the tiles. The vibrations of the roof tiles were measured by a laser Doppler vibrometer (LDV, OMETRON VS1000) and an accelerometer (ONO SOKKI NP-3560, Fig. 4 (a)), and the normal natural frequencies of the roof tiles were analyzed using an impulse force hammer test. The vibration velocity could be measured up to 1,000 mm/s by a 1 mW LDV, and the range of the vibrational frequency was from 0 to 50 kHz. One roof tile was equipped with an accelerometer (Fig. 4 (b)). The accelerometer was used to measure the dynamic behavior of the tiles in three directions, X-, Y-, and Z under a no-flow condition,

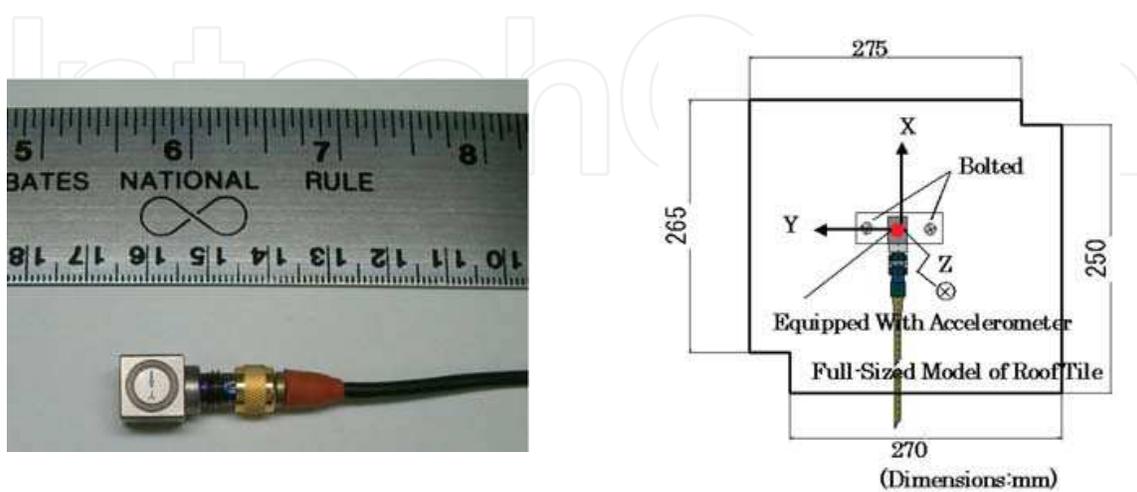
(a) Accelerometer

b) Roof tile equipped with accelerometer

Fig. 4. Accelerometer used in the experiments

and weighed approximately 5.0 g. The experimental measurement of the vibration frequencies for tiles was performed with the accelerometer. However, the vibration frequencies identified by the LDV were limited to small-amplitude modes. In this study, the accelerometer and LDV were used to determine the resonant frequencies of roof tiles that were and were not bolted to the roof bed.

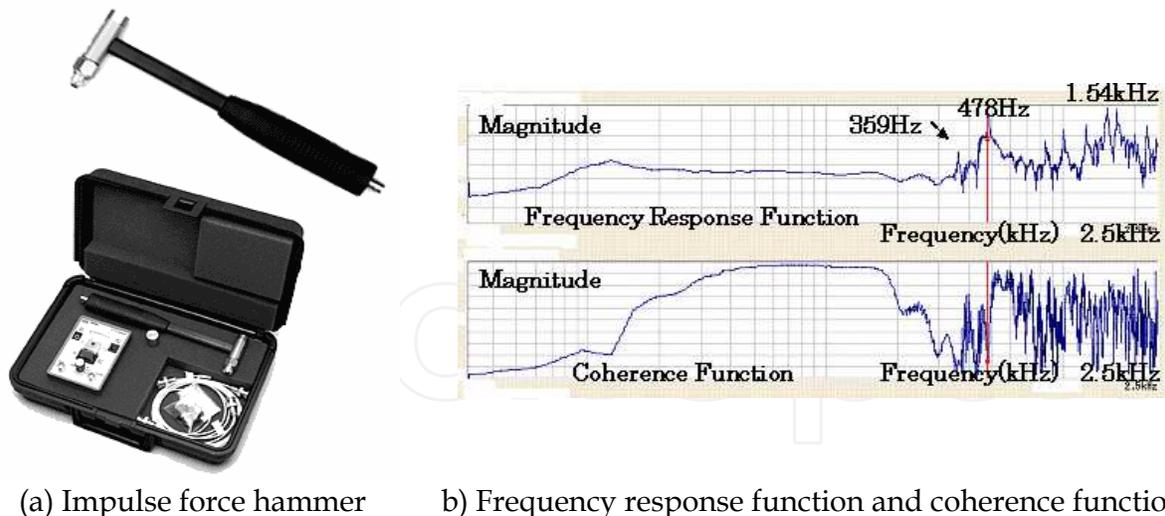
Fig. 5. Frequency response function and coherence function of a roof tile generated by an impulse force hammer test

An impact hammer with a force transducer was used to excite the tiles under no-flow conditions (Fig. 5 (a)). Two signal conditioners were used to provide power to the accelerometer and the force transducer, whose spectral analyses were performed using a fast Fourier transform (FFT) spectrum analyzer (ONO SOKKI DS-2100 4CH). The sampling frequency was 5,120 Hz over a frequency range of 0 - 2.5 kHz; 1,024 data points were sampled per spectrum. Unless otherwise stated, 64 spectra were averaged for each measurement. The frequency resolution of the spectra was 5 Hz. In order to analyze acceleration in a direction perpendicular to the surface of a roof tile, the time taken by the acceleration signal was recorded using the FFT analyzer. Two accelerometers were used simultaneously. Roof tiles that showed significant vibrations at any velocity, found from a series of experiments using accelerometers, were attached to two neighboring roof tiles on a model roof.

Fig. 5 (b) shows the frequency response function curve and coherence function curve of roof tiles measured using an impact hammer with a force transducer. One of the resonant frequencies obtained by the accelerometer was 478 Hz. As stated in the next section, the measured frequencies obtained using the wind tunnel test are nearly consistent with the resonant frequencies obtained by the excitation analysis of the impulse force hammer test.

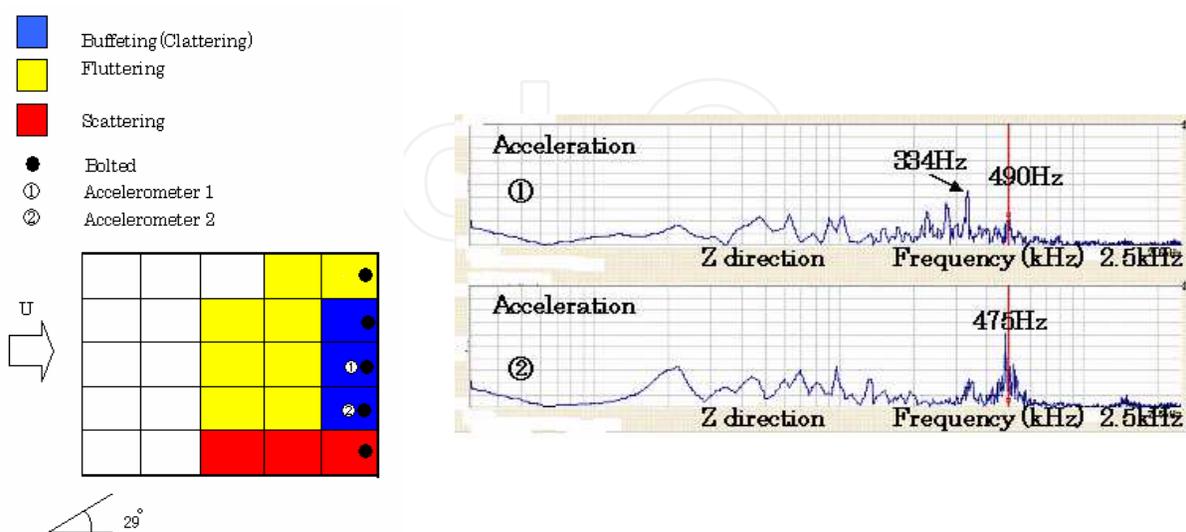
(a) Vibration of roof tiles b) Vibrational acceleration power spectrum for roof tiles

Fig. 6. Effect of slope angle of roof on vibration of roof tiles at $\theta = 29$ degrees, $U = 39.0$ m/s

The slope angle of the roof was changed, and the effects of fluttering in the last stage of roof tile scattering were examined (Figs. 6-8). The small-amplitude vibration of the model roof tiles appeared in a low-velocity flow at the maximum pitch angle of 29 degrees, while the model roof tiles showed fluttering when the wind velocity reached approximately 38 m/s. They were more buffeted at the pitch angle of 24 degrees than at the pitch angle of 29 degrees, and then fluttered when the wind velocity reached approximately 40 m/s. The model roof tiles did not flutter at the minimum pitch angle of 19 degrees, and they were buffeted at a higher wind velocity than that at other pitch angles. They did not flutter at pitch angles of 24 and 29 degrees because of the weight of the neighboring roof tiles and bolts. The fluttering of the model roof tiles appeared with relatively large-amplitude vibrations, and it was regarded as fluttering when the roof tile was completely lifted from the roofing board and the board was exposed.

Figs. 6-8 show the results for several pitch angles. The largest number of roof tiles were buffeted and fluttered at the maximum pitch angle of 29 degrees (Fig. 6 (a)), resulting in three roof tiles being scattered. The roof tiles were not scattered at a pitch angle of 24 degrees (Fig. 7 (a)), whereas they were both buffeted and scattered at a pitch angle of 29 degrees. In this case, the roof tiles attached with the accelerometers and the eight neighboring roof tiles fluttered. At the minimum pitch angle of 19 degrees (Fig. 8 (a)), the roof tiles did not flutter even at the maximum velocity of 40 m/s, but a few roof tiles were buffeted.

Similarly, the signals from the accelerometers revealed fluttering at pitch angles of 24 and 29 degrees. The results obtained by the FFT analysis of the accelerometer signals at pitch angles of 24 and 29 degrees are shown in Figs. 7 (b) and 6 (b), respectively. The small-amplitude vibrations were recognized using accelerometers 1 and 2 at a low velocity at these pitch angles. However, a 50 m/s² vibration was recognized momentarily when the wind velocity was increased. The small-amplitude vibrations appeared at a low velocity, but gradually increased at a higher velocity (Peterka et al., 1997; Cermak, 1998). Moreover, acceleration and amplitude of the vibrations are related to the critical velocity at which fluttering occurs for a constant pitch angle of the roof. At a pitch angle of 24 degrees, the values of acceleration and amplitude increased when the wind velocity reached 40 m/s (Fig. 7 (b)). The acceleration and amplitude observed at a relatively high velocity for a pitch angle of 24 degrees also appeared at a low velocity for a pitch angle of 29 degrees (Fig. 6 (b)).

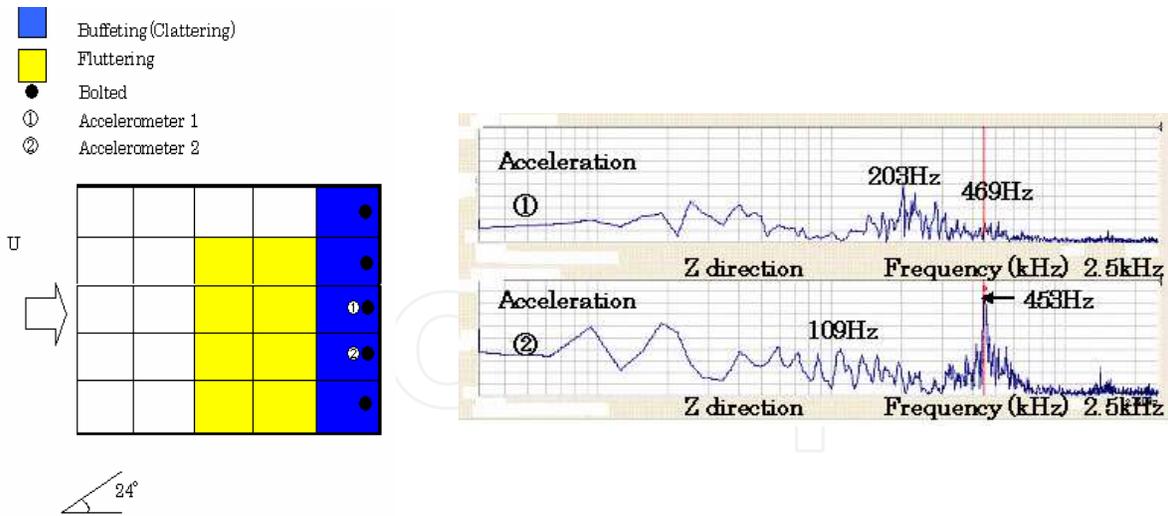
(a) Vibration of roof tiles b) Vibrational acceleration power spectrum for roof tiles

Fig. 7. Effect of slope angle of roof on vibration of roof tiles at $\theta = 24$ degrees, $U = 38.5$ m/s

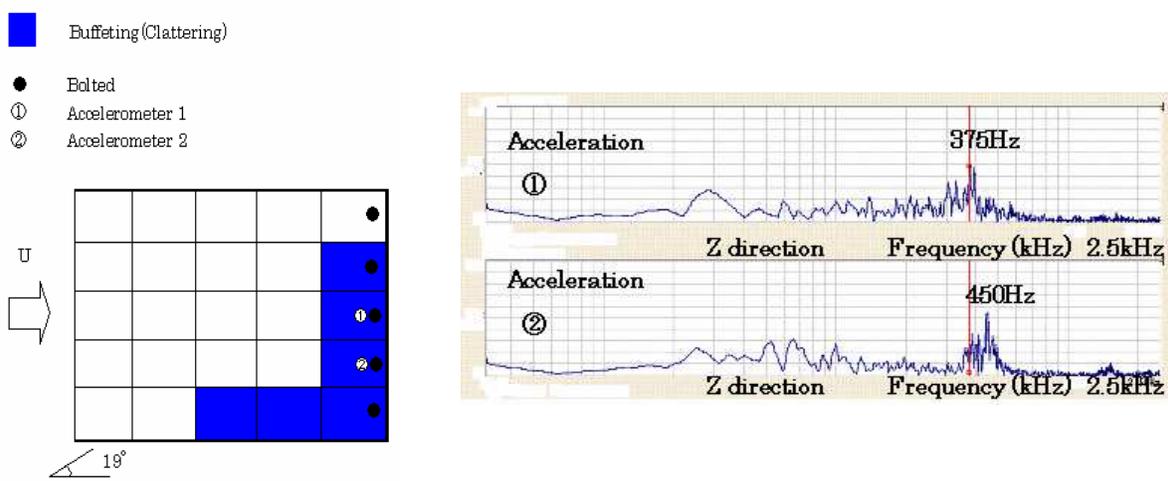
(a) Vibration of roof tiles b) Vibrational acceleration power spectrum for roof tiles

Fig. 8. Effect of slope angle of roof on vibration of roof tiles at $\theta = 19$ degrees, $U = 39.9$ m/s

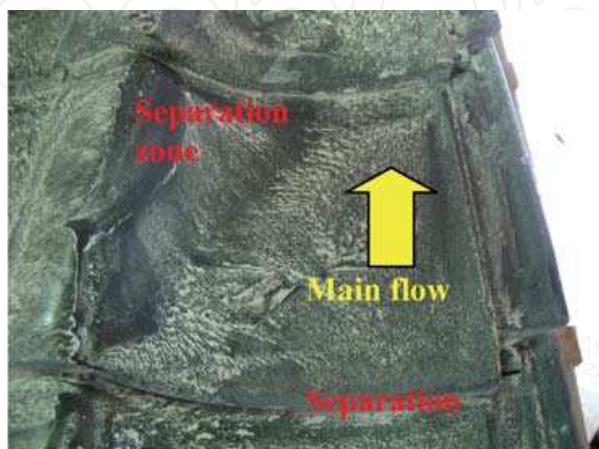
Fig. 9. Observation of the flow on the surface of the roof tile by the oil film method

If a roof tile is inclined with respect to the free stream, the flow will separate from one side as soon as the angle of incidence exceeds a critical value. Visualization using the surface oil flow method shows that the vortex cones caused by the yawing flow separation at the leading edges result in the highest negative pressure coefficients close to the windward gable and the windward eaves. If the roof pitch is increased, the vortex cones decrease in strength. In regions of separated flow, the external pressure distribution on a tiled surface

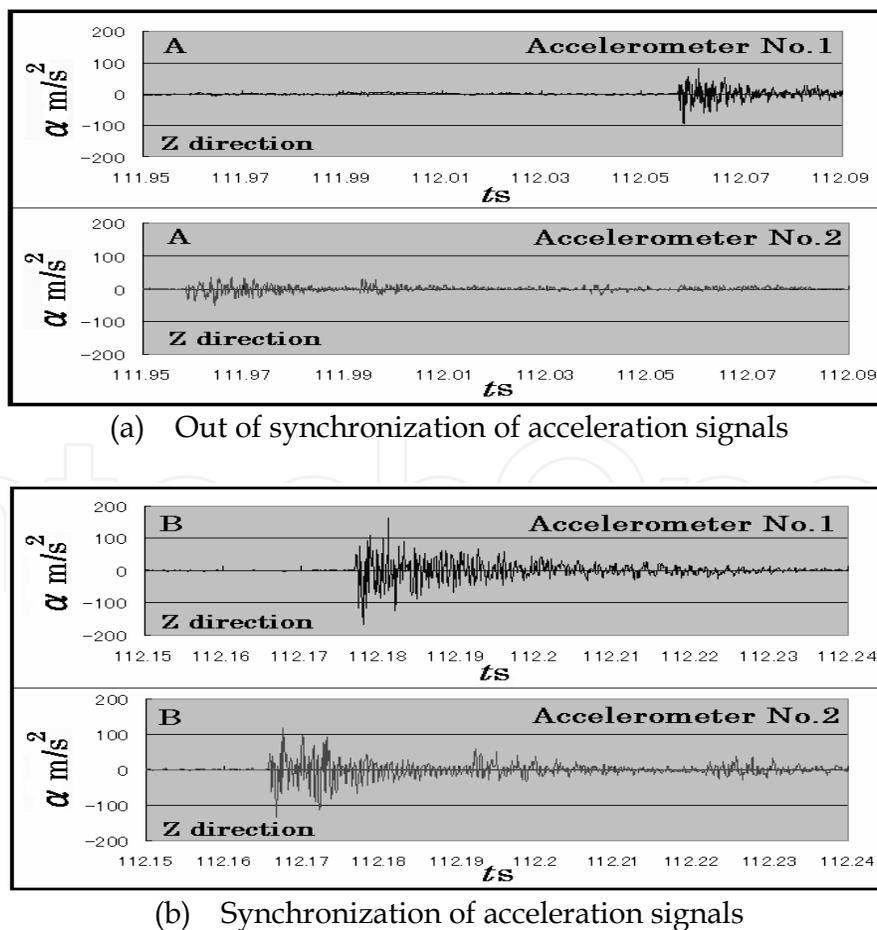
Fig. 10. Acceleration signals from accelerometers 1 and 2 at $\theta = 24$ degrees, $U = 40.0$ m/s

In a series of wind tunnel tests, the pitch angles of the roof were changed and two accelerometers were attached to neighboring roof tiles in order to detect and analyze acceleration signals. Fig. 10 shows an example of the acceleration signals that were frequently found whenever small-amplitude vibrations occurred. It shows the acceleration

signals and the behavior of the 25 model roof tiles at a pitch angle of 24 degrees and wind flow of 40 m/s. In this experiment, it was also recognized that the tiles locally arranged at the back and right side of the roof were often buffeted and scattered by strong winds. In a typical construction method, tiles are piled up and laid on the upper and lower side of a roof by their own weight. Therefore, the roof tiles locally arranged at the back and right side of the roof are held by the relatively lighter weight of the neighboring roof tiles. The wave-forms shown for case A in Fig. 10 (a) indicate that the signals are out of synchronization by a half cycle from both accelerometers. The wave-forms shown for case B in Fig. 10 (b) indicate the nearly synchronized signals from both accelerometers. Fig.10 shows the time history of the acceleration signals caused by the wind effect. These results show that it was found that the accelerations and time histories of the two roof tiles differ from each other. The forces affected both roof tiles simultaneously. On the other hand, even when a force did not act directly on a roof tile, it affected the other roof tile. In this case, the roof tile equipped with accelerometer ① was held by the roof tile equipped with accelerometer ② and the force of the roof tile equipped with accelerometer ② was added, although the force of the roof tile equipped with accelerometer ① did not act directly on it. The force of the tile equipped with accelerometer ① was added to the roof tile equipped with accelerometer ② although the force of the roof tile equipped with accelerometer ② did not act directly on it (case A). It was observed during a series of experiments that the roof tiles were buffeted almost simultaneously when vibration occurred (case B).

These results suggest that the roof tile held by the other roof tile was buffeted and then produced the reaction force on the neighboring roof tile. This behavior may be same as the “wave motion of roof tiles” phenomenon described by Ginger (2001), which is often reported to cause construction damage.

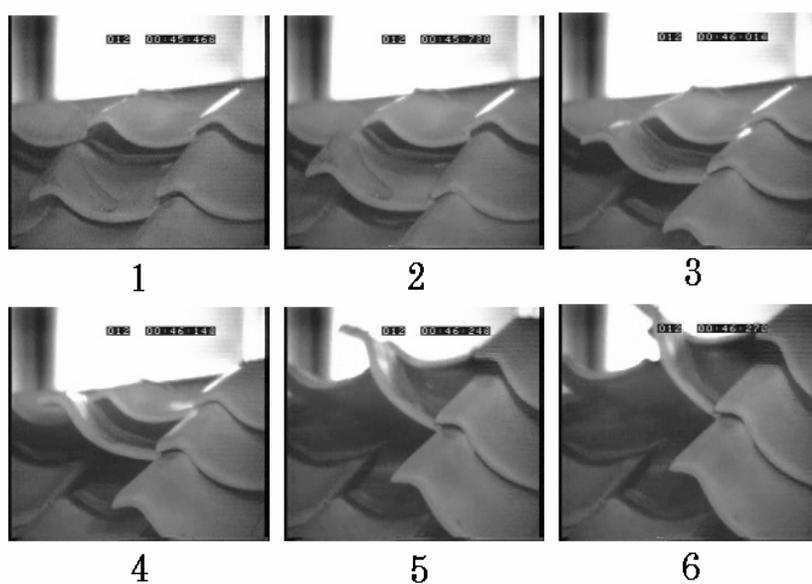
Fig. 11. Lifting up of roof tiles due to wind action as recorded by a high-speed video camera at $U = 40.0$ m/s

Hazelwood (1980b) described the lifting mechanism of a tile by a moment turning the tile upward around the pivoting point on the batten. The moment consists of a lifting force and two force couples caused by the external and internal pressure distributions, respectively. Fig. 11, which shows snapshots of a high-speed video camera picture, demonstrates this lifting mechanism for wind direction perpendicular to the eave. For a local flow direction perpendicular to the ridge, the internal pressure in the space between the tiles and underlay may become positive because of stagnation. As a result, the net wind load increases because of the sealing effect of the underlay. However, pressure equilibration in the gable roof is prevented, leading to a much lower net wind load for the leeward roof tiles. Aerodynamically favorable tiles should have a shape that prevents stagnation at the overlaps. The permeability at the overlapping gaps parallel to the ridge should be small and the permeability at the interlocking gaps perpendicular to the ridge, where suction occurs due to the element flow field, should be high (Hazelwood, 1980a).

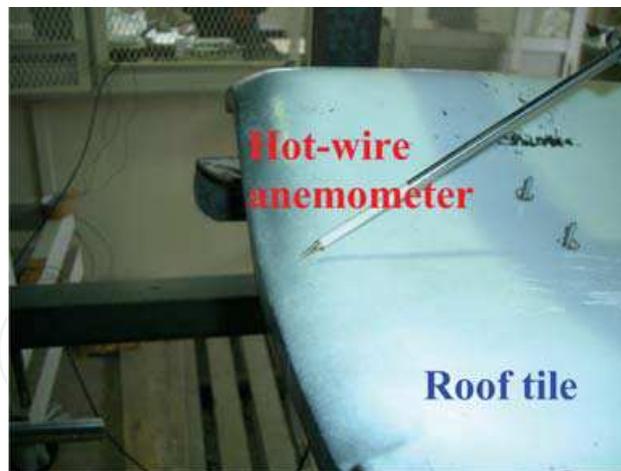
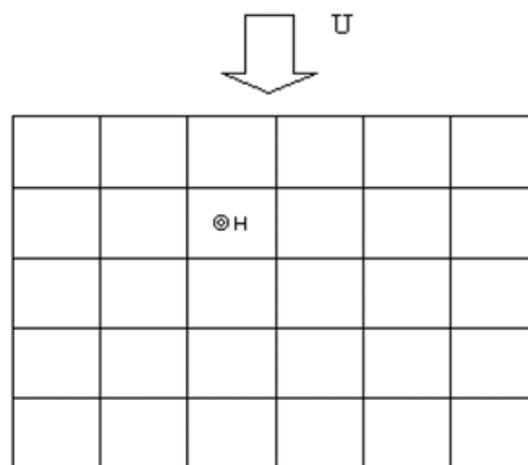
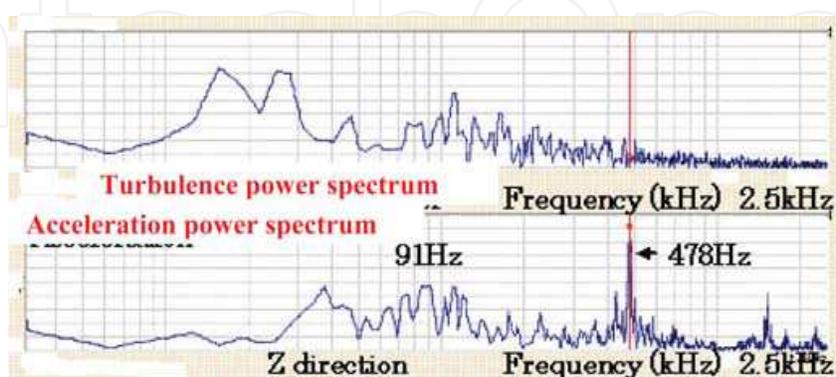
(a) Hot-wire anemometer and roof tile

⊙ Accelerometer
H Hot wire anemometer

(b) Positions of accelerometer and hot-wire anemometer

(c) Vibrational acceleration and turbulence power spectrum.

Fig. 12. Vibrational acceleration and turbulence power spectrum of roof tiles for $\theta = 0$ degrees, $\phi = 90$ degrees, and $U = 40.0$ m/s

Fig. 12 shows an example of the typical turbulence spectrum obtained by the hot-wire anemometer for $\theta = 0$ degrees, $\phi = 90$ degrees, and $U = 40$ m/s. With a turbulence level of surface flow close to the roof tiles, the tiles exhibited only the typical turbulence-buffeting response within the intermediate ranges of the angle of incidence. The Reynolds number during the experiment was so high that the edge separation was turbulent. The sources of vibration are the front and side edge vortices (Fig. 13). The vibration amplitudes increased progressively with increasing velocity, which indicates a typical buffeting response.

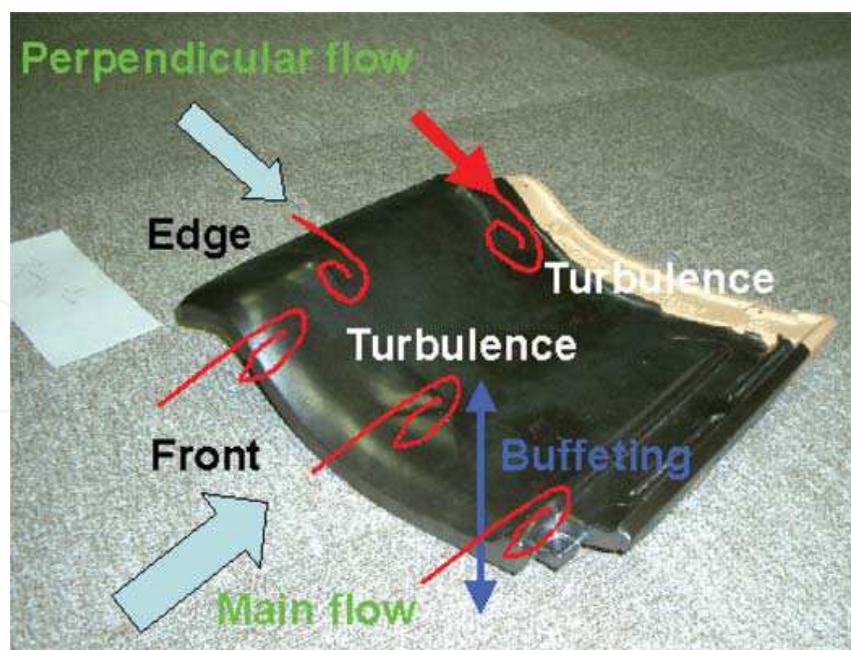
Fig. 13. Transverse vibration of roof tile

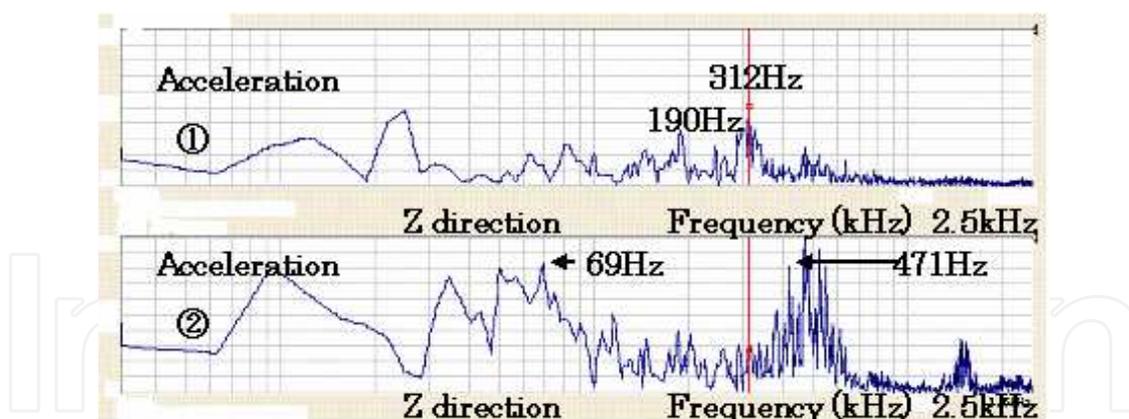
Fig. 14. Vibrational acceleration power spectrum of roof tiles at $\theta = 24$ degrees, $U = 40.0$ m/s

The results obtained by the FFT analysis of the acceleration signals in the experiment in which fluttering occurred are shown in Fig. 14. The results show the oscillation of fluttering at a pitch angle of 24 degrees and a wind velocity of 40 m/s. The wind velocity was gradually increased from the start of the wind tunnel test to its maximum velocity, and the acceleration measurement and the video camera recording were then started simultaneously. The sampling time of the FFT analyzer was set at 2,048 points, the frequency resolution was set at 800 lines, and the frequency range was 0 - 5 kHz. Moreover, the peak frequency of approximately 470 Hz, which appeared just before tile scattering, was the natural frequency and was also recognized by FFT analysis. To minimize the effects of sampling time on the results of the FFT frequency analysis, the FFT frequency was analyzed using a sufficient sampling time. As a result the relatively high frequency, i.e., the natural frequency, as well as the relatively low frequencies were recognized.

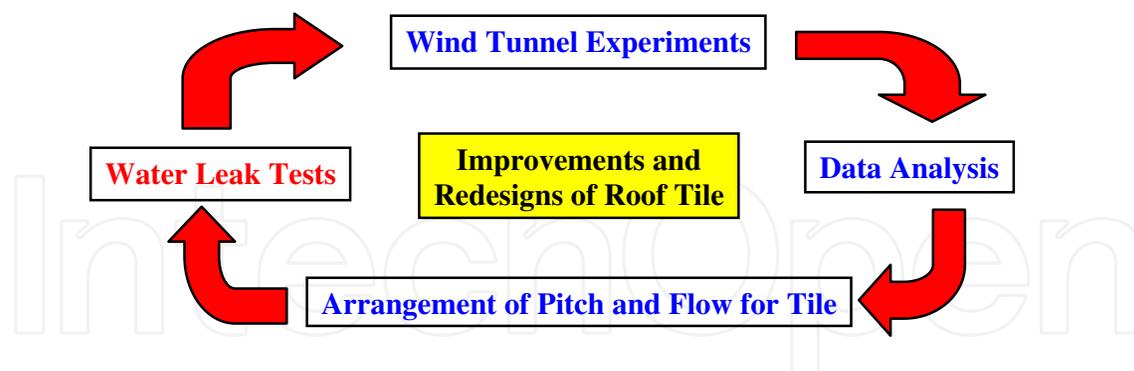
Fig. 15. Research plan for future work.

In future work, the authors will focus their attention on vibrations which cause the preliminary phenomena eventually leading to the scattering of tiles due to the effects of the wind, and will seek to understand the mechanism of these vibrations. Consequently, the authors will be able to connect together the mechanism and the preliminary phenomena of the occurrence of tile vibration induced by fluid flow. In accordance with these results, in future work the authors will go beyond the conventional understanding of water leakage amounts, aiming to establish appropriate experimental methods and to clarify the mechanism underlying the occurrence of water leak phenomena. The authors intend to investigate the previously unknown influence exerted by tile vibrations on water leaks. The ultimate goals are to provide a conclusive understanding of the effects of wind and to provide suggestions for possible improvement and redesign of roof tiles (Fig. 15).
