Low Impact Velocity Wastage in FBCs – Experimental Results and Comparison Between Abrasion and Erosion Theories

J. G. Chacon-Nava^{1,*}, F. Almeraya-Calderon¹,
A. Martinez-Villafañe¹ and M. M. Stack²

Abrasion Resistance of Materials

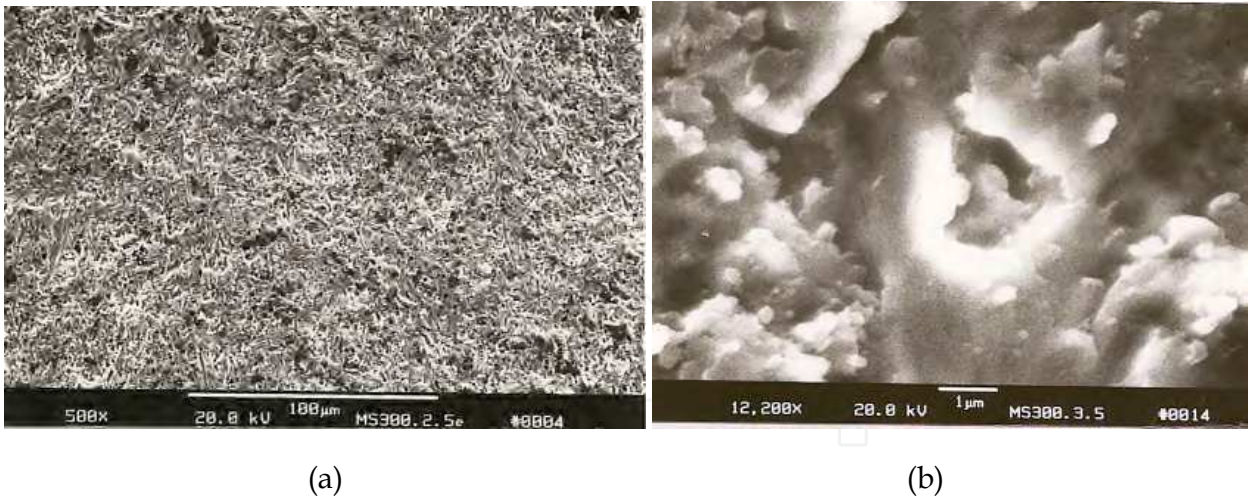
Fig. 7. Scanning electron micrograph of mild steel exposed in the FB rig at 300°C and 2.5 m s⁻¹ showing a) the surface morphology and b) morphology at higher magnification

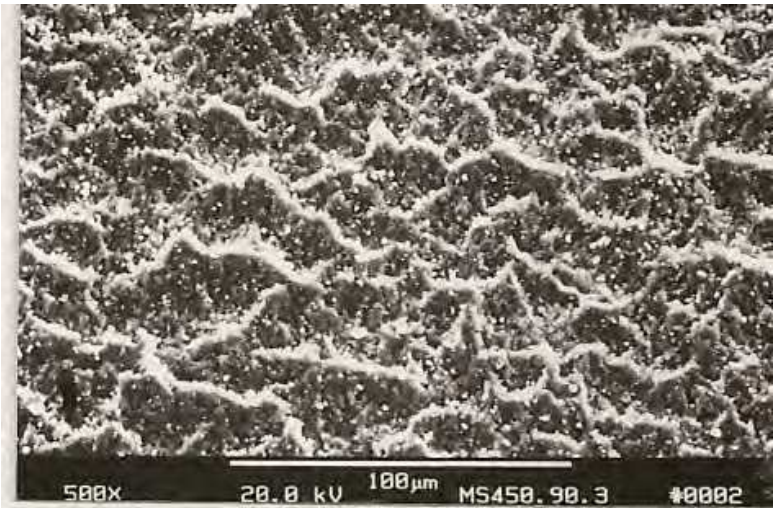
Fig. 8. Scanning electron micrograph of mild steel exposed in the FB rig at 450°C and 2.5 m s⁻¹.

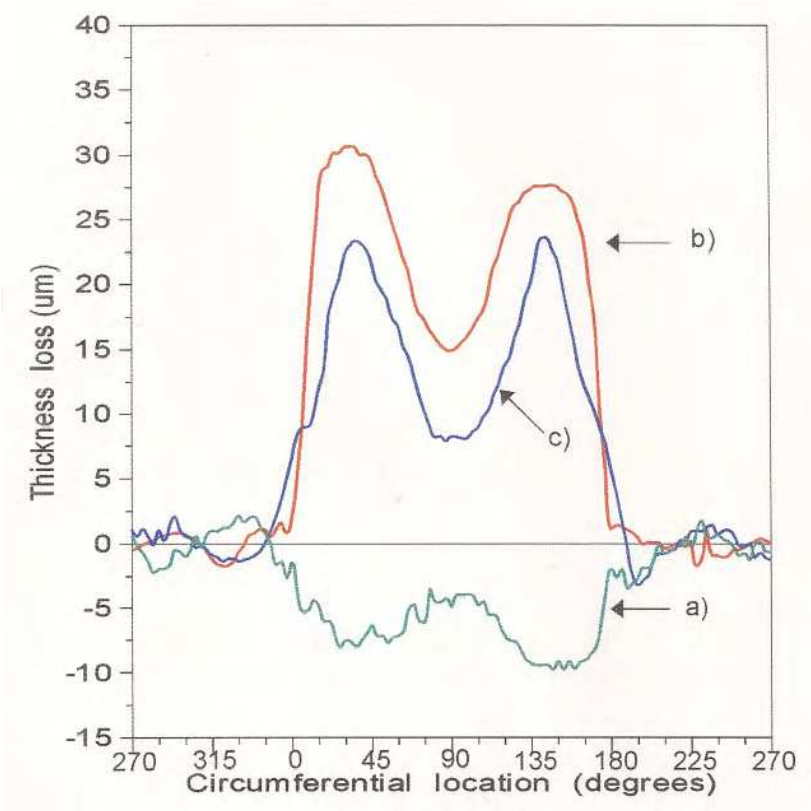
Fig. 13. Thickness loss as a function of impact angle for mild steel at 100°C eroded with the 560 μm alumina particles at a) 1.5 m s⁻¹, b) 4.5 m s⁻¹ and c) 310 SS at 4.5 m s⁻¹

Fig. 13 shows the angular dependence on thickness loss for mild steel and 310 SS at 100°C . In the first case, two wear profiles are shown: at 1.5 m s^{-1} , a negative thickness was recorded in the angular range from 0° to 180° . More likely, this pattern could be associated with deposition of erodent on the exposed area, as was confirmed by EDX analysis on the specimen surface. Indeed, this was the case for both steels at such low velocity and below 300°C . Increasing the impact velocity produced a typical M pattern with two peaks located at each side from the front of the specimen. For instance, at 4.5 m s^{-1} , the maximum thickness loss was about $30 \text{ }\mu\text{m}$, although some material loss was also evident at normal impact angle. For the 310 SS, a similar trend was found, although the thickness loss was slightly less at both shallow and normal impact angles, compared with the mild steel. For both steels, the angle of maximum attack was almost the same, about 35° (145°). The angle in the parenthesis corresponds to the second peak of the pattern.

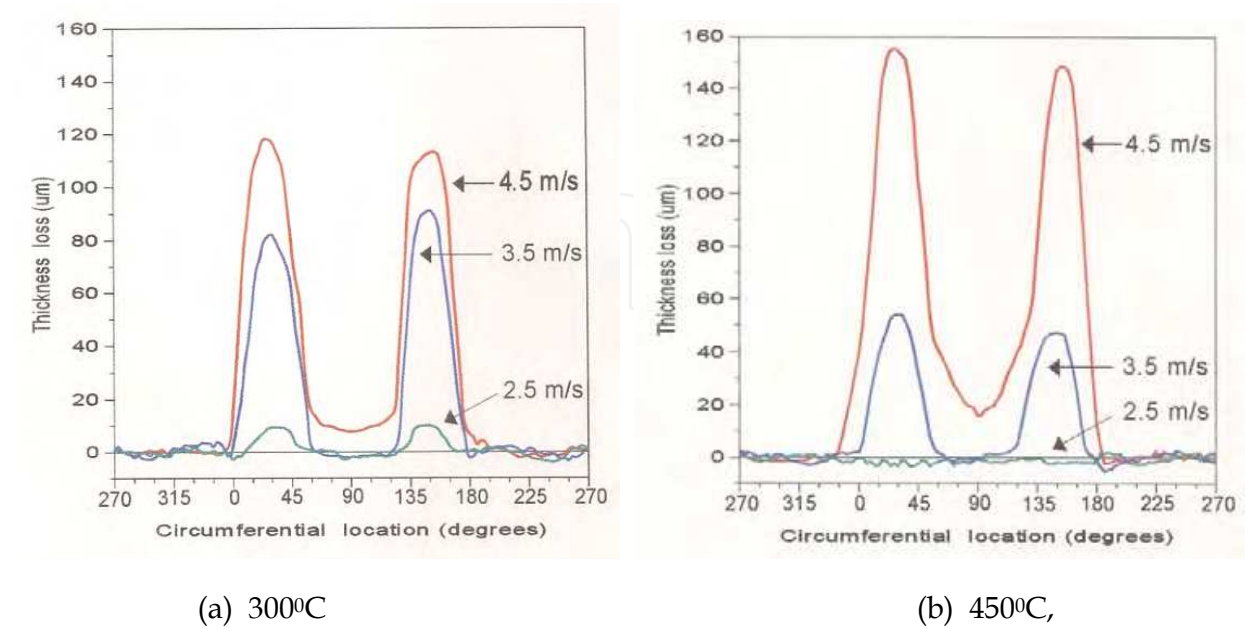
Fig. 14. Thickness loss as a function of impact angle for mild steel at a) 300°C and b) 450°C, eroded with the 560 μm alumina particles.

For mild steel at 300°C and 450°C , and impact velocities from 2.5 m s^{-1} to 4.5 m s^{-1} , the wear patterns found are shown in Fig. 14. At 300°C , it can be seen that the maximum angle of wear shifts slightly to lower angles i.e., from 33° to 27° (147° to 153°) with increasing speed. This also caused a large increase in thickness loss. At the highest speed, a maximum loss of about $115 \text{ }\mu\text{m}$ was recorded, whereas the specimen front has a typical loss of $15 \text{ }\mu\text{m}$ (a loss was not observed at lower speeds). At 450°C , and 2.5 m s^{-1} , no thickness loss was recorded, but further increases in impact velocity produced similar profiles to the ones observed at 300°C . At the highest velocity, the wastage at the specimen front was somewhat higher, with a V shape pattern. At shallow angles, the main difference at both temperatures was the thickness loss magnitudes. Fig. 15 shows the results at 600°C for mild steel. Here the angle of attack shifted from 33° to 24° (147° to 156°) on increasing the impact velocity from 2.5 m s^{-1} to 4.5 m s^{-1} .

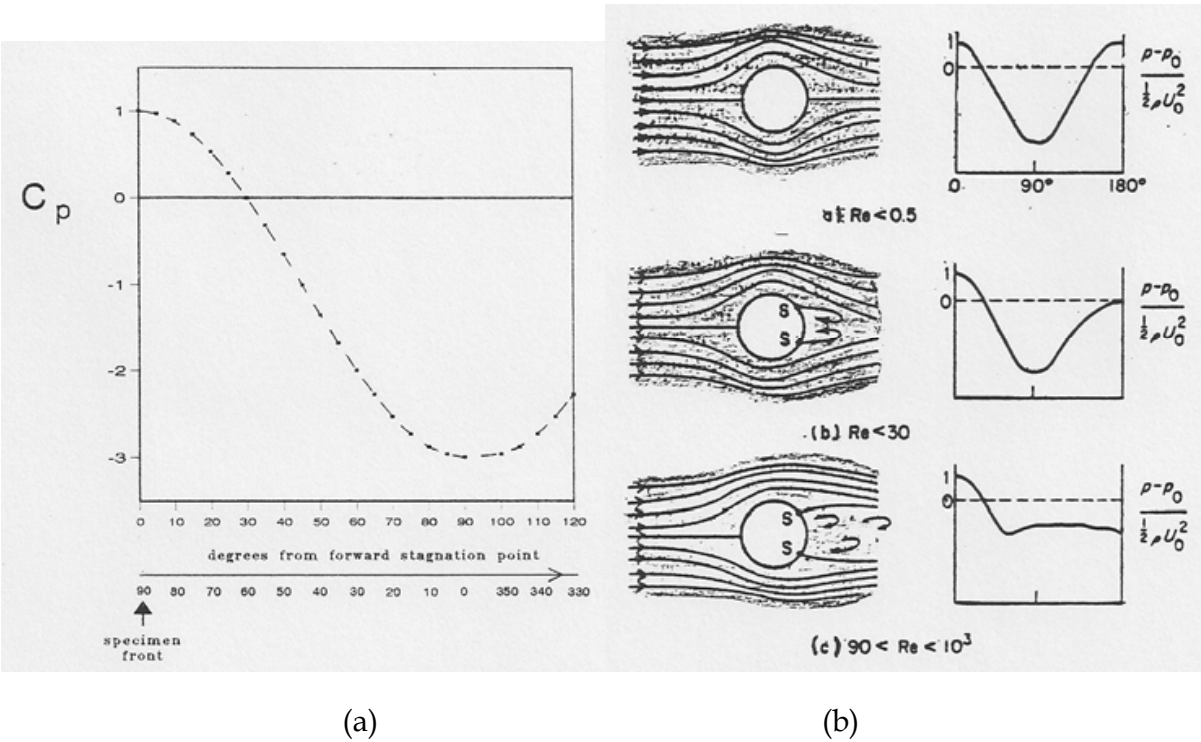
Fig. 19. Coefficient of pressure, C_p , on the surface of a cylinder as a function of angle, a) as derived from equation 13, b) for flow past a cylinder for various Re ranges

Where C_p is the pressure coefficient. A plot of equation 13 is given in Fig. 19(a), where it can be seen that the pressure distribution is similar to that found at low Re numbers, Fig. 19(b). From classical abrasion theory (Archald, J. 1953, Rabinowicz, E. 1960), the abrasive wear rate, AWR, can be expressed as
