Nondestructive Evaluation of FRP Strengthening Systems Bonded on RC Structures Using Pulsed Stimulated Infrared Thermography

Frédéric Taillade, Marc Quiertant, Karim Benzarti,
Jean Dumoulin and Christophe Aubagnac
*Université Paris-Est, IFSTTAR, F-75015 Paris
France*

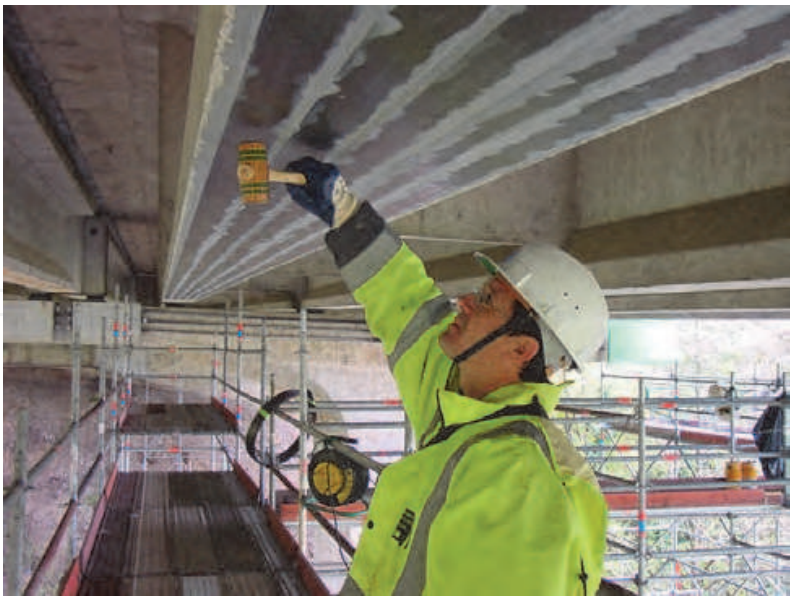
Fig. 1. Inspection with acoustic sounding (hammer tapping).

Visual inspection and acoustic sounding (hammer tapping) are commonly used to detect delaminations (disbonds) (Fig.1). However, these current practices are unable to provide relevant information about the depth (in the case of multilayered FRP systems) and width of debonded areas and they are not capable of evaluating the level of adhesion between the FRP and the substrate (partial delamination, damage or poor mechanical properties of the polymer adhesive). Adherence properties of FRP systems installed on concrete substrates can be evaluated by conducting on site pull-off adhesion tests on witness panels specifically bonded on test zones (Fig.2).

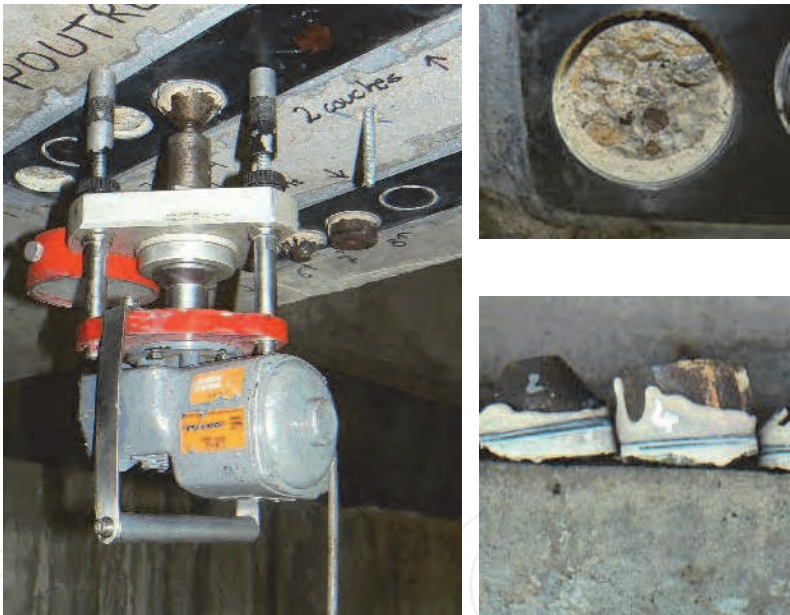
Fig. 2. Pull-off method.

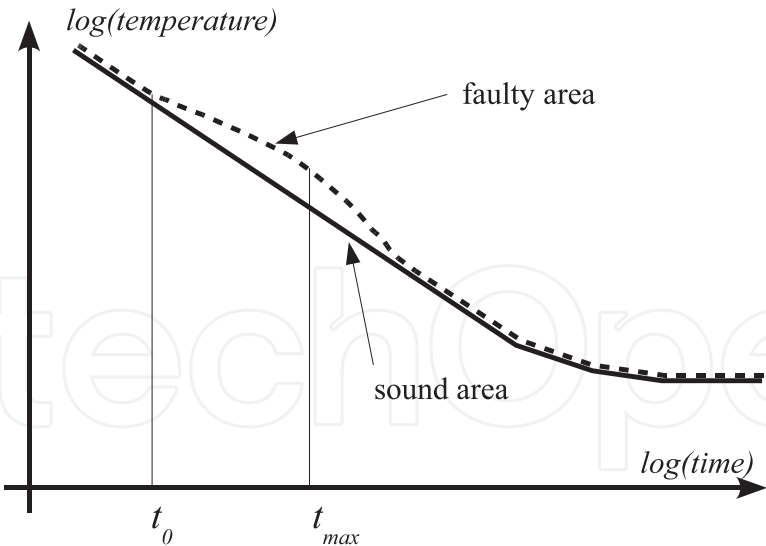
Fig. 4. Thermograms of sound and faulty regions.

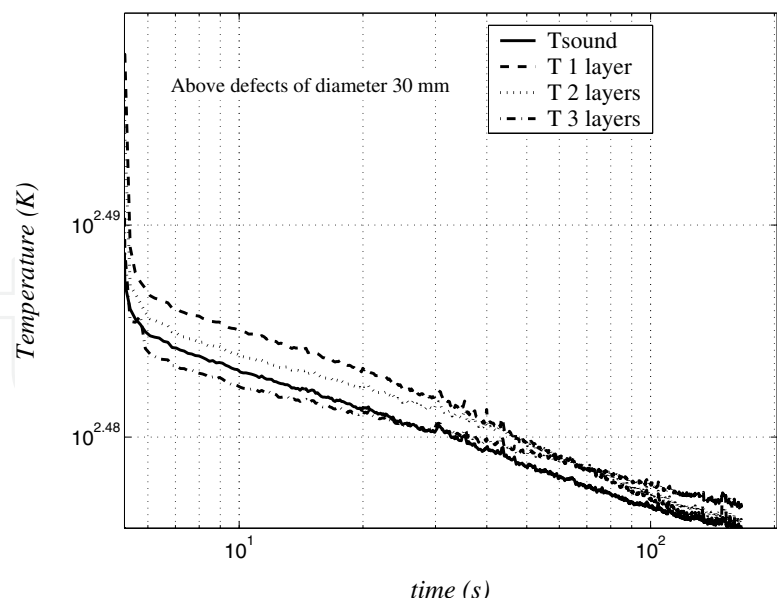
Fig. 14. Experimental thermograms of sound (solid line) and faulty regions above the larger defects (dashed line for a depth of 1.2 mm, dotted line for a depth of 3.4 mm and dash-dot line for a depth of 5.6 mm).

The thermograms (Fig.14) and the thermal contrast (Fig.15) are computed above the larger defect (diameter = 30 *mm*). The maximum contrast appears 7 *s*, 33 *s* and 120 *s* after the end of the heating respectively to the depth. Using equations (2) and (6) iteratively, it is possible to retrieve the defect’s depth with a good accuracy in the three cases considered here.

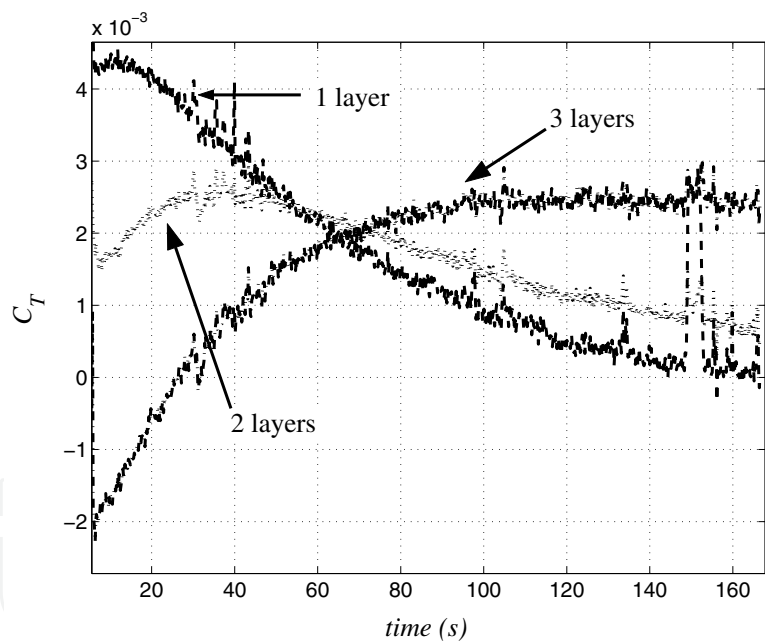
Fig. 15. Thermal contrast *vs.* computed time for regions above the larger defects (dashed line for a depth of 1.2 mm, dotted line for a depth of 3.4 mm and dash-dot line for a depth of 5.6 mm).

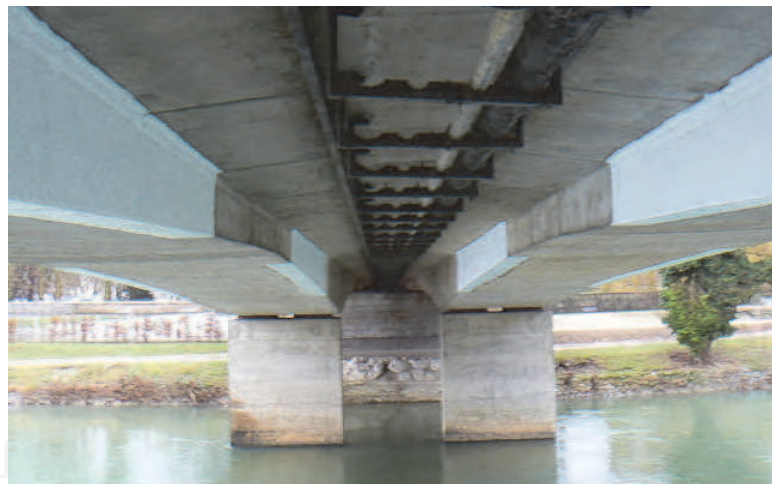
Fig. 17. View of the bridge under consideration; FRP repaired zones correspond to the white parts on the girders.

In order to prevent brittle failure at mid-span, it was decided to repair the cracked box-girders by bonding carbon fibre sheets according to the wet lay-up process (onsite impregnation). A recalculation of the structure was performed in order to optimize the repair design with respect to the shear stress distribution. Finally, composite reinforcements were installed at the outer side of the web of girders as shown in figure 17.
