# Investigation of Broken Rotor Bar Faults in Three-Phase Squirrel-Cage Induction Motors

Ying Xie

*Harbin University of Science and Technology,  
China*

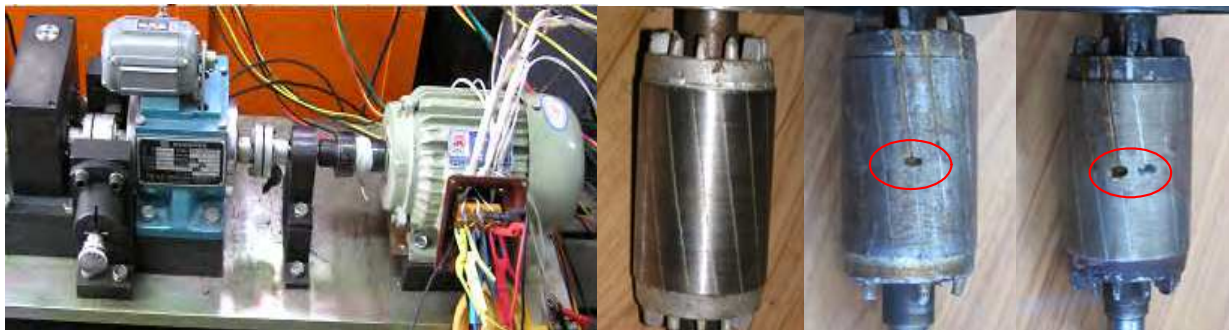
Fig. 1. The experimental setup and the three rotors.

A dedicated experimental test bench has been designed for testing squirrel-cage induction motor faults. One stator and three originally identical rotors have been employed to study the behaviours of the induction motor with or without broken bars. Prior to the start of the testing process, two out of the three rotors are damaged deliberately by drilling holes in the bars on all their depth and used with the same stator to ensure the testing accuracy. The healthy rotor is considered here as a reference. The laboratory test setup and broken bar rotors are shown in Fig. 1.

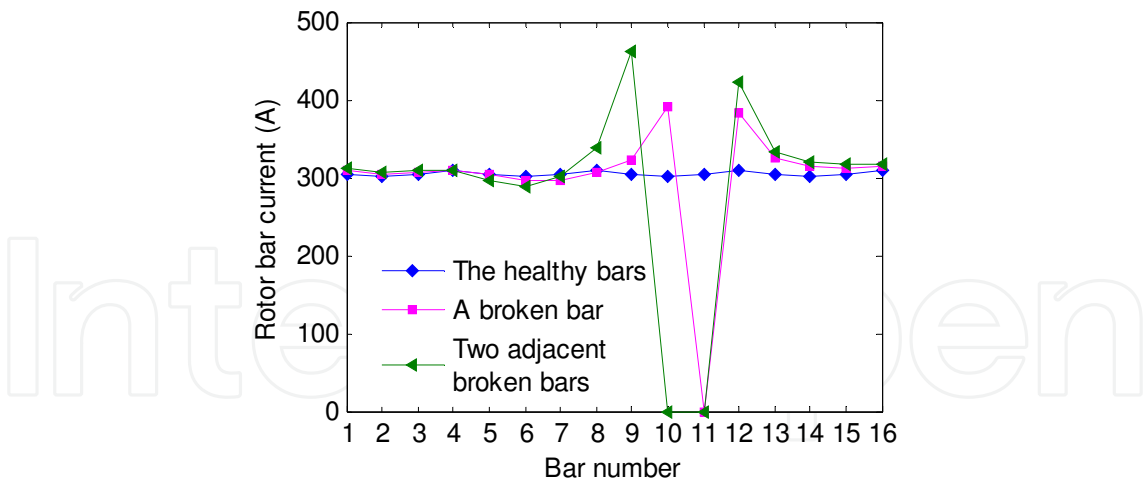
Fig. 13. The simulated rotor bar current at rated load.

When the rotor is rotating, each rotor bar passes every stator slot, so that each bar will be equally influenced by all the stator-driven flux waves, and all the currents of the rotor bars at rated load are sensibly uniform around the rotor periphery. Fig. 13 shows rotor-bar currents at rated load. It can be seen that the amplitude of the adjacent bars has the highest value in the bars next to the broken ones, this explains why and how bar damage propagates. The currents in bars far away from the broken bars remain almost the same.

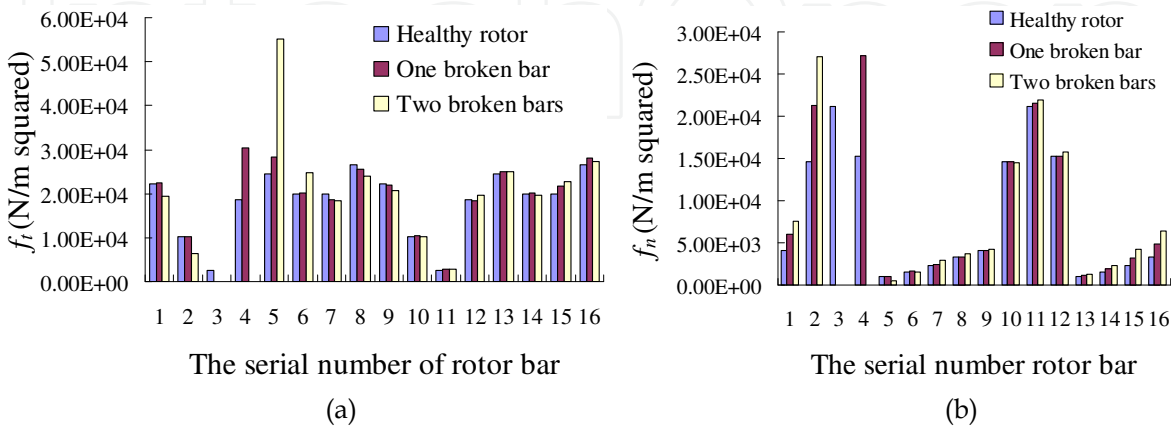
Fig. 16. The magnetic force distribution of every rotor bar at rated load. (a)Tangential component, (b) Normal component

In this section, the magnetic force distribution on the rotor bar at rated load and at standstill is computed, and the position of broken bars is shown in the Fig.15. The magnetic force distributions on the rotor bar at rated load and at standstill are computed by the FE method and the results are shown in the Fig. 16-17 for comparison. It can be noticed that the bars with the highest magnetic force are those immediately adjacent to the broken bars, whether the motor operating under rated load conditions or standstill conditions. Consequently, such non-uniform distribution of the force inevitably leads to excessive mechanical stress in the bars, and the bars would become more susceptible to additional wearing and eventual breaking.

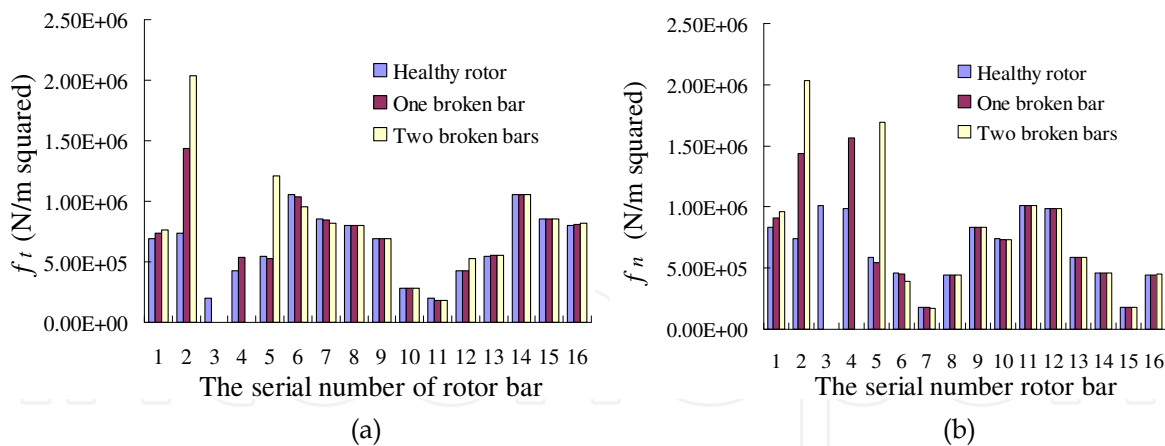
Fig. 17. The magnetic force distribution of every rotor bar at locked rotor. (a) Tangential component, (b) Normal component

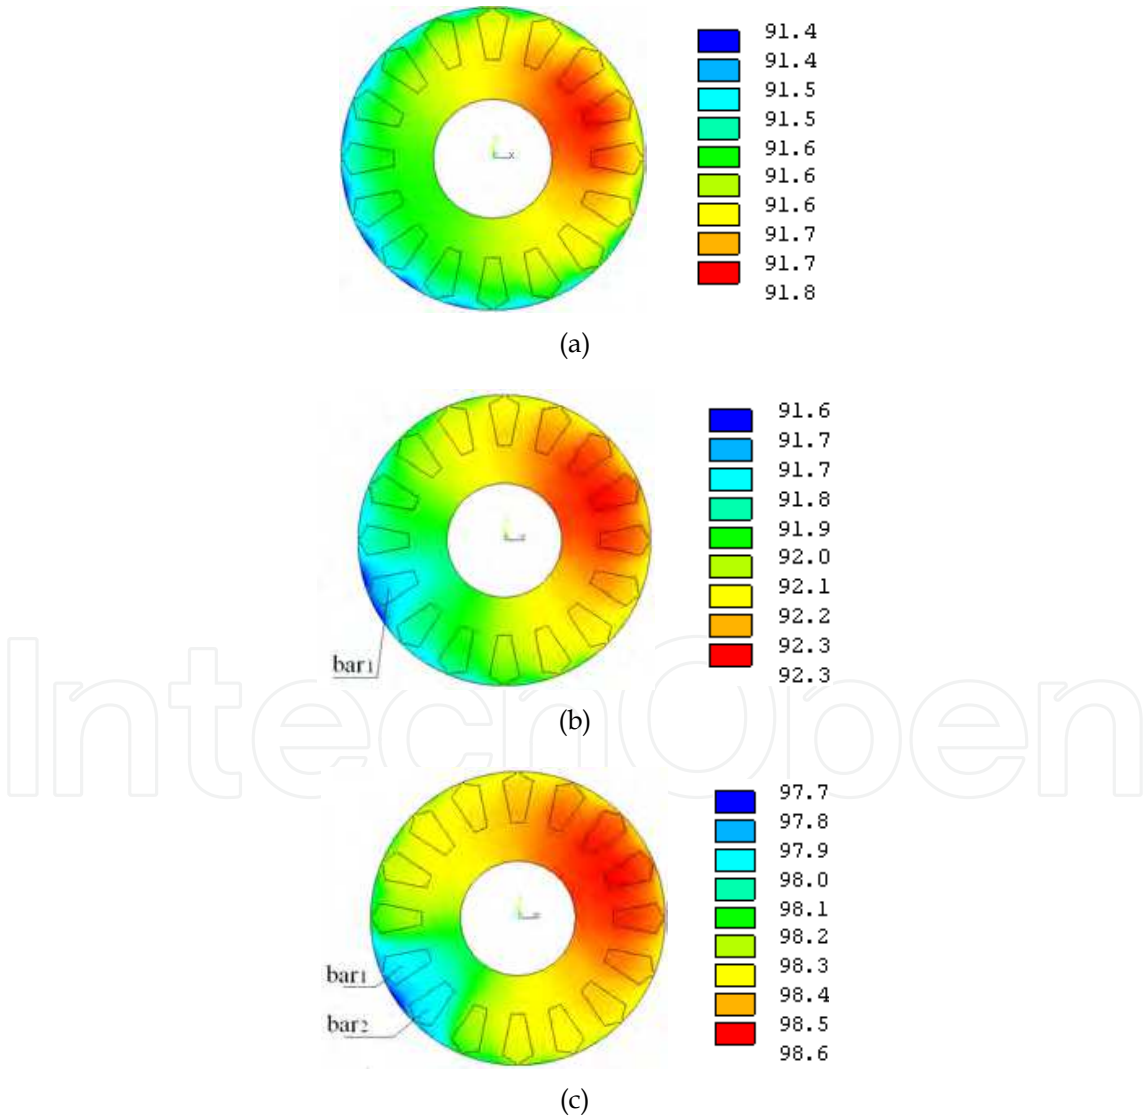
Fig. 24. Rotor temperature distribution. (a) healthy motor cage, (b) a bar 1 broken, (c) bar 1 and bar 2 broken (ying xie 2010)

Fig.24 are the steady rotor temperature distributions of the motor at the above three states. The rotor temperature distribution of the motor with a healthy rotor is not complete symmetry because of the quasi-stationary-state treatment of the air-gap and the incomplete symmetry of the motor house. But the whole rotor solving region is quite small which is due to the large thermal conductivities of the rotor core and rotor bar. It can be found that the lowest temperatures are in the positions of broken bars in the whole rotor solving region from Fig.24 (b) and (c). It indicates that with the increase of the broken bar number, the temperature-rise at the same position of the motor increases. It can be predicted that the temperature-rises of the stator windings and the rotor will increase dramatically in the case of the motor with serious adjacent broken bars fault.

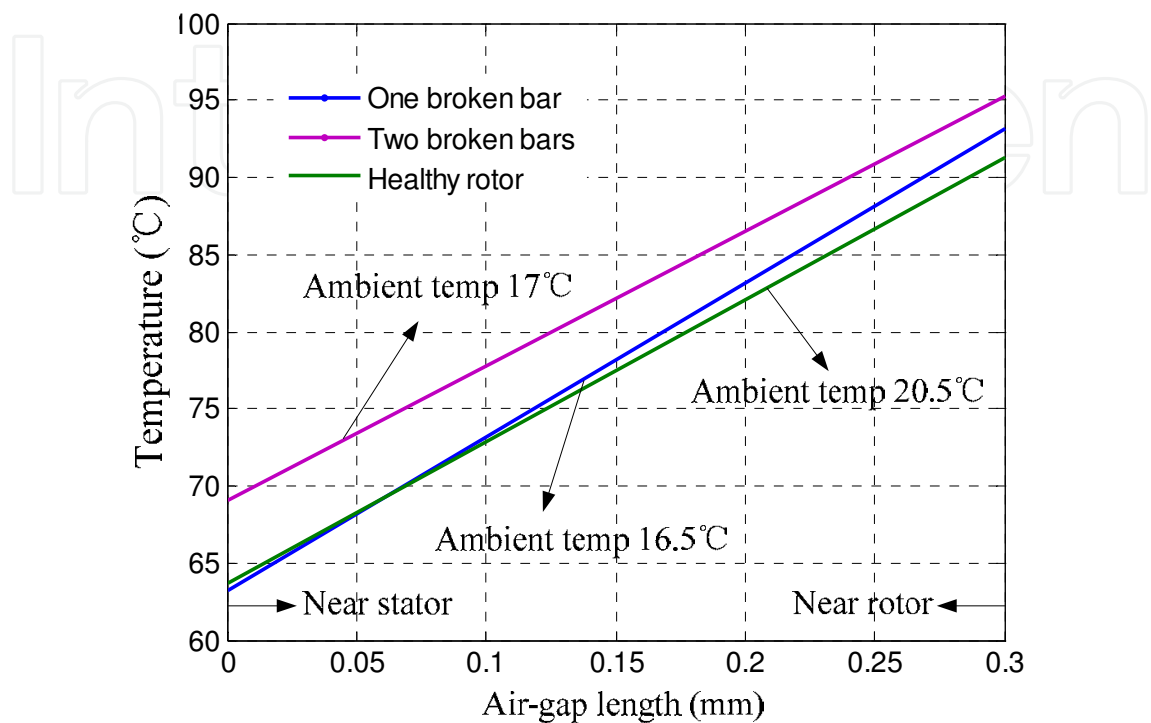
Fig. 25. The air-gap temperature distribution along radial

The air-gap temperature distribution along radial is given in Fig. 25. From it the temperature gradient of the air-gap along radial is rather large. The temperature distribution throughout stator slot along radial of the motor cross section is given as Fig. 26.

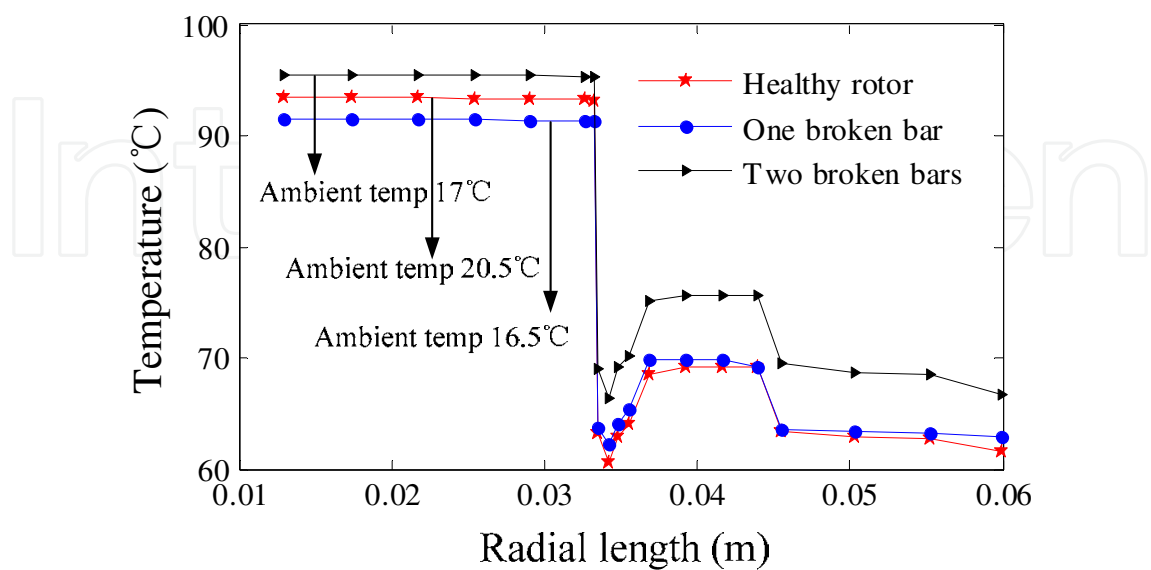
Fig. 26. Temperature distribution throughout radial
