A Geologic and Geomorphologic Analysis of the Zacatecas and Guadalupe Quadrangles in Order to Define Hazardous Zones Associated with the Erosion Processes

Felipe de Jesús Escalona-Alcázar, Bianne Escobedo-Arellano, Brenda Castillo-Félix, Perla García-Sandoval, Luz Leticia Gurrola-Menchaca, Carlos Carrillo-Castillo, Ernesto-Patricio Núñez-Peña, Jorge Bluhm-Gutiérrez and Alicia Esparza-Martínez

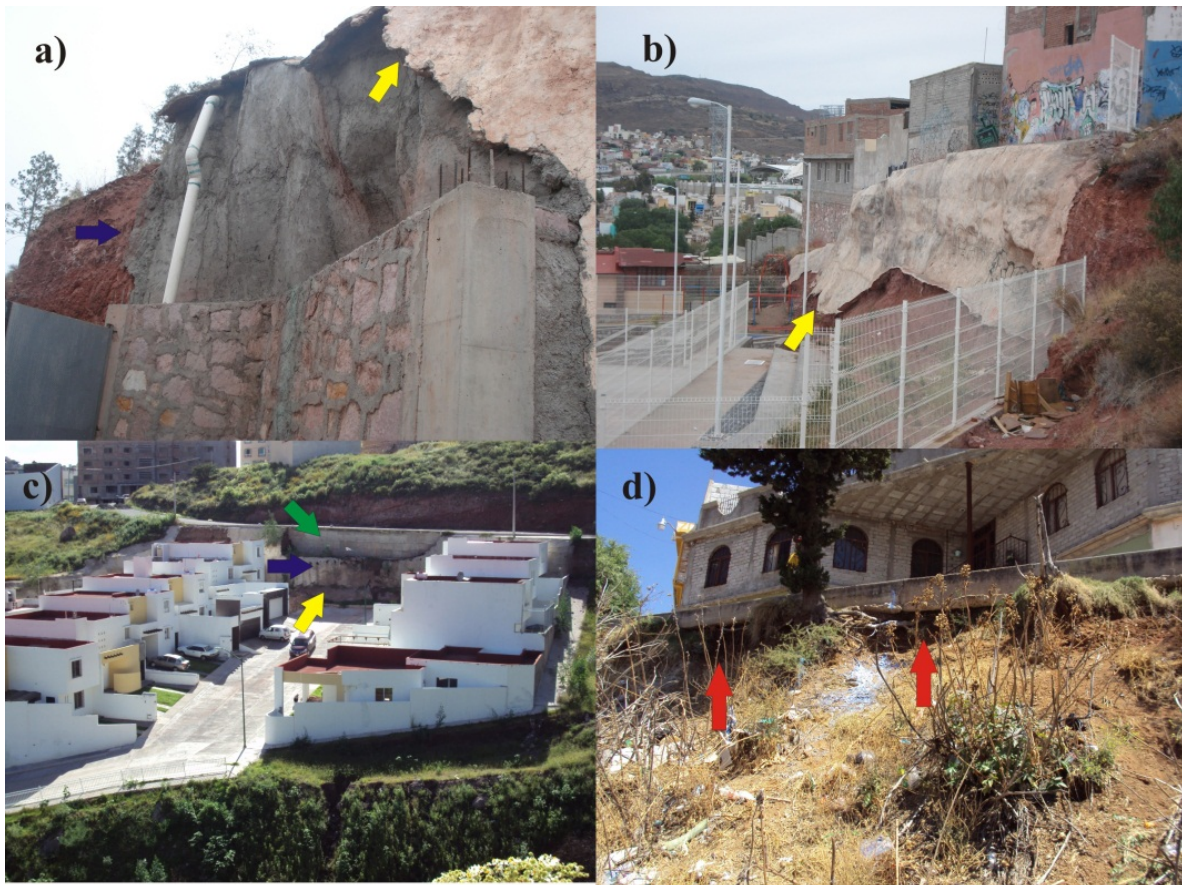
Figure 2. Images showing the erosion hazards associated with different lithology: a) and b) are in the granitic facies of the Zacatecas Conglomerate; c) moderately consolidated facies of the Conglomerate; and d) deformed lava flows from Las Pilas Complex. Yellow arrows point toward the first attempt of damage repair. Purple arrows are the sites where a second repair phase has been attempted; while the green arrow shows a third repair phase. The red arrows point to the voids created due to the soil removal by the erosion processes.

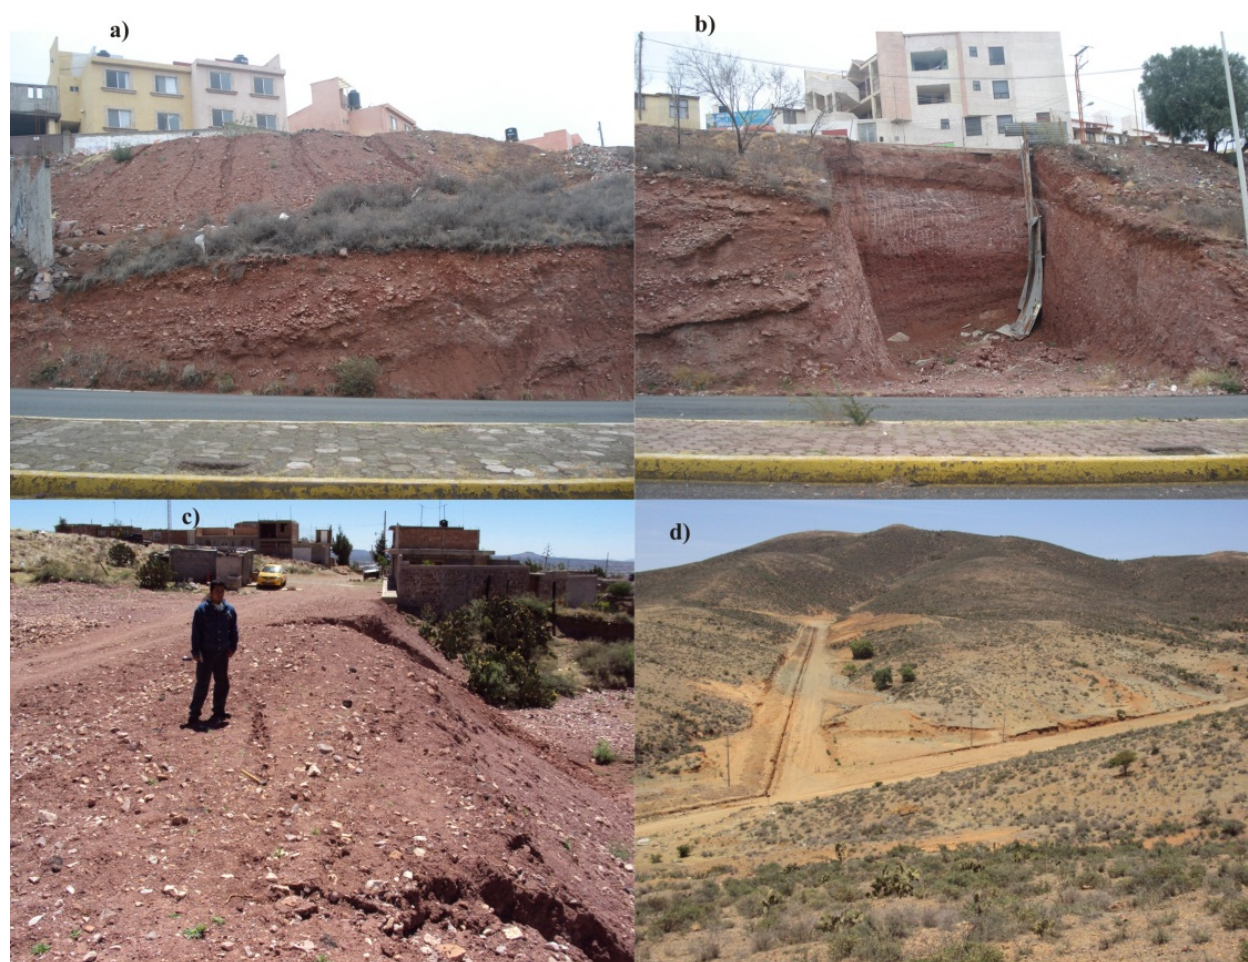
Figure 13. Field verification of the proposed model for hazardous zones associated with erosion. a) Moderate erosion zone; in the filling deposit can be seen gullies formed after the rainy season; whereas the conglomerate is affected by differential erosion. b) Intense erosion zone. An excavation was made

for unknown reasons. The effects after the rainy season were that the wall and sidewalk fall. c) A Low erosion zone in a semi plain area; more than one year after the road was built, large gullies developed. d) An intense to moderate erosion zone. The undisturbed area is in the intense erosion where no visible effects are seen; while the moderate one is where the streets are traced.

The results shown in **Figure 12** were verified in the field and they are presented in **Figure 13**. The erosion removes unconsolidated materials if the original conditions are changed; otherwise the process is very slow. The velocity at which erosion acts depends on the zone they are in. The model here defined should be taken into account for the urban development planning. This model locates areas potentially affected by erosion if the landscape is modified.
