Extensor Mechanism Complications After Patellar Resurfacing in Knee Replacement – Can They Justify Non-Patellar Resurfacing?

Antonio Silvestre, Raúl Lopez, Fernando Almeida, Pablo Renovell, Francisco Argüelles and Oscar Vaamonde

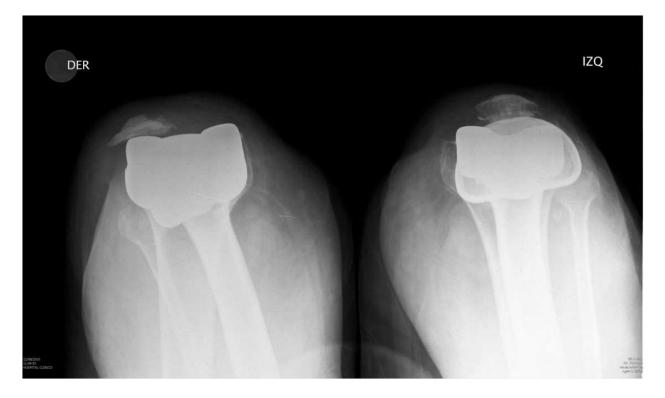
Figure 1. Advanced-age patient suffered subluxation of the extensor mechanism due to a patella infera, after total knee replacement. It was well tolerated; orthopedics measures were employed (a brace and avoiding activities that aggravate instability)

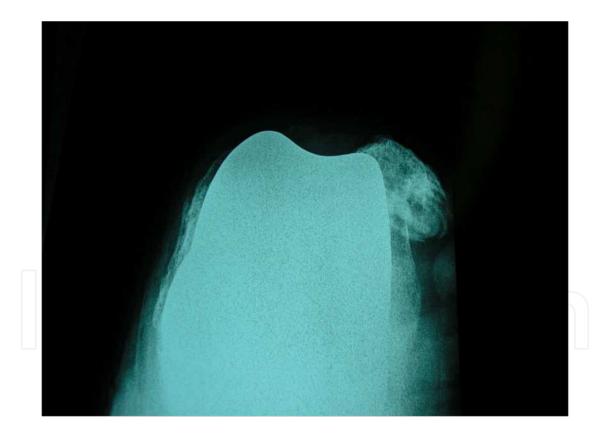
Figure 2. Frank dislocation of the patella who required revision surgery. Internal rotational alignment of the femoral component made us to revise it, getting good functional outcome after surgery.

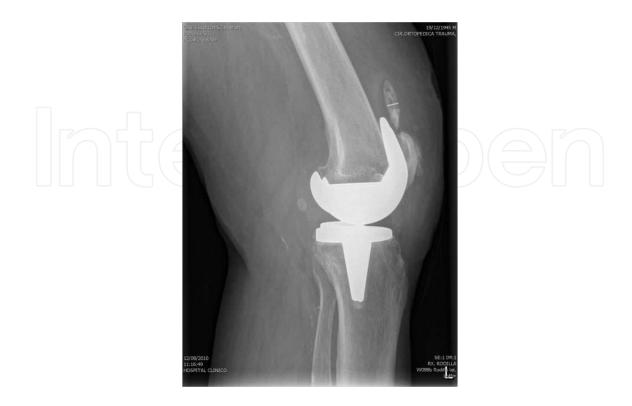
Figure 3. Loosening of the patellar insert that required removing of the polyethylene. As quality of remaining bone wasn't good, no other all-polyethylene implant was placed

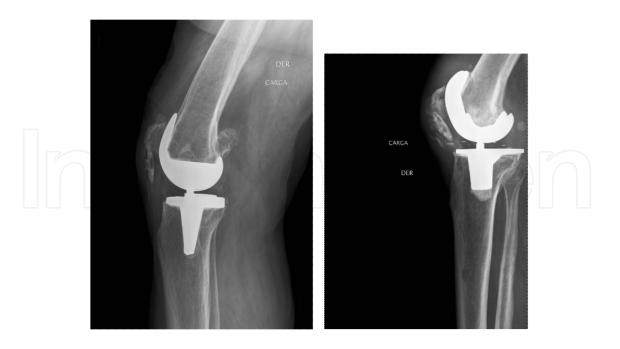
Figure 4. Two examples of fracture of the patella with loosening of the patella. The patients referred a previous trauma in both cases and revision surgery with extensor mechanism reconstruction was done.
