The Structural Performance of Stone-Masonry Bridges

George C. Manos, Nick Simos and
Evaggelos Kozikopoulos

<http://dx.doi.org/10.5772/64752>

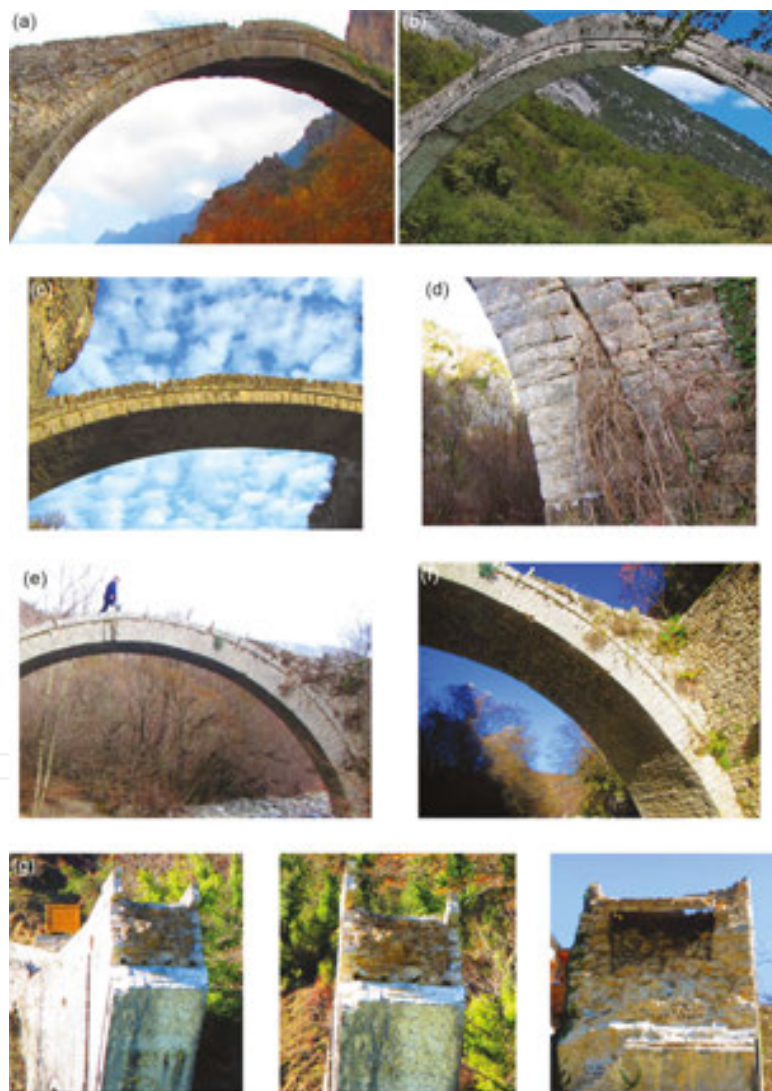
Figure 10. (a) Konitsa Bridge with the primary and secondary arches of the central span; (b) Plaka Bridge with the primary and secondary arches of the central span; (c) and (d) Kokorou Bridge with the primary and secondary arches of the central span; (e) and (f) Kontodimou Bridge with the primary and secondary arches of the central span; and (g) stone-masonry construction visible for the internal part of the mandrel walls of the remaining parts of Plaka Bridge.

7. On the contrary, neither the shape nor the quality of the stones or the mortar was of equal importance for the mandrel walls. As can be seen in **Figure 10g** that depicts the remaining part of the Plaka Bridge, these mandrel walls were internally constructed with some form of rubble. However, in order to protect these parts from the weather conditions, the mandrel walls were also encased within facades of good-quality stone masonry (**Figure 10g**).

8. Because the primary and secondary main arches were constructed at different construction stages, there is a continuous cylindrical joint that lies between them (see **Figure 10a–f**). As revealed by the remains of the collapsed Plaka Bridge, wooden beams with iron inserts were employed to connect the primary and secondary arches at certain intervals.
9. Iron ties were also used to connect the two opposite faces of the primary arch in many bridges. These iron ties are visible in the photos of the main central arch of the Plaka Bridge before its collapse and they are still in place at the parts of the arch that were salvaged after its collapse (**Figures 11 and 12**). The iron ties were also used to connect the opposite faces of the primary arch of the main span in Tsipianis Bridge (**Figure 13**) and in Voidomatis bridge at Klidonia (**Figure 14**).

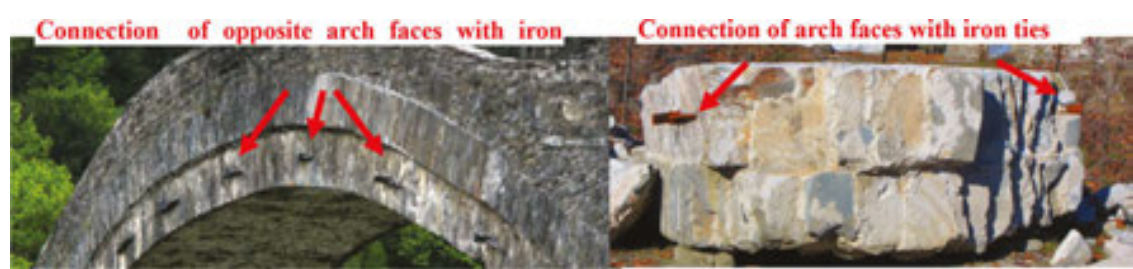
Figure 12. Iron ties used to connect the two opposite faces of the primary arch in Plaka Bridge.

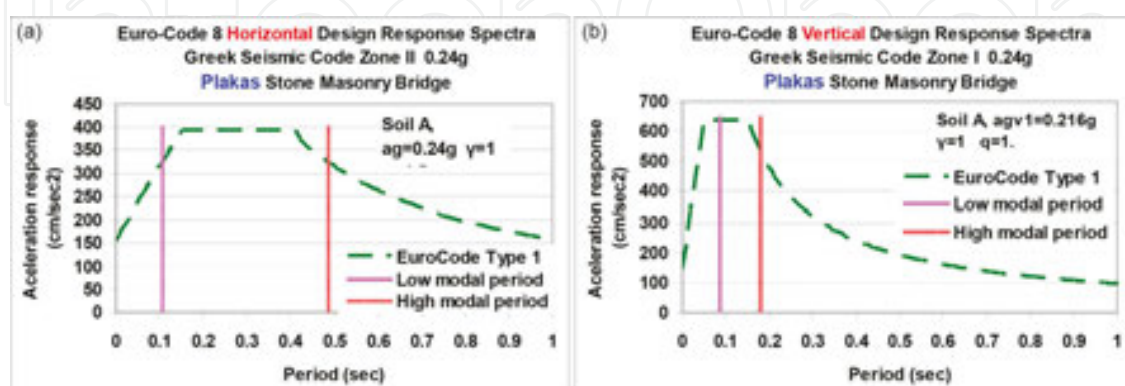
Figure 32. (a) Horizontal spectral curves for type-1 Euro-Code to be applied in Plaka bridge and (b) vertical spectral curves for type-1 Euro-Code to be applied in Plaka bridge.

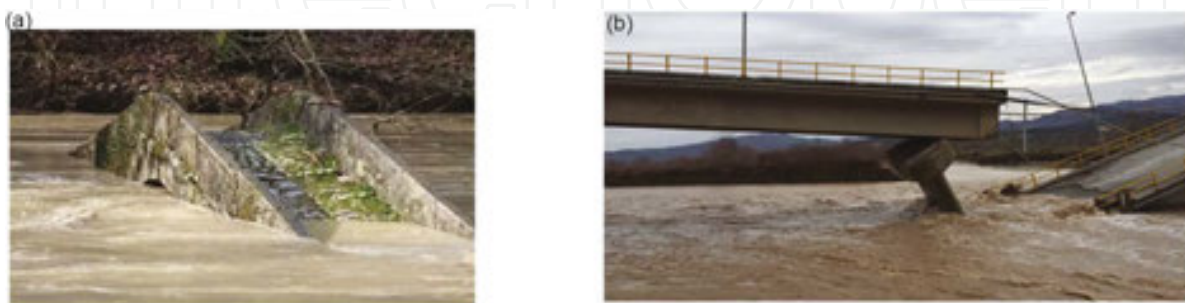
Figure 49. (a) Almost total flooding of a stone masonry bridge and (b) tilting of a mid-pier and partial collapse of the Diava-Kalampana reinforced concrete bridge in Thessaly, Greece (16th January, 2016).

window as was demonstrated by a recent flooding of Pineios river that caused the tilting of a mid-pier and the partial collapse of the Diava-Kalampaka-reinforced concrete bridge in Thessaly, Greece (16 January 2016, **Figure 49b**).

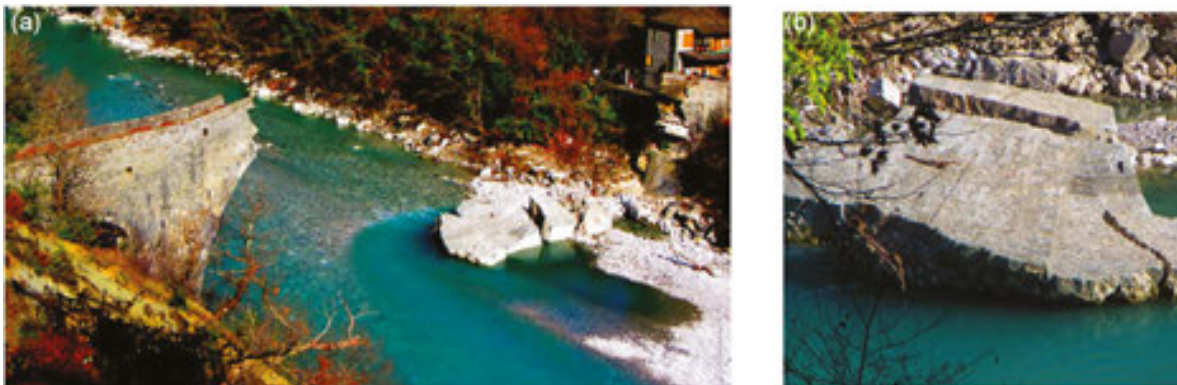
Figure 50. (a) View of the Plaka Bridge after the collapse from the West bank. Note the total destruction of the mid-pier (see also **Figure 7d**). (b) Close-up of the total destruction of the mid-pier of Plaka Bridge (see also **Figure 7d**).

Thus, foundation maintenance seems to be of the utmost importance. The flooding of Arachthos river, which caused the collapse of Plaka Bridge on 31 January 2015, was of considerable proportions. It is of interest to observe the conditions of the mid-pier of Plaka Bridge after the collapse (**Figure 50a** and **b**). As can be seen, the foundation of this pier is almost non-existent being covered by the remains of the East part of central arch and of part of the adjacent arch and mid-pier. Thus, it is evident that this mid-pier was highly distressed leading to this mode of collapse.

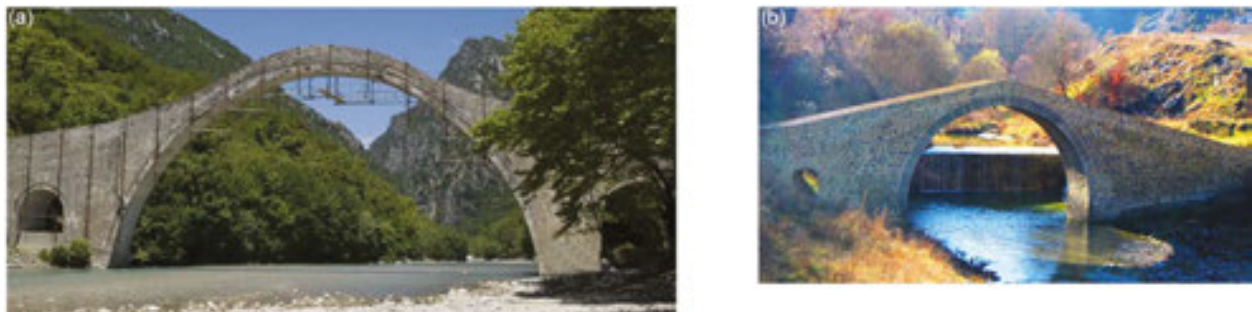
Figure 52. (a) Maintenance works at Plaka Bridge sometime before its collapse from flooding and (b) stone-masonry bridge at Dasilio-Grevena, Greece after being retrofitted.
