Application of Seismic Tomography and Geotechnical Modeling for the Solution of Two Complex Instability Cases

Roberto Balia and Pier Paolo Manca

Keywords: slope instability, structure instability, geotechnical modeling, geophysical methods, refraction tomography

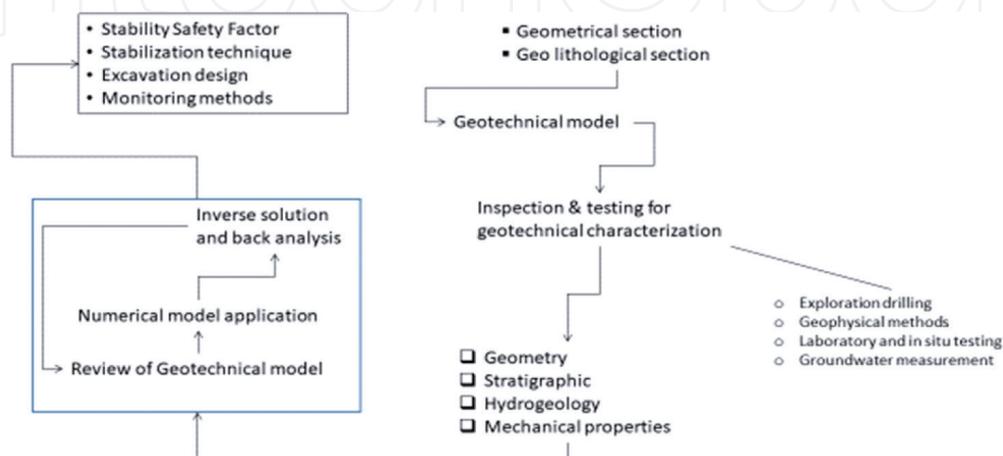
Figure 1.
Flowchart of an iterative analysis modeling—inverse solution.

The combined use of geophysical surveys and geomechanical modeling can make it possible to solve complex geotechnical problems for which geognostic surveys alone prove insufficient [1]. As illustrated graphically in **Figure 1**, the proposed procedure is composed of different phases. These are (1) analysis, (2) measurements, (3) processing, (4) preliminary model, (5) in situ surveys, (6) model revision, and (7) back and sensitivity analysis [2]. The above phases are connected to each other in an iterative way as indicated in the graph, until a satisfactory level of coherence between processing results and direct observations is reached. Actually, there may be cases in which it is difficult to know with precision the complete geometry of the problem, the lithology, and the mechanical properties of natural or artificial materials, as they are not directly investigated. In the present cases, it is possible to carry out iterative evaluations in which the formulation of an initial geomechanical model suggests typology and modality of in situ investigations. In other terms, the initial model integrates and improves the interpretative capacity of the geomechanical model whose processing, in turn, must be compared with direct observations (back analysis or inverse problem). The latter observations could be the observed stability or the instability witnessed, for instance, by easily detectable break surfaces. The last phase of the procedure consists of the sensitivity analysis [3].

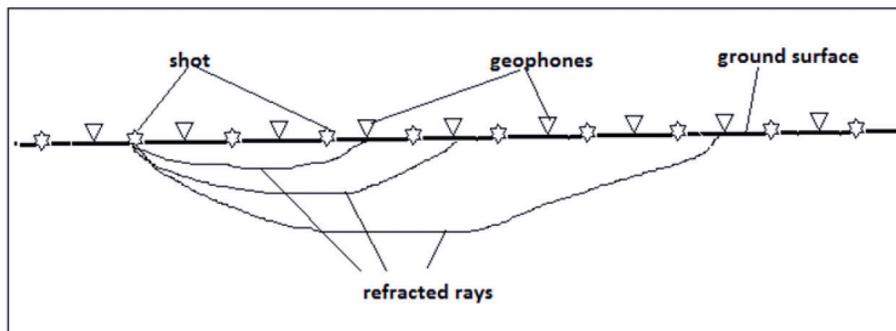
Figure 2.
Acquisition system of the classical seismic refraction tomography.

conceived and represented as broken lines, and only the main refractors could be highlighted. With respect to geotechnical study field, the most important leap, leading to current refraction data processing, has been the operational advent of the seismic tomography [9]. Among the numerous scientific works concerning the topic, the one of White [10] is undoubtedly worth mentioning. As for the inversion algorithm, the most used were FBP, filtered back projection; ART, algebraic reconstruction technique; and SIRT, simultaneous iterations reconstruction technique. In the examples discussed here, the inversion algorithm named ASA—adaptive simulated annealing [11]—has been used. In the seismic tomography, data acquisition is carried out with ordinary energy sources, such as hammers, dropping masses, downhole energy sources, and small charges of dynamite, and with standard receivers such as electromagnetic geophones and piezoelectric hydrophones. **Figures 2–4** show the most common acquisition schemes in seismic tomography. The first one is the classical refraction tomography with both shots and receivers at the ground surface; the second, in **Figure 3**, is the cross-hole tomography where both shots and receivers are placed inside boreholes, better if filled with water; the third, in **Figure 4**, is the up-hole tomography. Referring to **Figure 4**, if the position of shots and detectors is inverted (i.e., the detectors are placed inside the borehole and the shots are placed at the ground surface), the acquisition system is properly named “downhole tomography.” It must be underlined that though in the schematic sketch of both cross-hole and up-hole, the ray paths are rectilinear, and this can

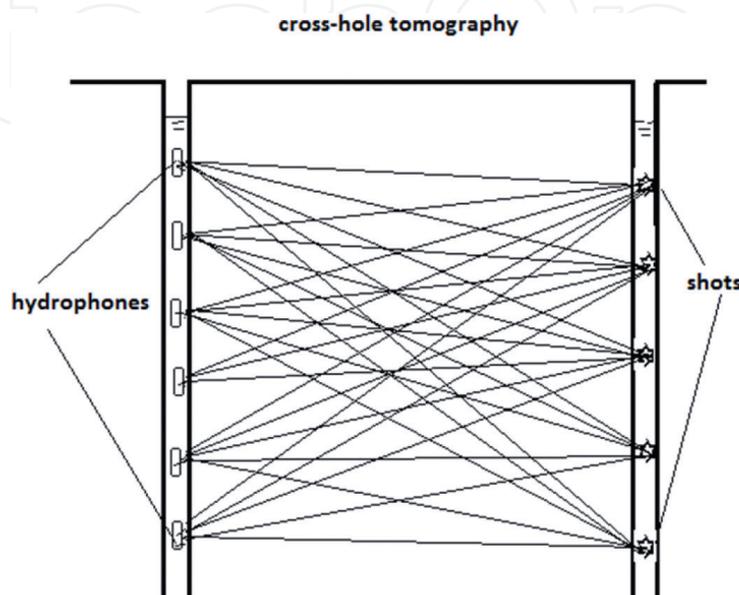
Figure 3.
Acquisition system of the seismic up-hole tomography.

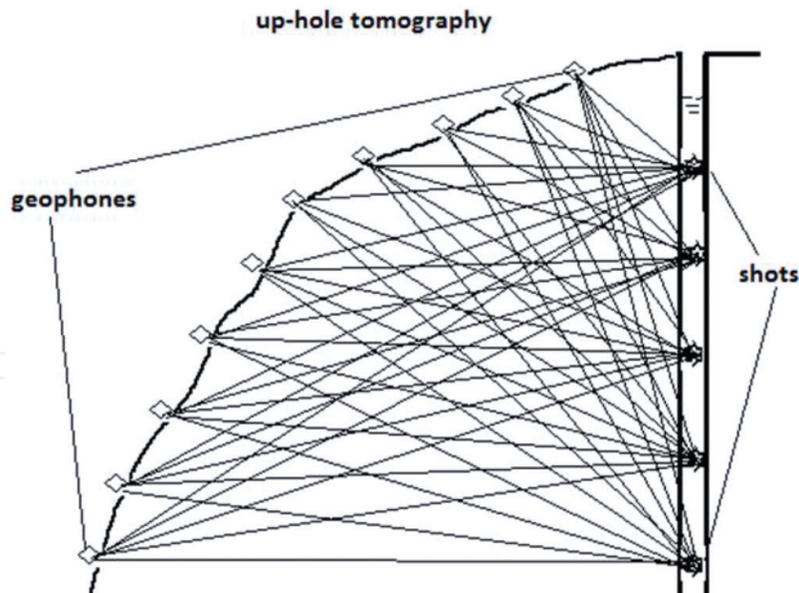
Figure 4.
Acquisition system of the seismic cross-hole tomography.

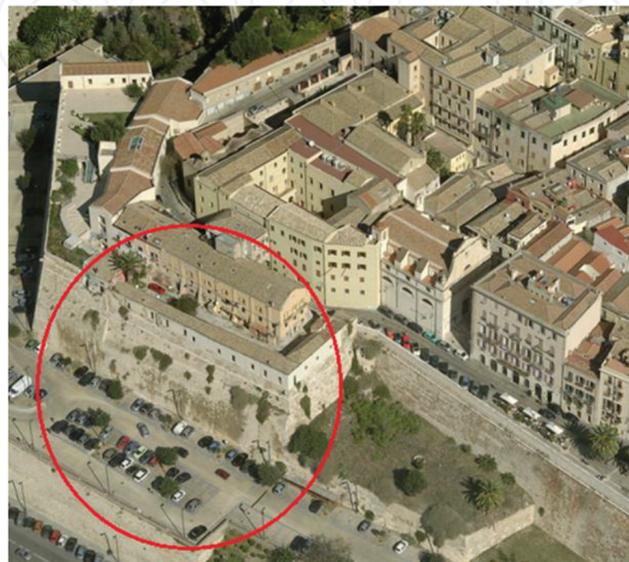
Figure 5.
The northwestern sector of the Spanish walls. The circle indicates the survey area.

The study area lies in the northwestern sector of the ancient walls of Cagliari. Apart from the Roman works, of which few traces remain, the original body of the walls, built by the Pisans (Republic of Pisa), dates back to the thirteenth century; in literature, these walls are also referred to as “the Pisan walls” or “the medieval walls.” Three centuries later—that is, in the sixteenth century, after the advent of firearms, in particular the artillery—the Spanish, who at that time dominated Cagliari, decided to modify the defense line incorporating the medieval walls in an embankment coated with limestone blocks; the latter, apart from few modifications and consolidation works, is the current structure of the walls. **Figure 5** shows in detail (the circle) the area in which two up-hole tomographies have been carried out

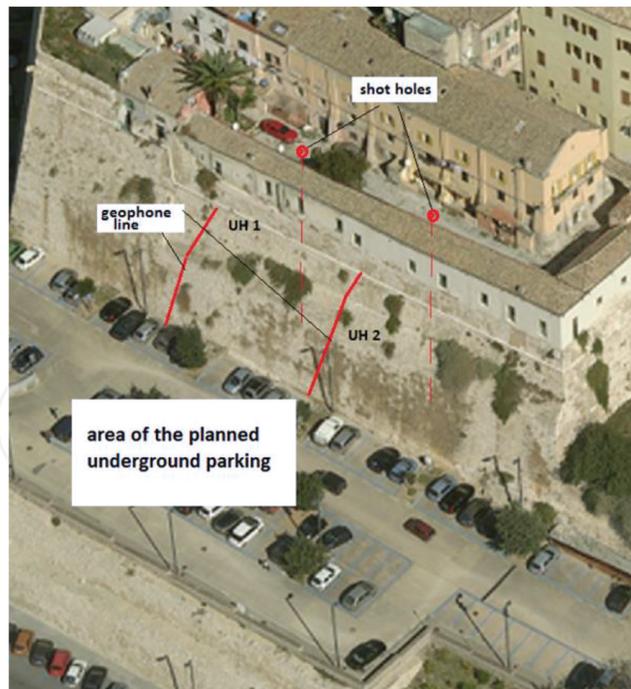
Figure 6.
Position of the two acquisition arrays.

Data processing has been performed by means of a software based on a nonlinear optimization technique (ASA, adaptive simulated annealing) [11] that works in terms of modeling, starting from the set of the first arrival times and the spread geometry. **Figure 6** shows the position of the two acquisition arrays, and **Figure 7** shows their schematic view. The results after processing and interpretation are in

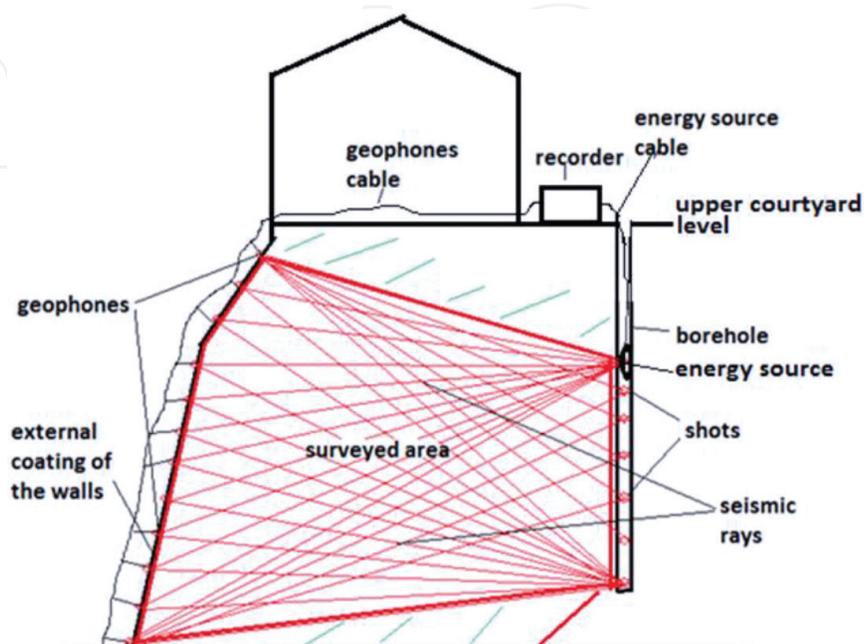
Figure 7.
Schematic view of the up-hole seismic tomographies across the ancient walls.

Figures 8 and 9. The two tomographies show very similar characteristics, and the ancient medieval wall, the limestone basement, and the filling on both sides of the medieval wall are clearly depicted. On the contrary, the tomographies show no trace of the external coating of the current walls, though its presence is certain. This is a clear sign that thickness of the coating is relatively small and therefore has not been covered satisfactorily by the seismic rays, as deductible from **Figure 7**.

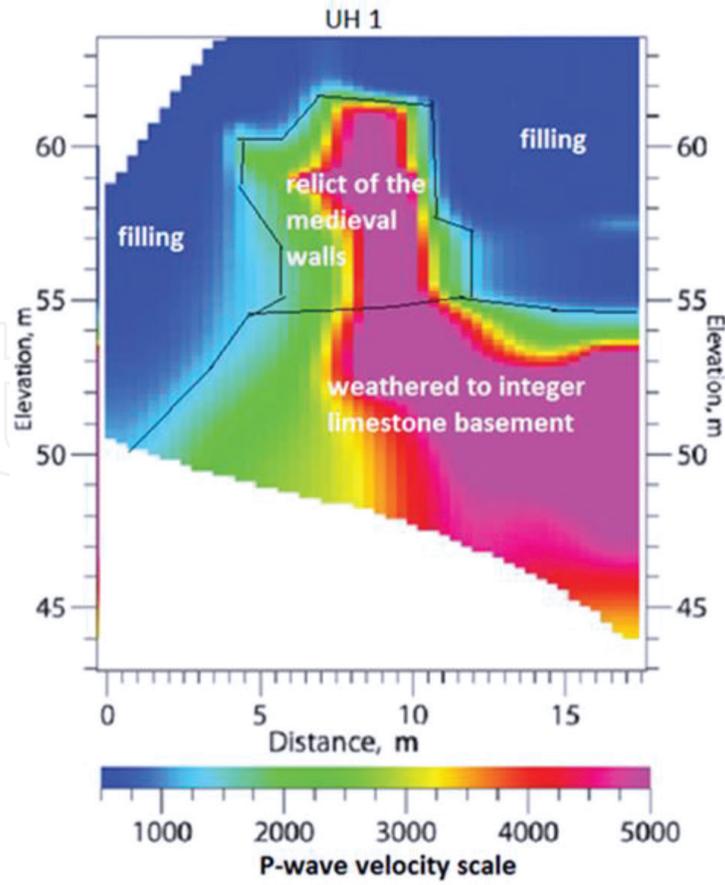
Figure 8.
Up-hole tomography UH1 interpreted.

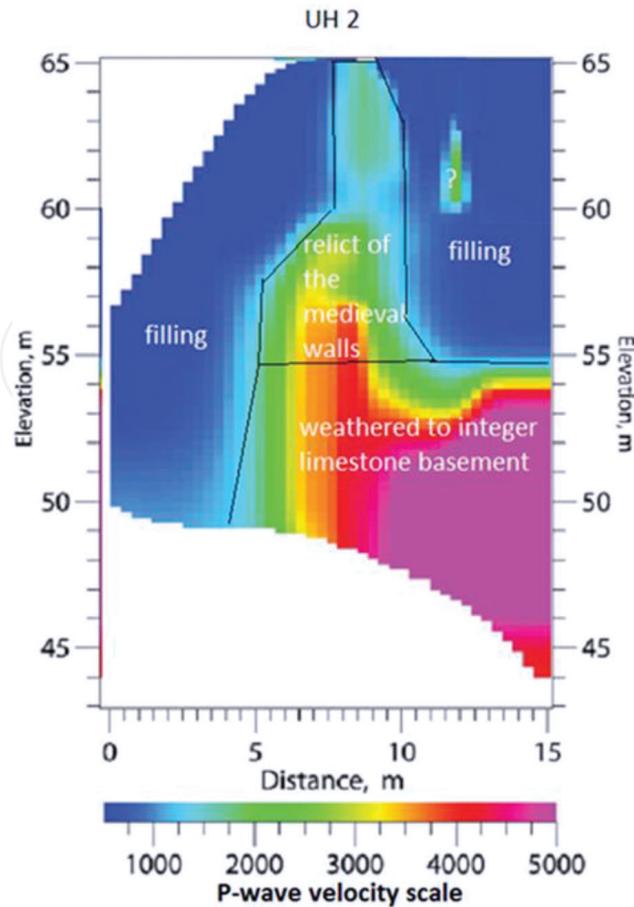
Figure 9.
Up-hole tomography UH2 interpreted.

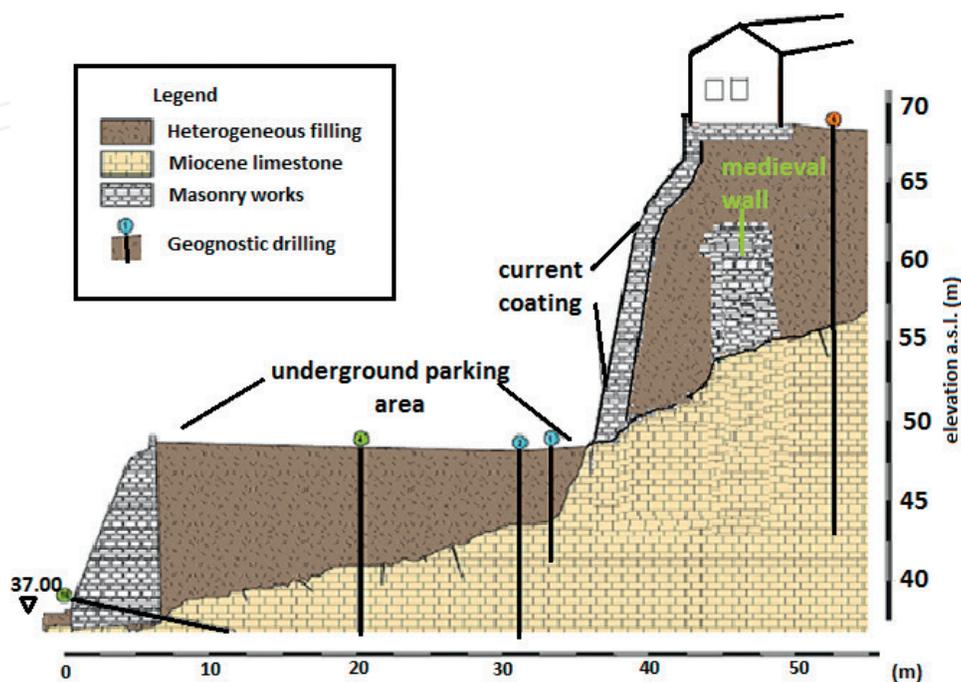
Figure 10. Geotechnical model deduced from the two up-hole seismic tomographies and four geognostic boreholes indicated in the figure.

From the two up-hole tomographies and several drillings, the base model for the geotechnical assessment has been compiled as shown in **Figure 10**.

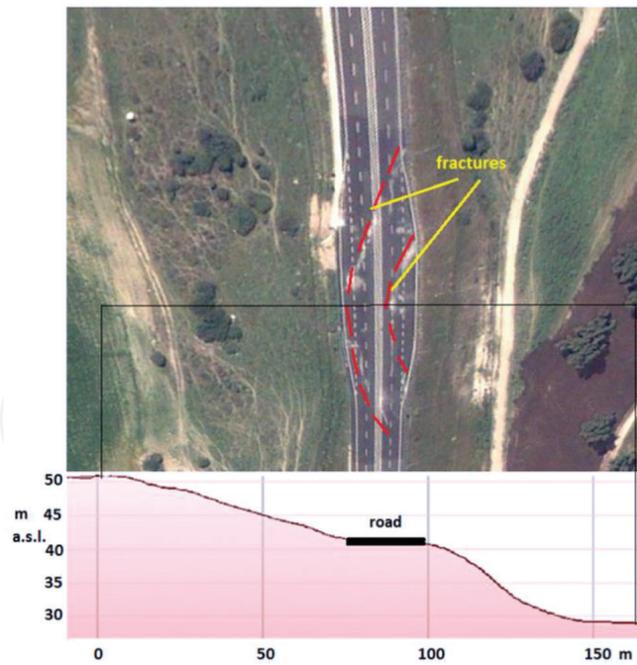
Figure 11.
The stretch of road affected by the landslide phenomenon and the elevation profile.

Figure 11 shows a satellite view of a road that runs along the side of a hill in Sardinia, Italy. A few years from the construction of the road, after an exceptionally rainy season, progressively pronounced fracture lines, indicated in the figure, appeared on the asphalt. It was the beginning of a landslide that affected the background and the road itself. **Figure 12** shows a detail of a fracture. After 1 month of monitoring, since fracturing—and therefore the landslide—progressed, it was decided to verify the conditions of the subsoil through geophysical techniques. Then, two seismic refraction tomographies perpendicular to the axis of the road, as shown in **Figure 13**, were executed. Data acquisition was carried out with a 48-geophone spread, detector interval of 2.7 m, and same interval for shots (hand hammer with vertical stacking); the processing was performed with the same software employed in the previous case study. The position of the two seismic lines is in **Figure 13**, and the two P-wave velocity sections are in **Figures 14 and 15**.

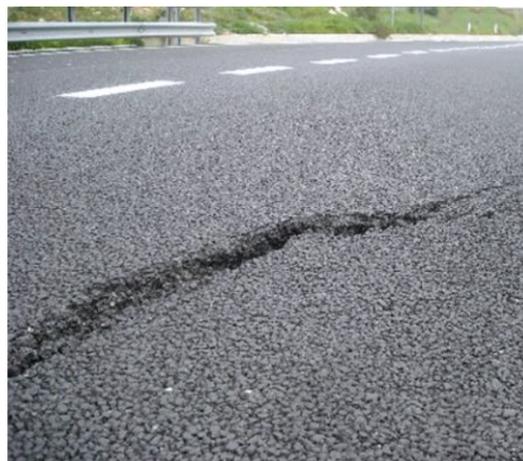
Figure 12.
Detail of a fracture in the asphalt at the beginning of the landslide phenomena.

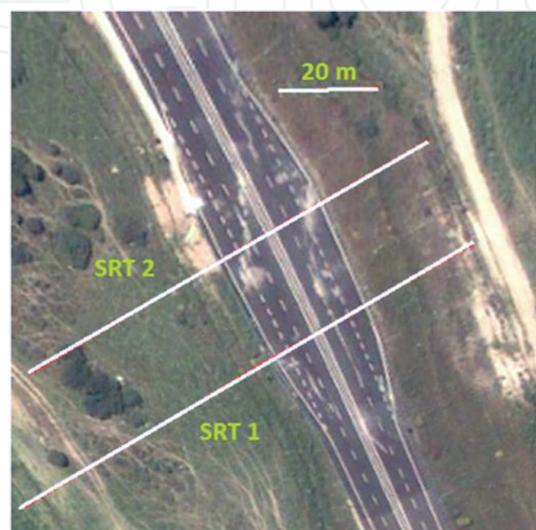
Figure 13.
Position of the two seismic refraction tomographies.

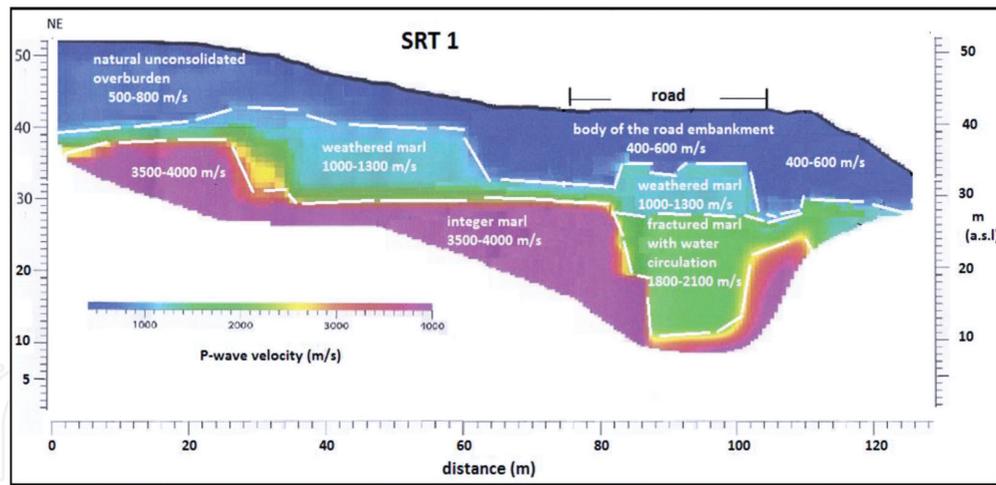
Figure 14. Seismic refraction tomography SRT 1 interpreted.

Tomography SRT1 (**Figure 14**) exhibits a surface zone 5–14 m thick that extends along the whole section. It is composed of the natural unconsolidated overburden and the artificial body of the road embankment, with P-wave velocity in the range 400–800 m/s. The underlying marls are initially much altered for a thickness in the range 2–10 m. Worth of notice is that just under the road, there is a 15–20 m wide zone that deepens for about 20 m, in which, after the demolition of the embankment, water was found. At the base, at depths of 15–20 m from the surface, except

in the abovementioned area below the road, there are integer marls. At least three faults can be identified.

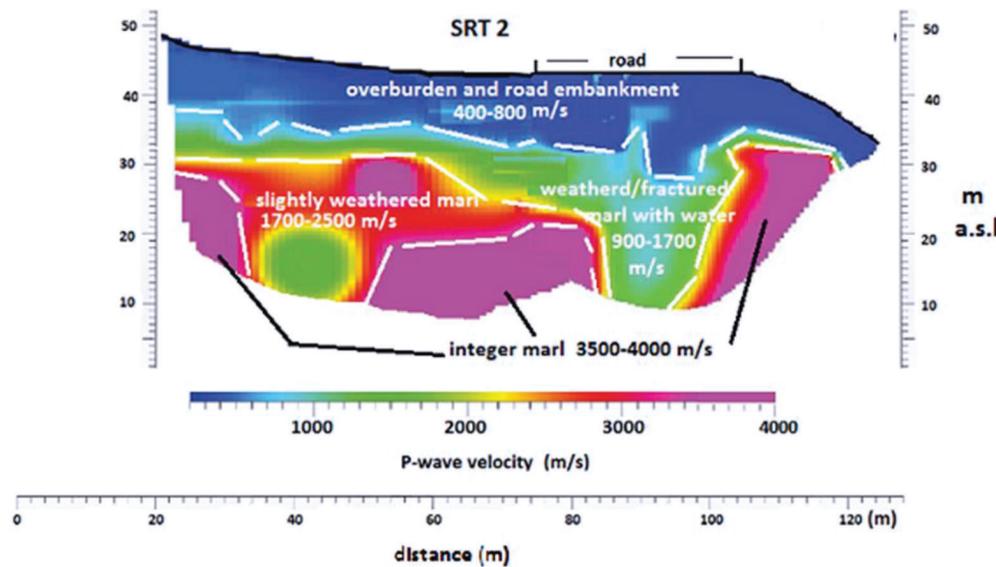
Figure 15. Seismic refraction tomography SRT 2 interpreted. The SRT 2 is parallel to SRT 1, and the scale indicates the alignment.

The seismic tomography SRT 2 (Figure 15) exhibits features similar to those of SRT 1. In this case at least two faults can be identified. The two tomographies will constitute the basis for the road slope stability study.

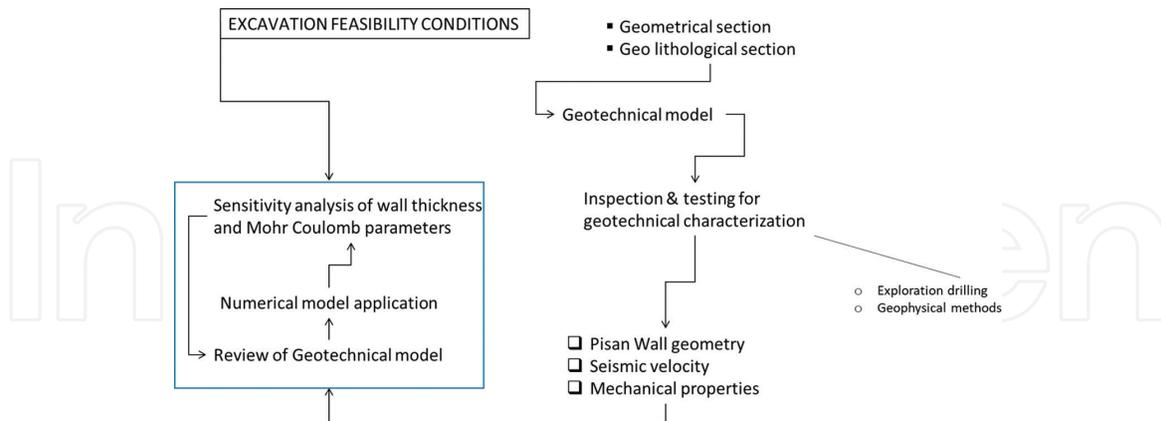
Figure 16.
 Case 1: flowchart of iterative analysis modeling—inverse solution.

the results as the geometric and geomechanical characteristics of the external containment wall of the bastion vary. **Figure 16** shows the flowchart of the whole procedure.

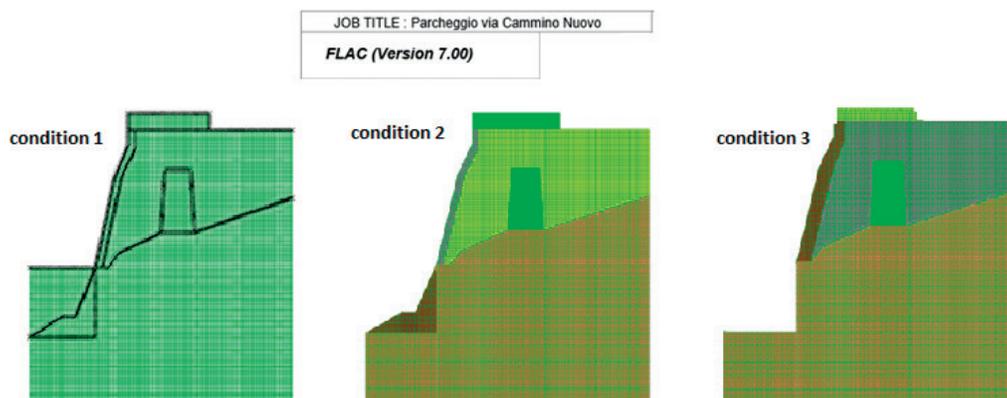
Figure 17.
 Left to right: pre-excavation, first excavation, and second excavation.

possible excavation steps, that is, (1) without excavation, (2) excavation of the only loose material, and (3) excavation extended to a portion of the underlying rock (Figure 17). The results are shown in histograms of Figure 18.

- Changes in the mechanical properties result in unimportant changes in the SF. For variations of cohesion in a range of $\pm 20\%$ and of the tensile strength of $\pm 40\%$, the corresponding SF values vary by only $\pm 5\%$.
- The realization of the first excavation, that is, the removal of the ground in front of the wall (Figure 17), does not cause significant SF variations that can

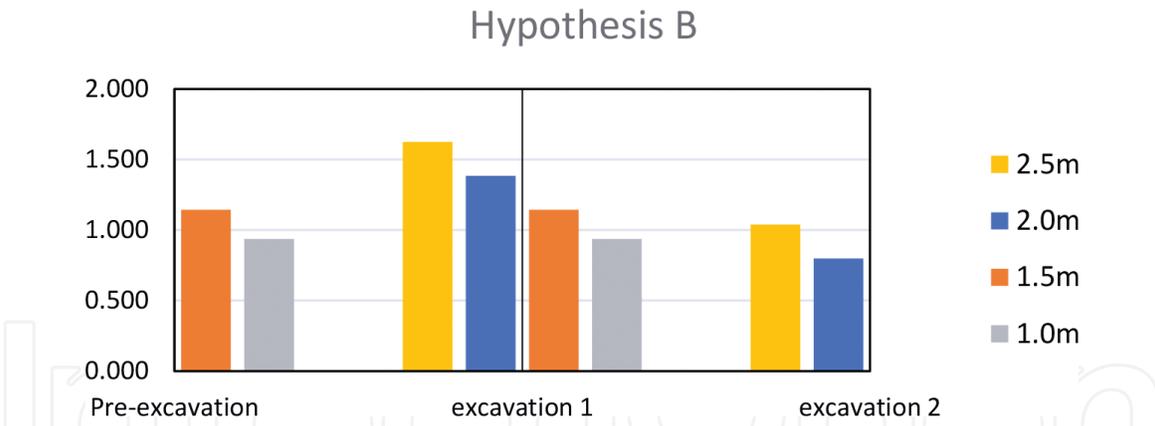
Figure 18. Results for the hypothesis B: SF versus excavation steps and wall thickness (m).

be considered constant (see **Figure 18**) for any wall thickness. The subsequent excavation n.2, corresponding to the removal of a rock portion, determines reductions in the SF (see diagrams in **Figures 18** and **19**) between 30% and 55%. As less thick is the wall as smaller is the SF (see **Figure 20**).

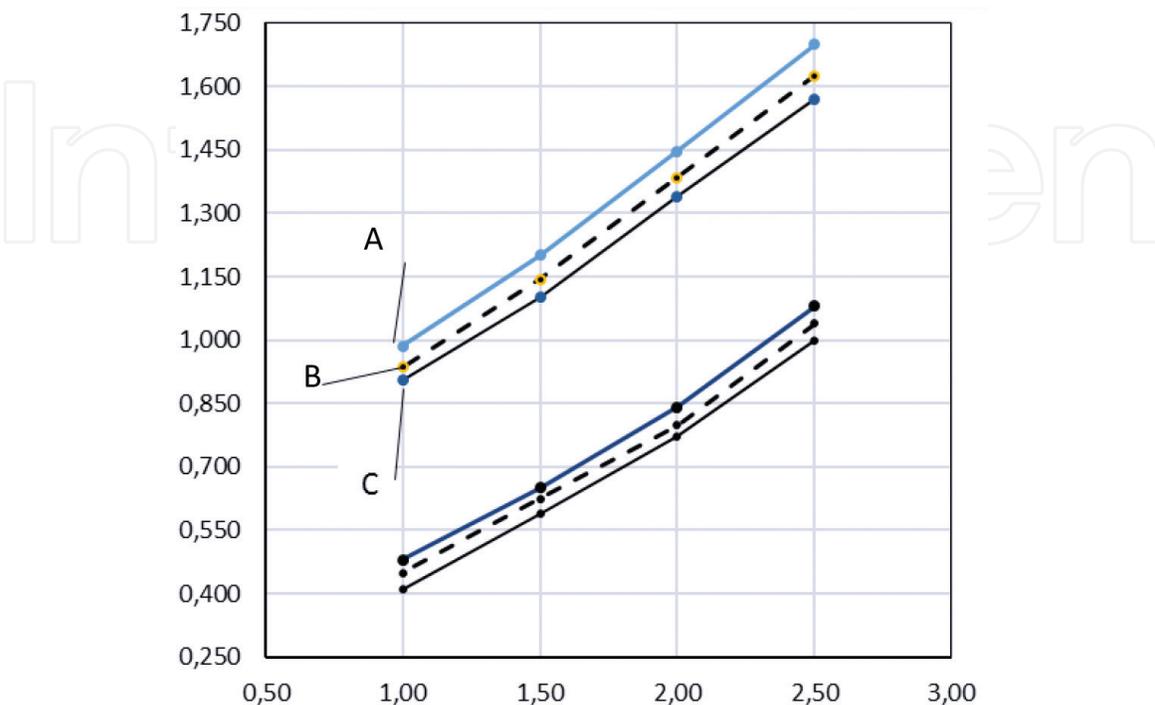
Figure 19. SF versus wall thickness (m) for A, B, and C hypotheses of mechanical properties.

The hypothesis B has been modified in A and C that differ for the cohesion and the tensile strength. The results obtained are illustrated in the diagrams of Figure 19.

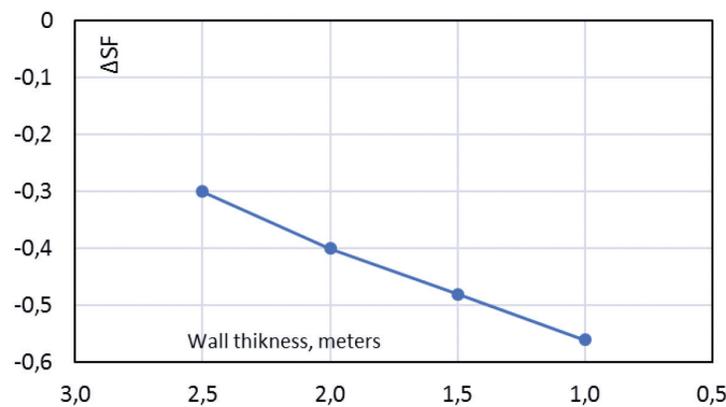
Figure 20.
 SF reduction for the second excavation versus wall thickness (meters).

In summary, in all the cases examined, the execution of the excavation must always be preceded by retaining structures; these must concern only the base of the wall, if only the first excavation will be carried out, or even the rock wall, if the second excavation will be carried out. The retaining structures design will have to consider the effective thickness of the wall and will have most important and binding extension, the lower the measured thickness will be (**Figure 20**).

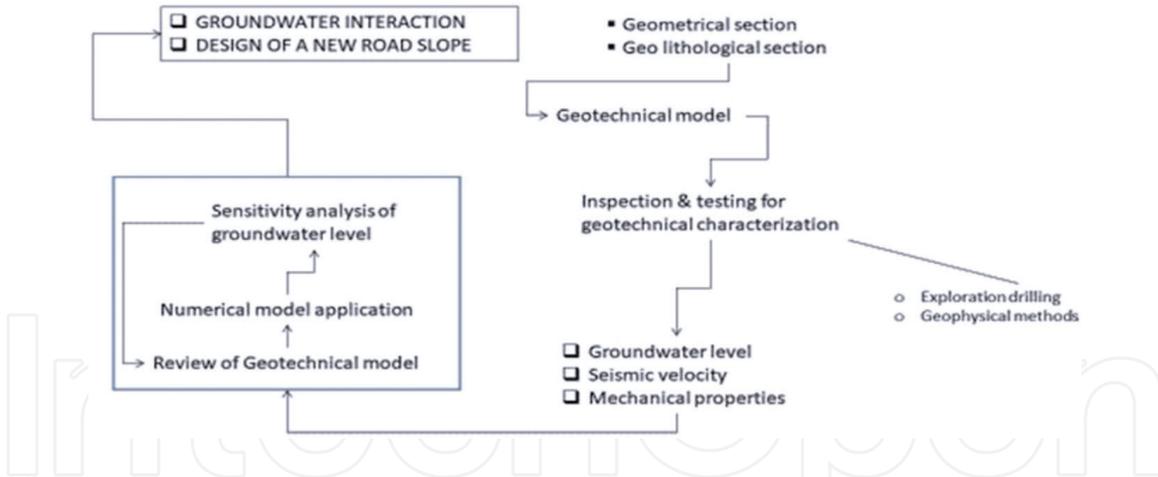
Figure 21. Case 2: flowchart of iterative analysis modeling—Sensitivity calculations.

In accordance with the results of exploration drilling and geophysical survey (see geotechnical properties in **Table 2** and flowchart of **Figure 21**), a geotechnical model was reconstructed whose solution was obtained with numerical methods and the application of the 2D FLAC software [2] (see **Figures 22–24**).

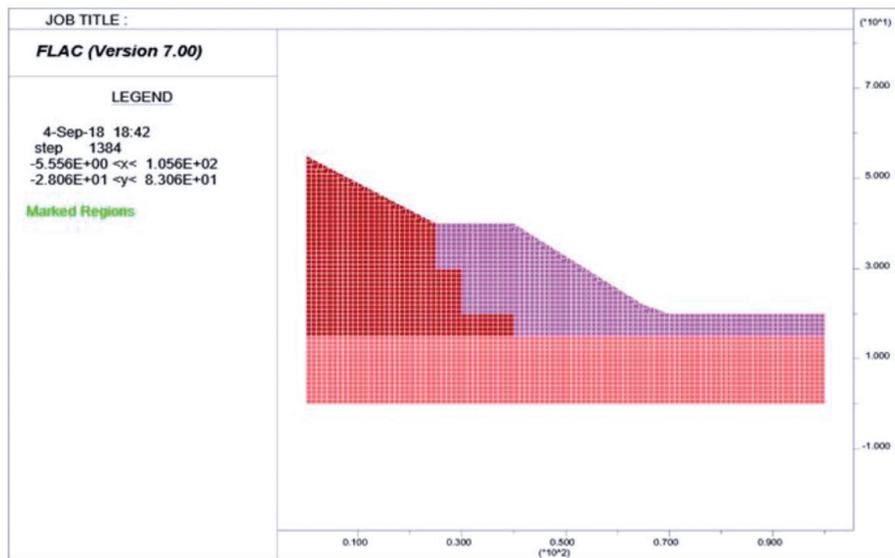
Figure 22. Numerical model of the slope.

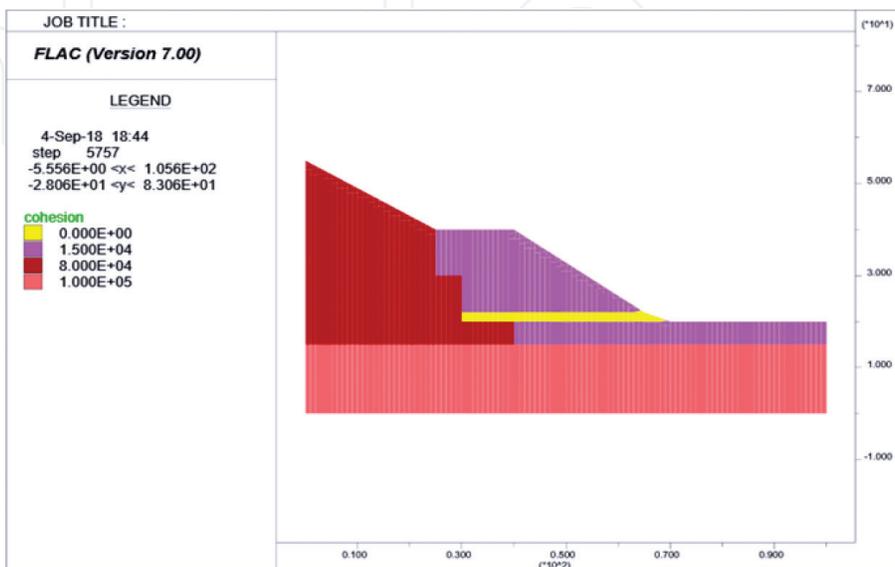
Figure 23. Cohesion of the different materials.

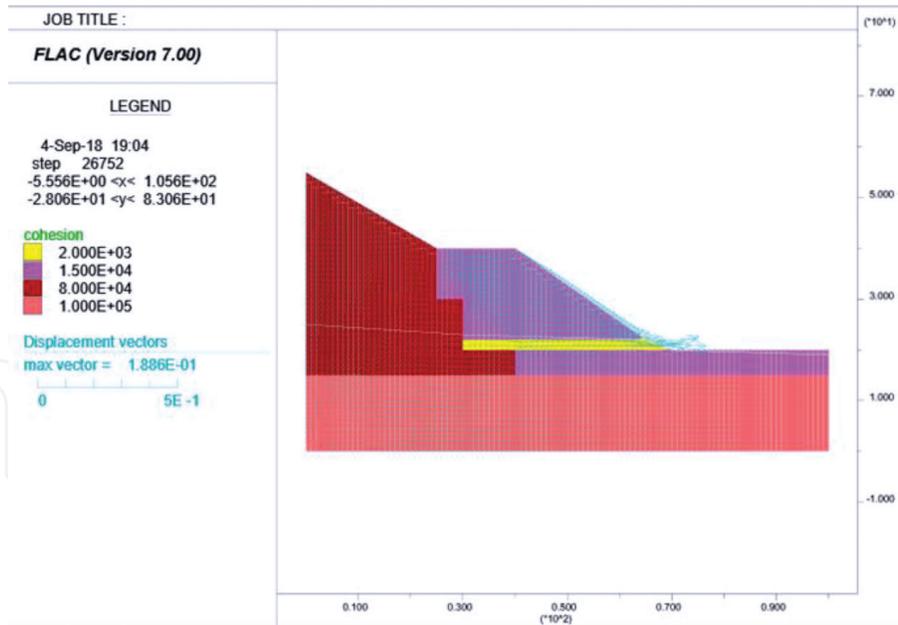
Figure 24.
 Displacement vectors of the slope instability.

The results show that the groundwater presence (GL) and a consequent reduction in cohesion of the altered marl horizon determine a drastic reduction of the safety factor below the unit value, as illustrated in **Figure 24** (displacement vectors) and in the diagrams of **Figure 25**.

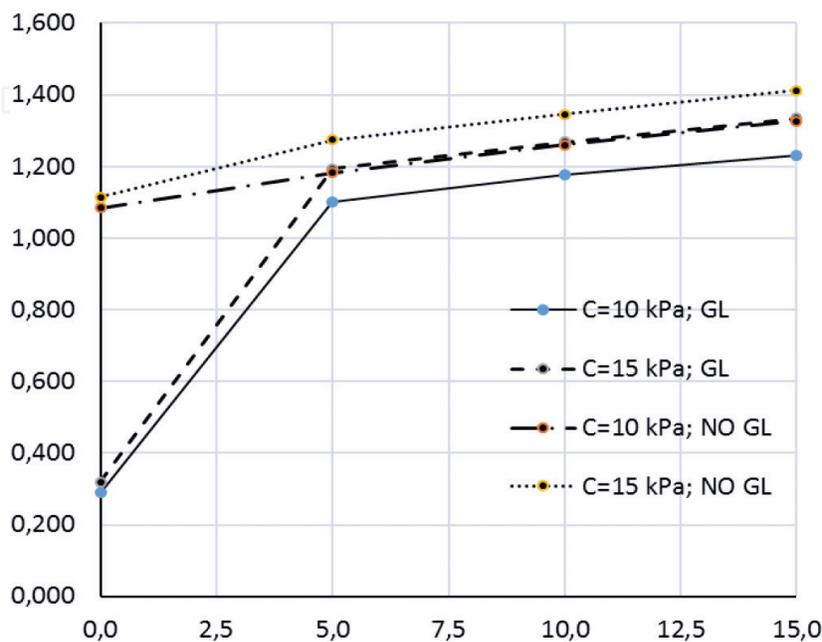
Figure 25.
 SF versus altered marlstone's cohesion (kPa) for two conditions of intact marls ($C = 10$ and 15 kPa) and groundwater level presence (GL) and absent (NO GL).

The numerical model was corrected according to an iterative procedure to reconstruct the instability mechanism observed in situ. The next step was to highlight the effects of a growing groundwater. The datum to which the simulation referred was the presence or not of the groundwater level (GL or not GL in the **Figure 25**).

The results obtained are highlighted in the diagrams of **Figure 25**, which show the trend of the SF versus the cohesion of the altered marls, for two cohesion conditions (15 and 10 kPa) of intact marls. The diagrams show that to verify instability ($SF \leq 1$), two conditions are necessary: (i) the presence of a water table under the

roadway and (ii) the circulation of water that causes the reduction of cohesion in the altered marls below the value of 5 kPa.
