# Experimental Setup for Swellable Elastomers in Cased and Open Holes

Sayyad Zahid Qamar, Maaz Akhtar and Tasneem Pervez

A full scale experimental setup was designed and commissioned for testing of swelling elastomer seals against a casing (cased hole) and formation (open hole). Actual replicate of wellbore was designed with varying inside diameters and roughness to reproduce the effect of actual formation. The Dynaset packer mounted on a 7-inch tubular was allowed to swell against a 9-5/8-inch casing, while the fast swell packer mounted on a 9-5/8-inch tubular was allowed to swell against the 12-1/4-inch replicated well bore. This one-of-its-kind test setup can demonstrate the way the elastomers swell out and fill the asperities against smooth outer casing (cased hole) or against rough wellbore surface (open hole). Dismantling of the test setup midway through the testing scheme revealed a severely dimpled surface of the swelled elastomer.

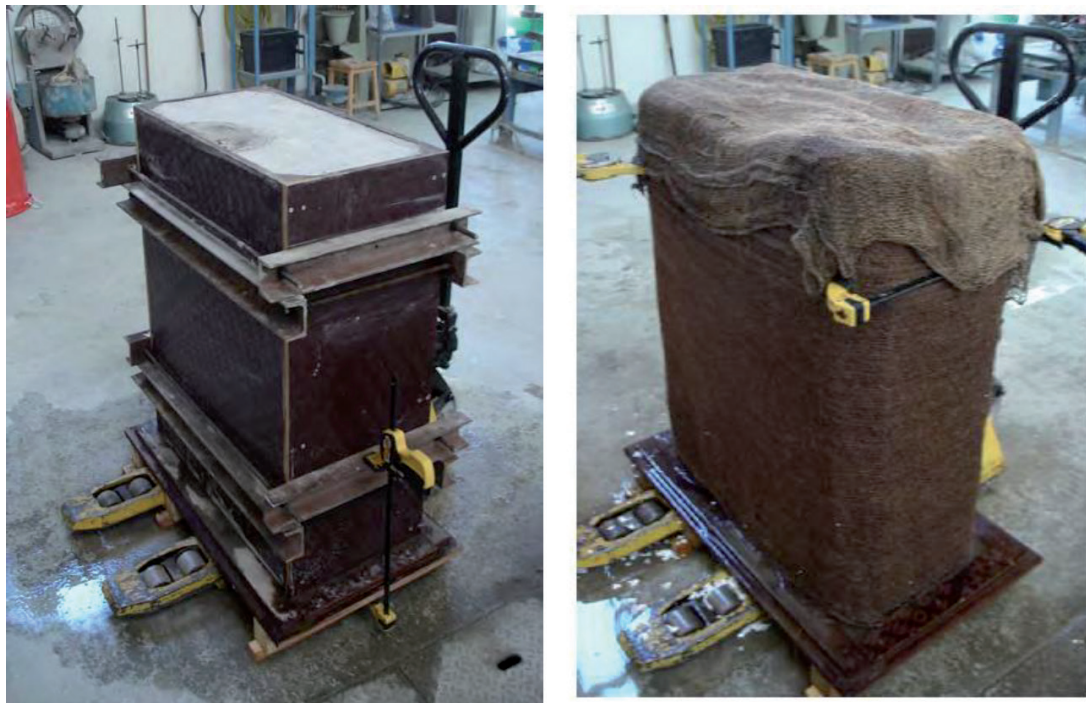
**Figure 3.**  
*Concreting of the half-block with polystyrene half-cylinder carefully placed inside; and curing of the assembly.*

In consultation with oilfield engineers, and following the recommendations of concrete requirement for oil-well cementing jobs, a special concrete mixture was prepared to provide sufficient strength, durability and relatively quick curing time. In order to develop different inside diameters and sections of varying roughness, polystyrene layer of sufficient thickness was mounted on a cylindrical column of a wood pattern. The varying diameters and surface roughness for each diameter were carefully generated on the polystyrene using a long-bed lathe machine. This wood-polystyrene unit was then cut longitudinally into two parts. With this half-cylinder forming a core, the concrete half-block was formed by pouring the special concrete mixture into an already prepared large wooden pattern. After proper curing of the concrete, the wooden pattern was disassembled, the polystyrene core was completely removed, and the block was carefully cleaned. The process is summarized in **Figures 3** and **4**. A close-up view showing the variation of diameter and roughness in the concrete half-block are presented in **Figure 5**. The inside and outside packers were also precision-cut into two longitudinal halves as shown in **Figures 6** and **7**. The tubulars and packers were carefully positioned and fitted inside the concrete half-block, and the assembly was then fitted with plexi-glass front and top walls. A hook-type lifting mechanism was fixed onto the top (**Figures 8** and **9**) to move the full assembly from one place to the other, using overhead crane or other moving/lifting equipment.

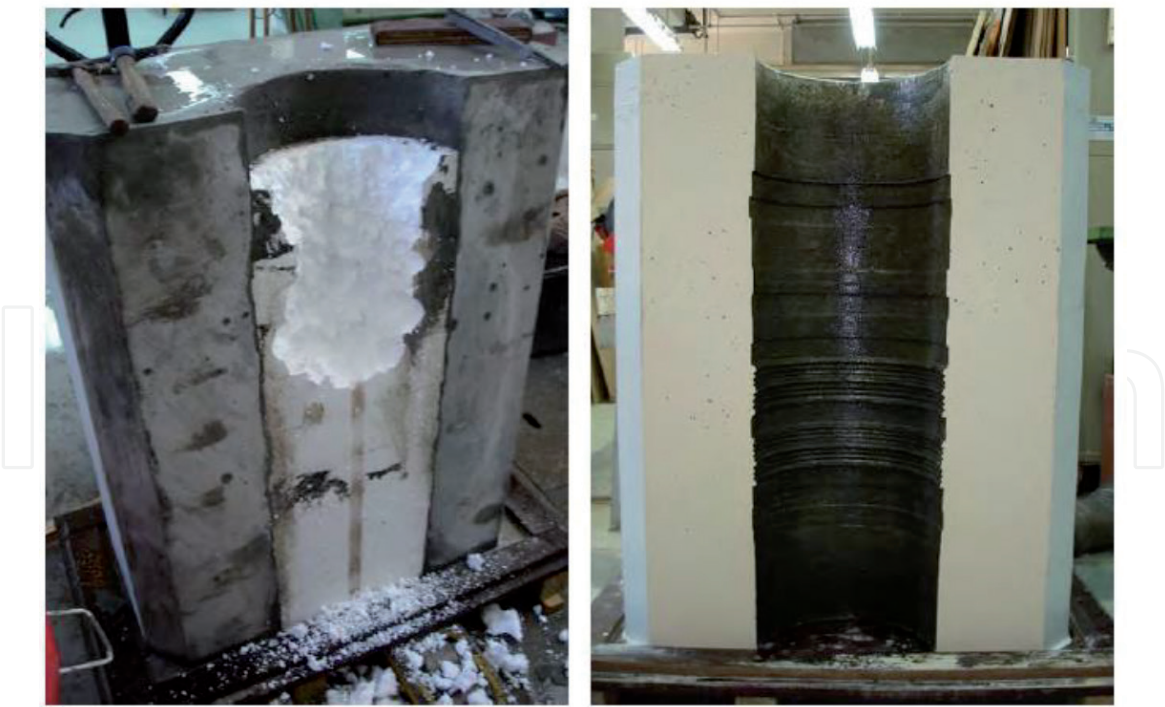
**Figure 4.**  
*Removing of polystyrene core (left); final shape of the setup with varying roughness and hole diameter (right).*

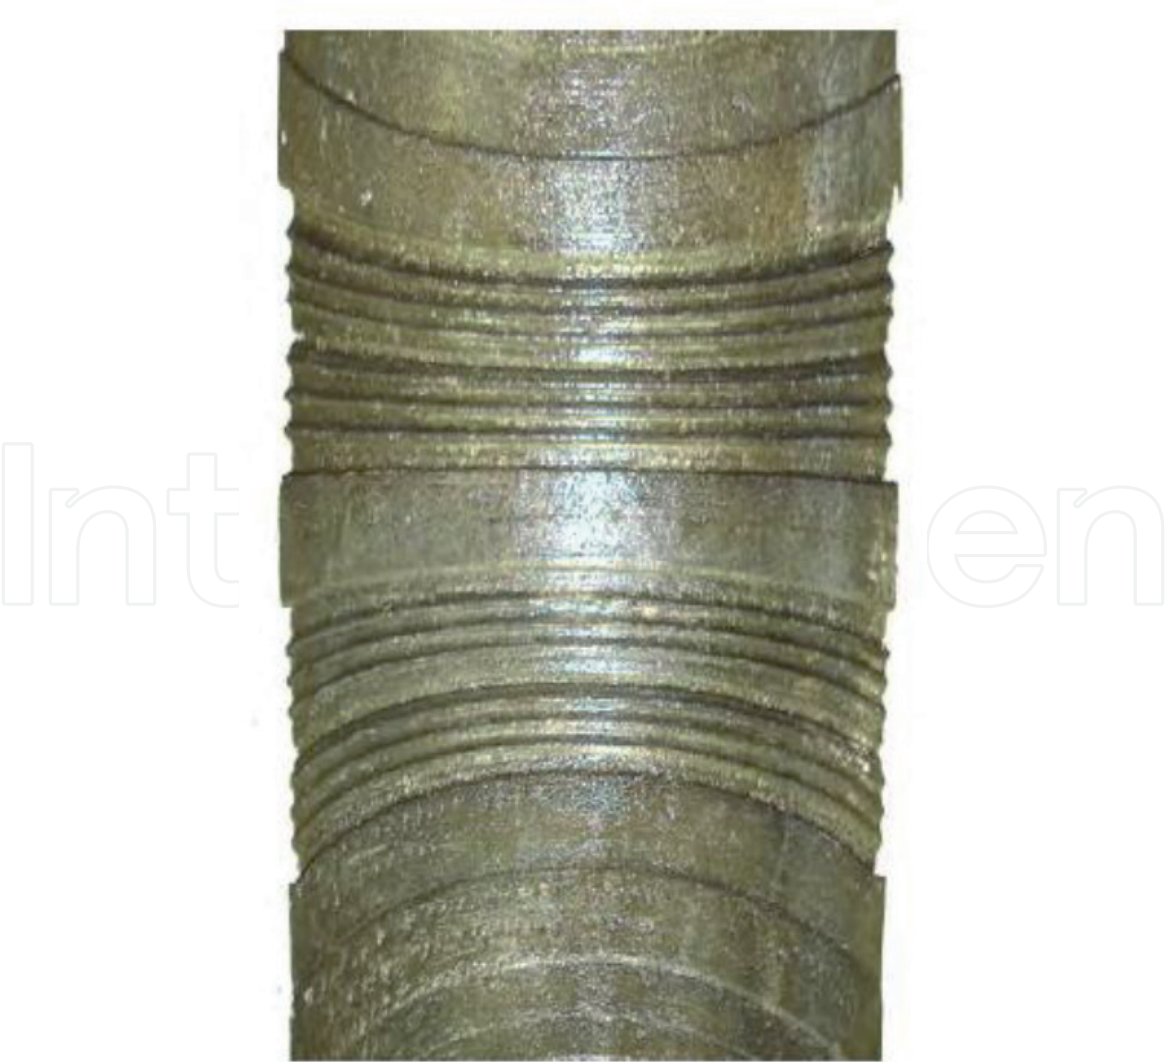
**Figure 5.**  
*Close-up showing variation of diameter and roughness in the concrete half-block.*

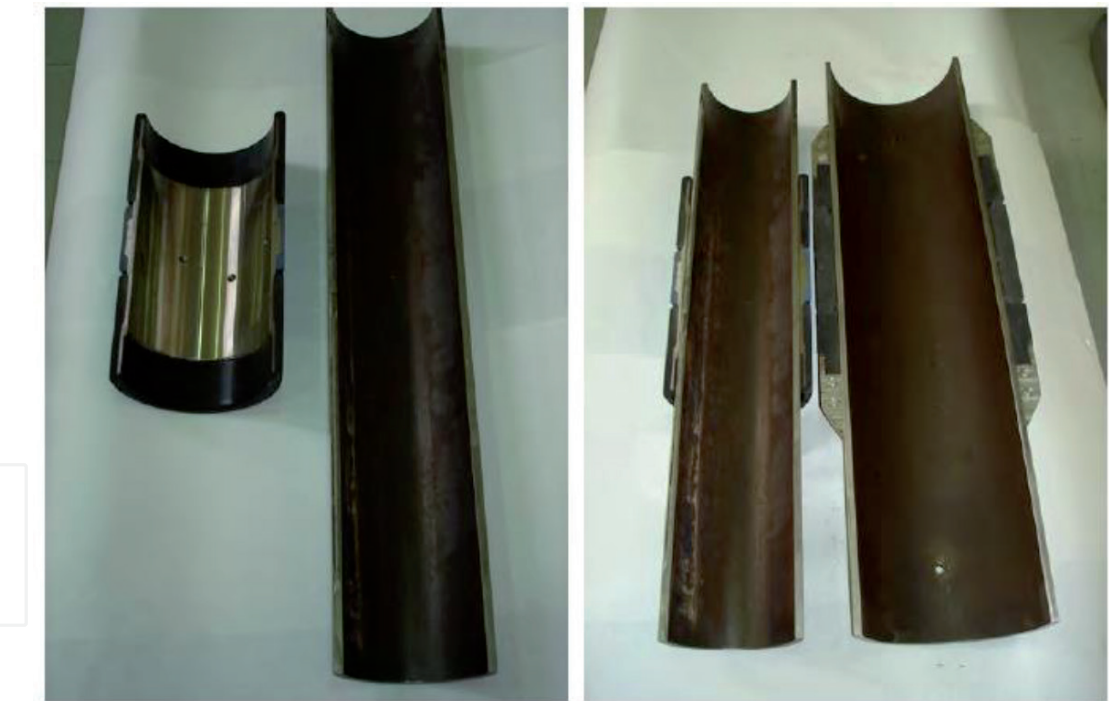
**Figure 7.**  
*Half portions of inside swell packer and pipe (left); inside and outside swell packers fitted on respective pipes (right).*

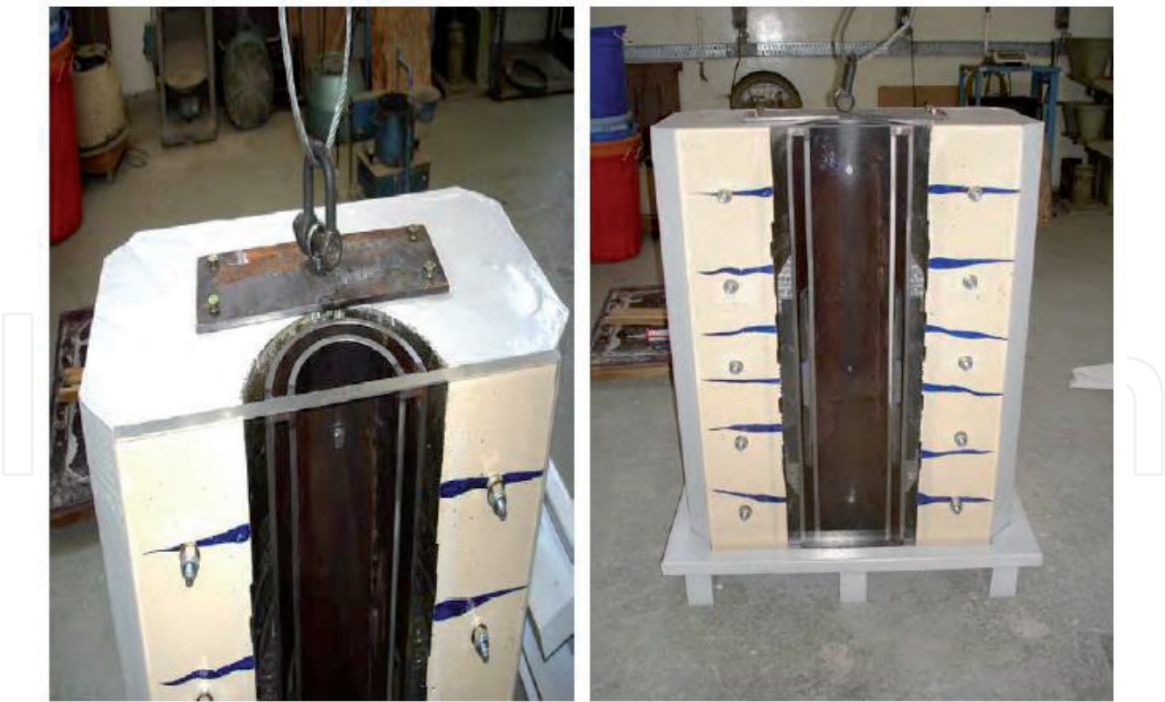
**Figure 8.**  
*Fitting of the tubular in the concrete block, together with the lifting arrangement (left); fixing of the plexi-glass front wall (right).*

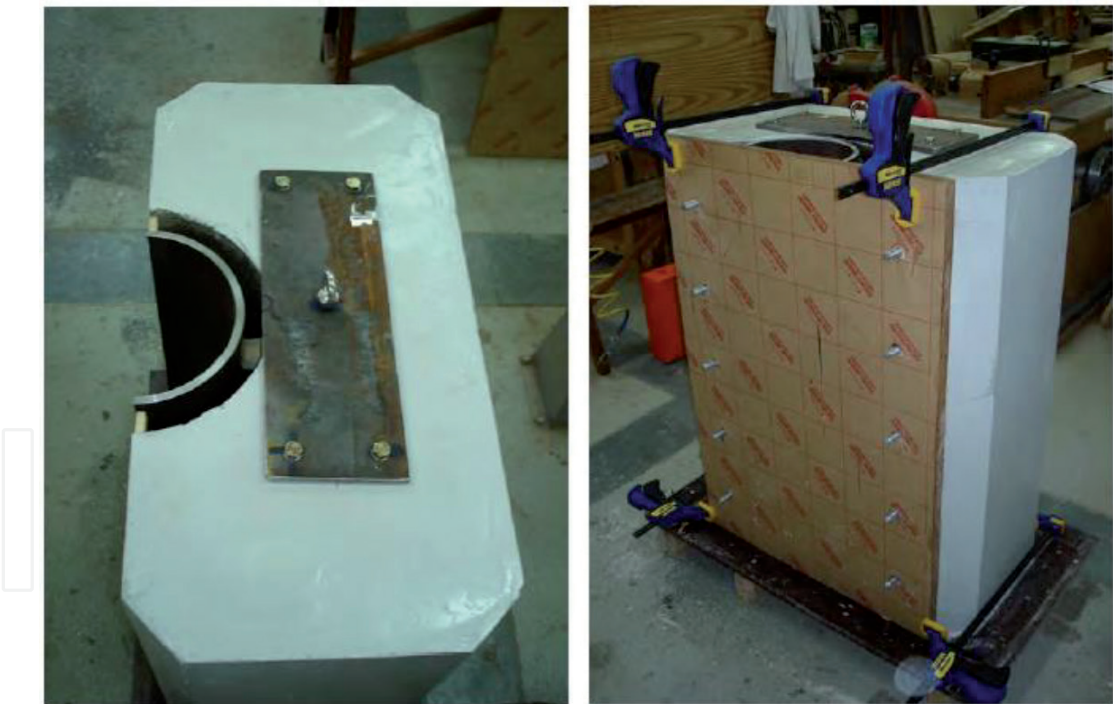
**Figure 9.**  
*Assembled setup with inner and outer packers, plexi-glass front and top walls, and lifting arrangement.*

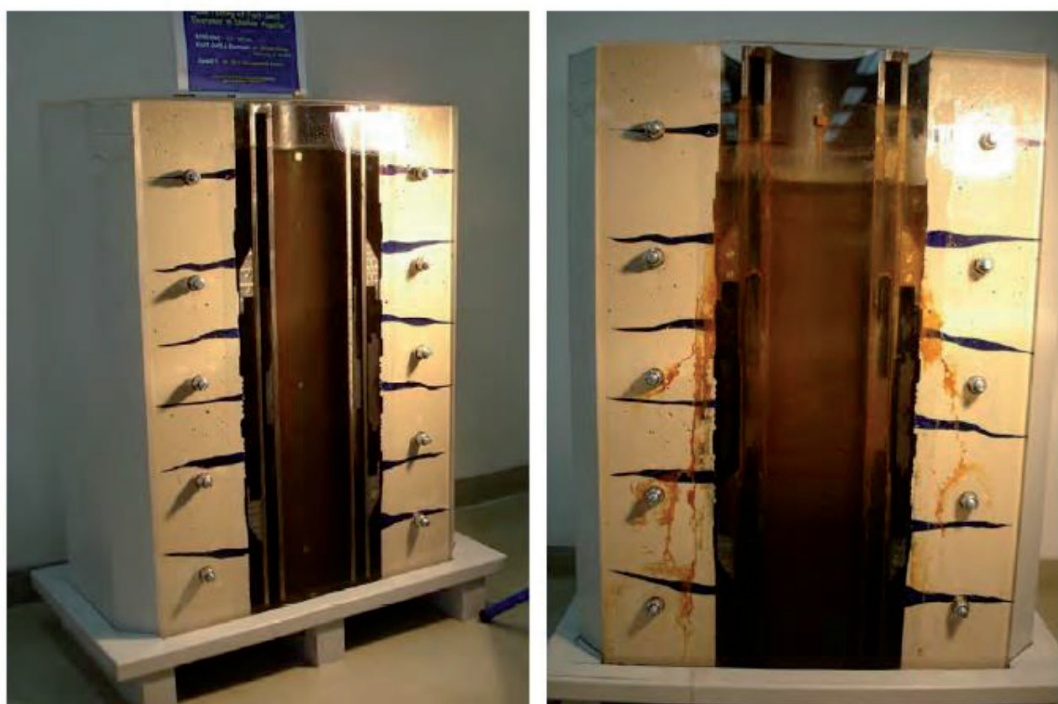
**Figure 10.**  
*Assembled unit after initial water fill-up (left); rust stains after 8 days of water exposure (right).*

had started to corrode. This would have only a minor effect on swelling, but the rust particles diffused into the water and visibility reduced drastically after more corrosion took place as shown in **Figure 10**. To remedy this problem, the water was siphoned off using a portable pump, and the rust stains and particles were vigorously cleaned. This flushing-cleaning of the unit improved the visibility significantly (**Figure 11**). Under actual shallow-aquifer field conditions of around 50 degrees Celsius temperature and 0.5% salinity, 70% swelling had been predicted for the outer packer (elastomer E1) in six hours during swelling tests conducted on laboratory size samples [9, 10], confirming its fast swell character. Fresh water used in test unit behaves almost the same in terms of salinity as the 0.5% brine solution, so this field condition was almost replicated. However, the unit being kept in an air-conditioned lab meant that the test temperature was nearly 20 degrees Celsius, a large difference from the field temperature, which definitely reduced the swelling rate of the elastomer by a significant percent. Also, the packer in the test unit could swell only in the outward direction, and was swelling against a concrete hole of varying diameter and roughness, markedly different from lab-size elastomer samples swelling freely on all sides. It was thus no surprise that it took more than 10 days for the elastomer to fill the irregular cavities in the concrete half-block.

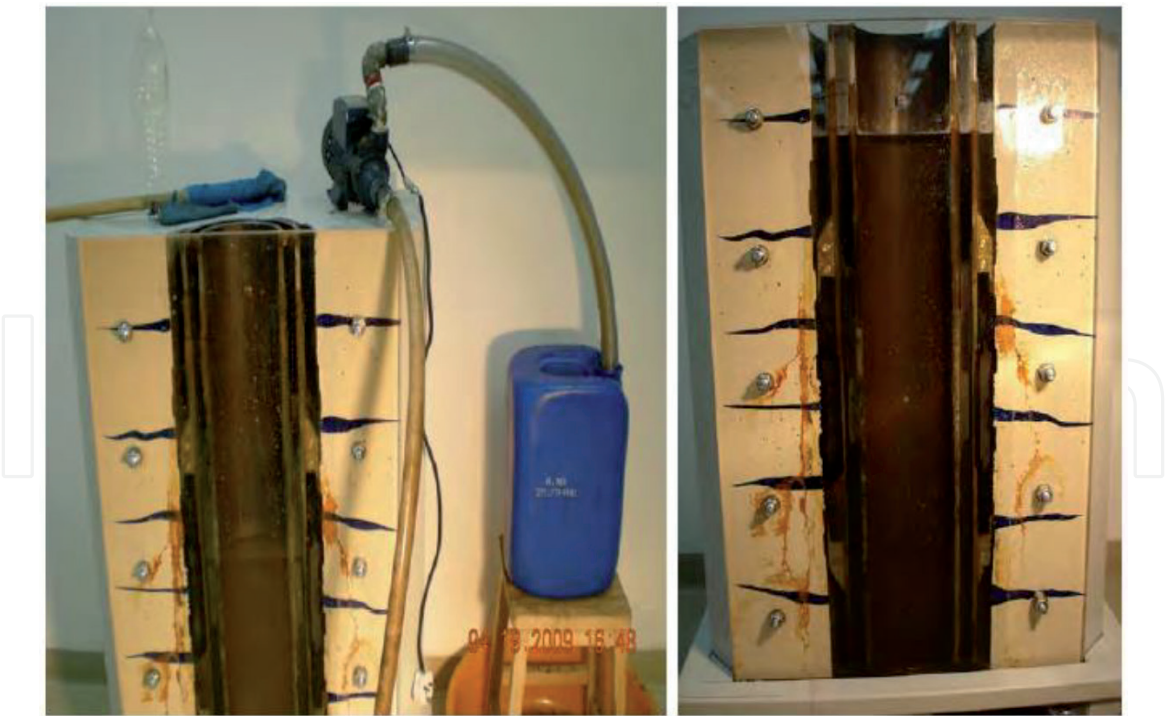
**Figure 11.**  
*Flushing and cleaning of the unit (left); water fill-up after flushing (right).*

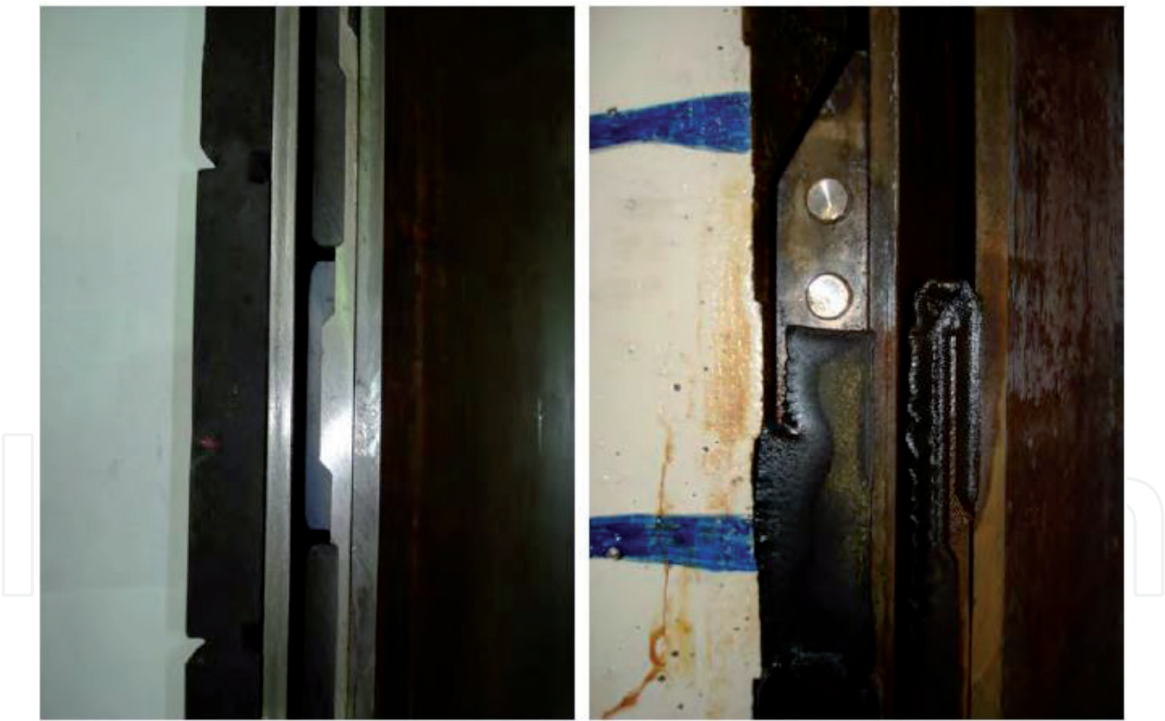
**Figure 12.**  
*Elastomer seals before exposure to water (left), and after near-complete swelling of the outer packer (right); inner packer has only partially expanded.*

The inside swell packer (E2) was intended for an application with salinity ranging from 12–18%, and working temperature environment of 40 degrees to 90 degrees Celsius environments. This test unit could be classified as a low-salinity and medium-temperature setting. According to earlier lab tests [9, 10], it was estimated to reach 70% swelling in 3 to 4 weeks. This was not too far off as it took the inner swell packer almost 5 weeks to swell against the casing, even though the salinity and temperature conditions were different. There was apprehension about the behavior of this elastomer under fresh water. However, it remained glued firmly to the tubular. **Figures 12 and 13** give an idea of the behavior of fast-swell and inside swell packers before exposure to water, and at different stages after being in contact with water.

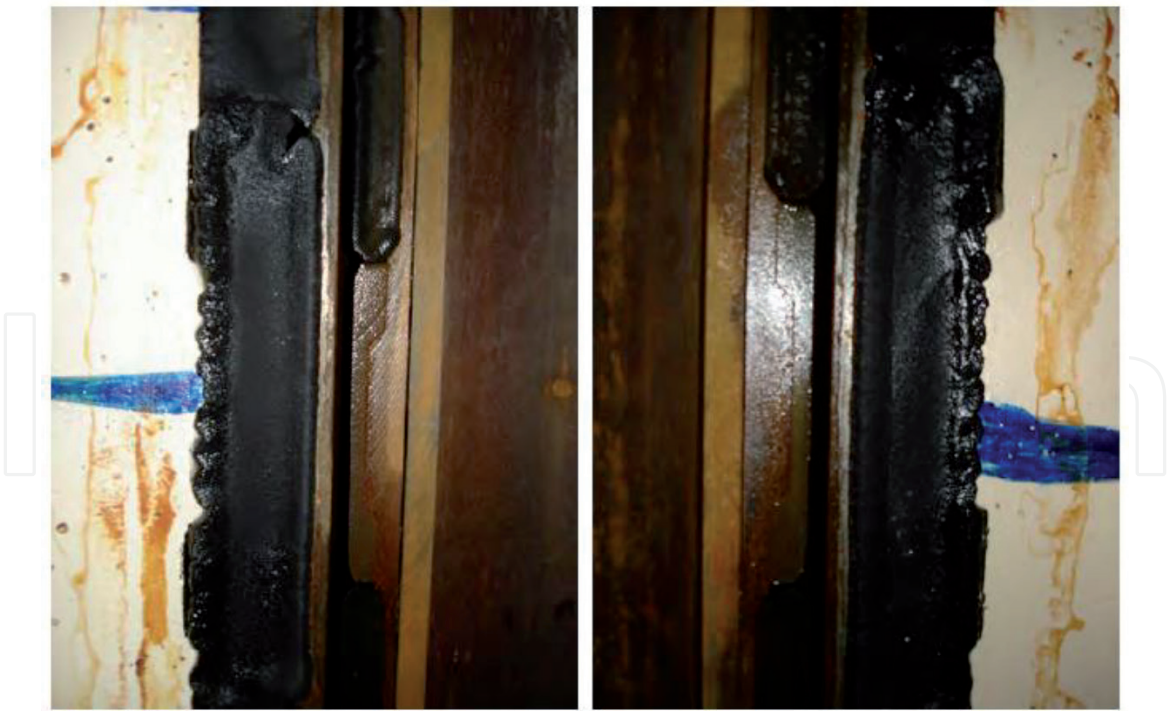
**Figure 13.**  
*Near-complete swelling of the outer elastomer seals against cavities of varying diameter and roughness.*

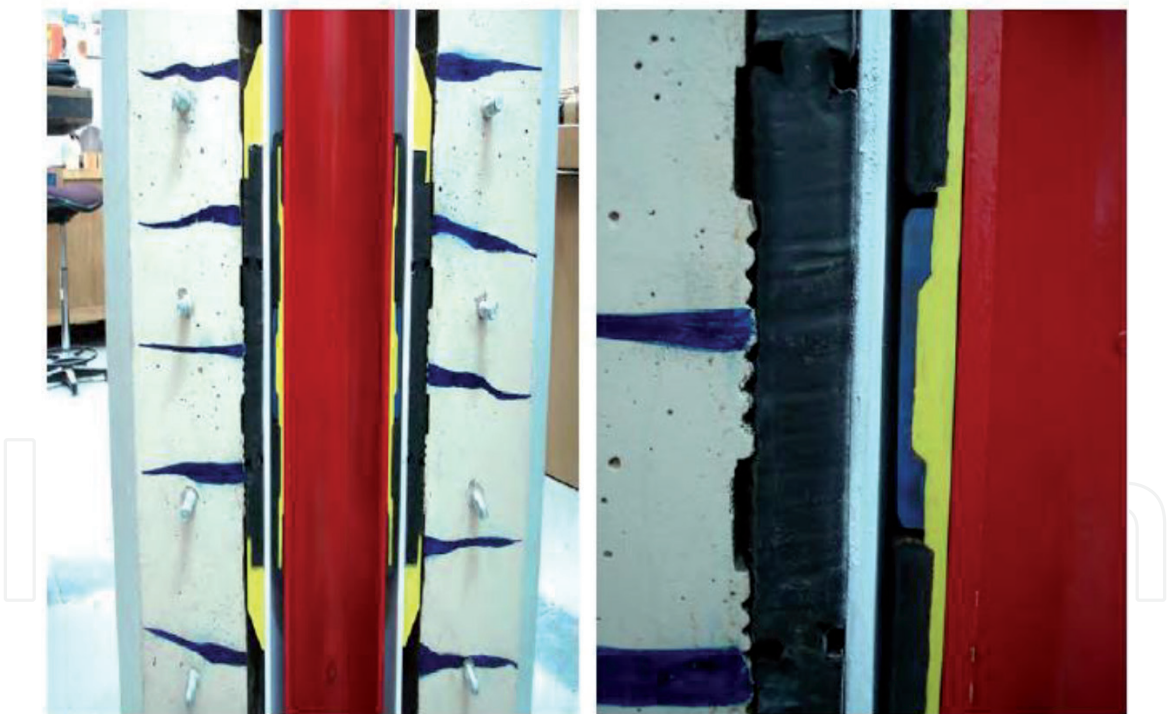
**Figure 14.**  
*Demonstration-test unit after disassembly, flushing and cleaning, repainting of different components, and reassembly; partial de-swelling can be observed.*

Once assembled and filled again with water, the two swell packers started to swell again as shown in **Figures 14** and **15**. Long-term contact of packers and concrete and metal elements to standing water without any flushing could pose another serious problem. Algae and other biological growth can crop up in the water over time. This can have unseen effects on the swelling setup, and can again reduce the visibility to very low levels. In order to alleviate this problem, a chemical was identified that inhibits bacterial and other biological growth in standing water. When water was filled into the reassembled unit, this chemical was added to the water in measured quantity. With the help of these modifications/improvements, the system exhibited improved visibility and no leakage even after several months of continuous water exposure as shown in **Figure 16**.

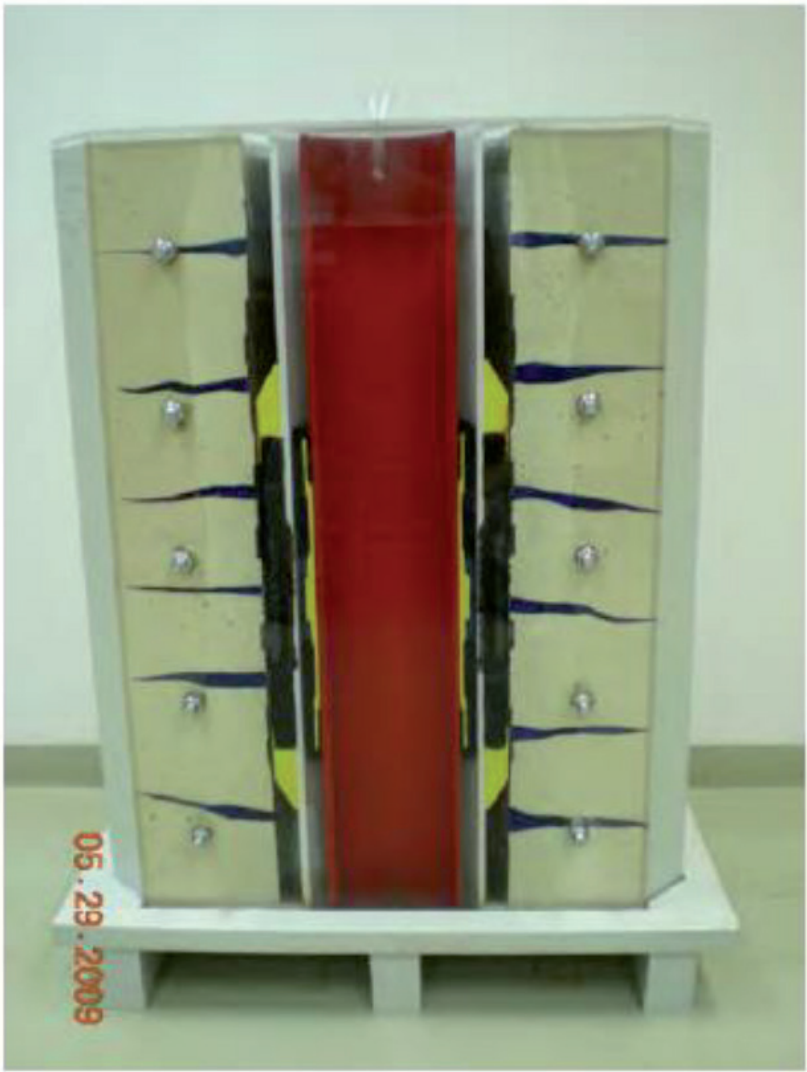
**Figure 16.**  
*Experimental unit after one year of re-swelling showing the swelling durability.*

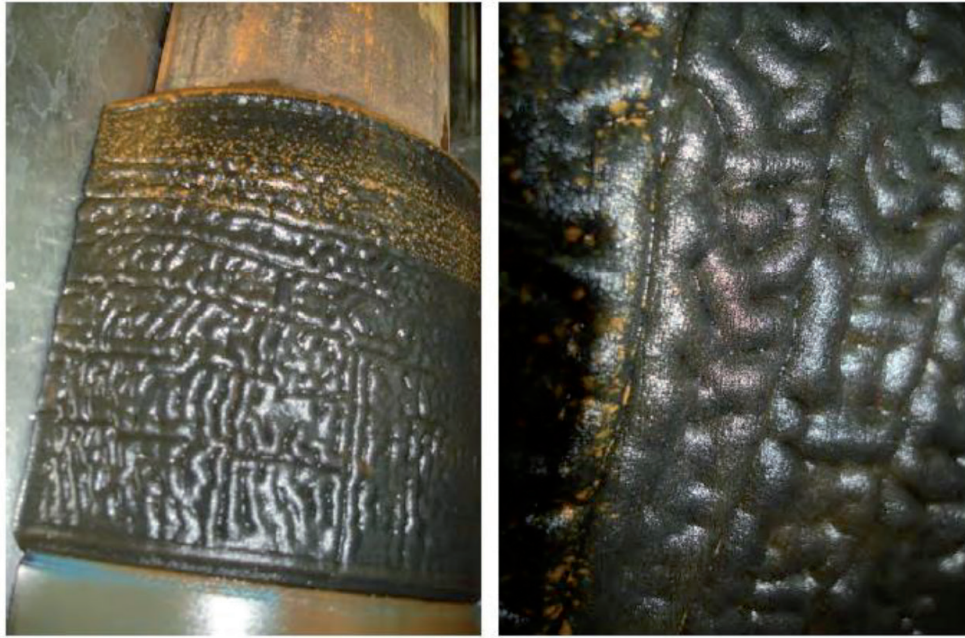
**Figure 17.**  
*Pictures of the elastomer surface that swells against formation (concrete block), after swelling and partial de-swelling.*

Dismantling the system gave a great unexpected benefit. Generally, no one has a clear idea of how the elastomer looks after swelling against the casing or the formation. However, as the system was disassembled, there was a chance to have a close look at the elastomer surface that was swelling against the concrete block. **Figure 17** displays extremely interesting and unique photographs of the almost brain-like elastomer surface that is pressed against the concrete block due to swelling. Further investigation of this behavior could reveal interesting physical phenomena responsible for this pattern after swelling and partial de-swelling of elastomers in general, and of these specific types of elastomers in particular.
