Analysis of Landslide and Land Subsident Using Geophysical Method in the East Java Province, Indonesia

*Adi Susilo, Sunaryo Sunaryo, Eko Andi Suryo,
Turniningtyas Rachmawati
and Muwardi Sutasoma*

Abstract

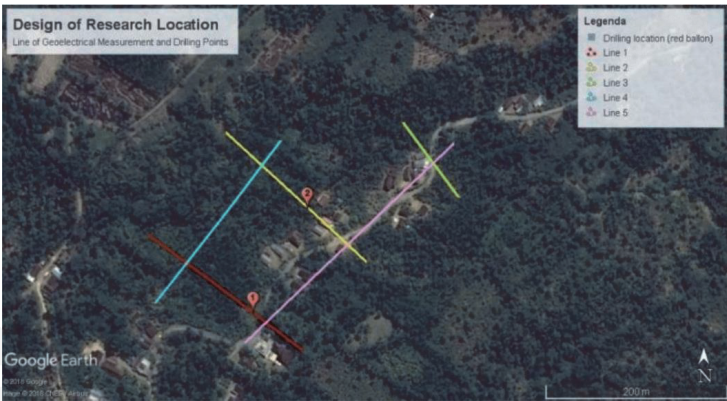
Figure 2.
Geoelectrical resistivity measurement survey design, Sri Mulyo Village.

The village of Sri Mulyo, Dampit subdistrict (**Figure 2**) is geographically located at 8.2928° SL 112.7991° EL. Administratively, Sri Mulyo village in the north is bordered by Bumirejo Village, Ampelgading Sub-District in the east, Sumbermanjing Wetan Sub-District in the west, and Sukodono Village in the south. In general, the soil structure in Sri Mulyo village is podzolic soil, where the topography is plains and mountains with an altitude of 400–790 meters above sea level, and the slope of the slope is less than 40%. The average annual rainfall is 5229 millimeters. The majority of the population is coffee and salak farmers.

The research in Jawar Hamlet, Sri Mulyo Village was carried out in 2015 which is located at the coordinates of $08^{\circ}18'44,86''$ - $08011'05,16''$ SL and $112049'22,02''$ - $112041'56,47''$ WL. There are 5 measurement lines for the resistivity method (**Figure 3**). Lines 1, 2, and 3 with a track length of 180 meters, 200 meters and 100 meters, respectively, and the spacing between electrodes is 10 meters. Lines 1 to 3 are measured from Southeast to Southwest. Line 4 with a track length of 200 meters with an electrode spacing of 10 meters while line 5 with a line length of 300 meters and an electrode spacing of 15 meters. Lines 4 and 5 are measured from West to East.

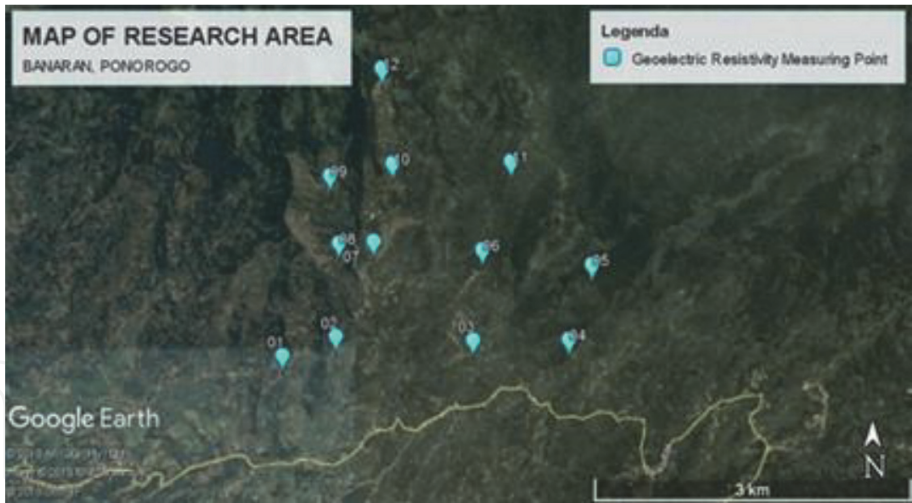
Figure 5.
Distribution of geo-electric resistivity measurement points.

The method used in this research is geo-electric resistivity method, sama seperti yang dilakukan di desa Srimulyo. There are many configurations used in this method. In this research, we used a modified Wenner-Schlumberger configuration (**Figure 5**) with fixed electrode potential and the current electrode to obtain Vertical Electrical Sounding (VES). To obtain the lateral direction variation, the VES through interpolation dots are measured. This configuration is the right choice if the desired target is the VES with optimal field effectiveness and reduction accumulation error. Measurements were made at 12 points. The selection of this measurement point is based on the fact that the area is still relatively flat and the results of the interpretation can be correlated from one location to another.

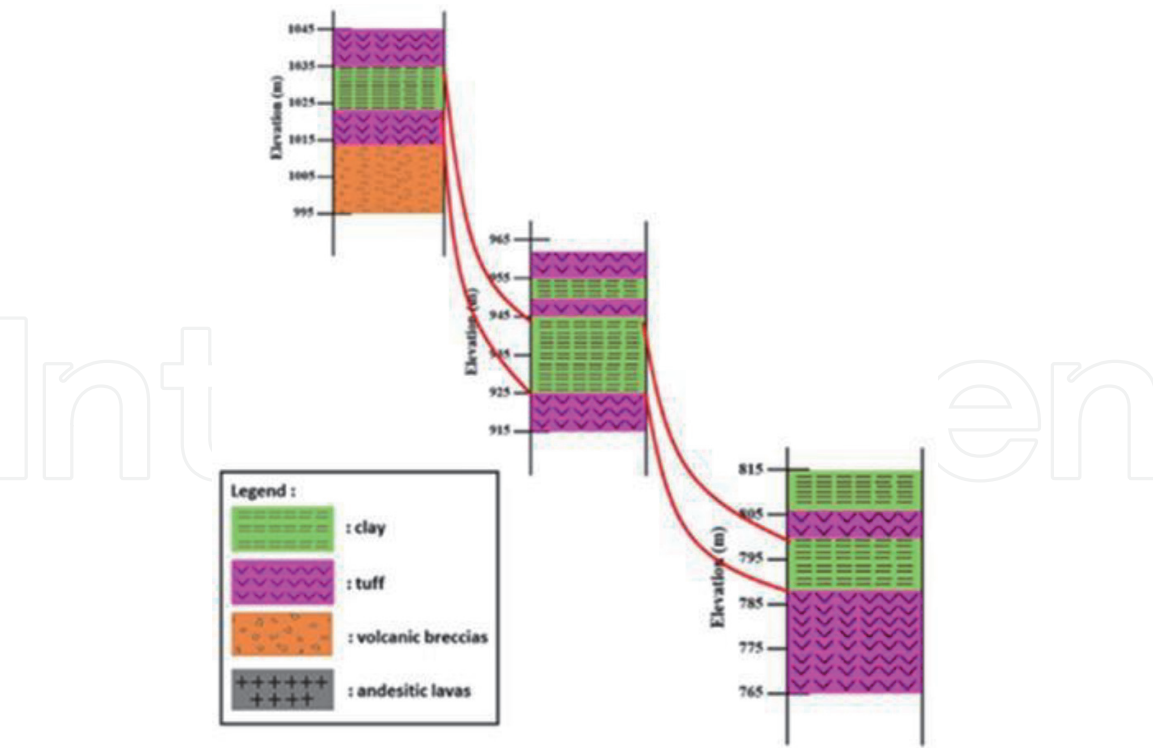
Figure 11.
Correlation of lithology of measuring points 11, 06, and 03 (from top to bottom).

If the correlation is made for inline points, the following results (**Figure 11**) will be obtained:

The results of data processing from this resistivity method indicate that the landslide field is located at a depth of 8 to 35 meters. Tuff is indicated as a landslide field. Interpretation of resistivity data for lithological correlation shows that the upper part of the landslide area is dominated by rocks with low resistivity (conductive) and quite thick (5–35 m) which is indicated as clay. Clay is a type of rock that has very small permeability, which is 10^{-7} cm/s. In addition, the research location is a steep slope. From the interpretation of the lithological correlation, the estimated slope of the location is ≥ 400 , and the rainfall was quite high at that time, namely 18.95 mm per day. The length of the rainy month is nine months.
